type
HDC

subject
EXAMPLE OF TROUBLE
DUE TO LOOSENED FIXING BOLTS (for terminals, etc.)

Ref. No.
AS-DC14-001
Issued: October, 2014

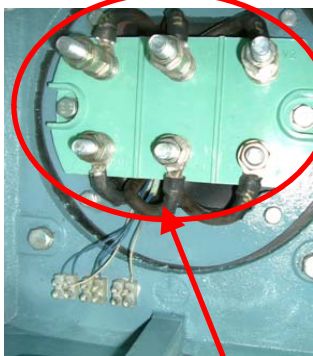
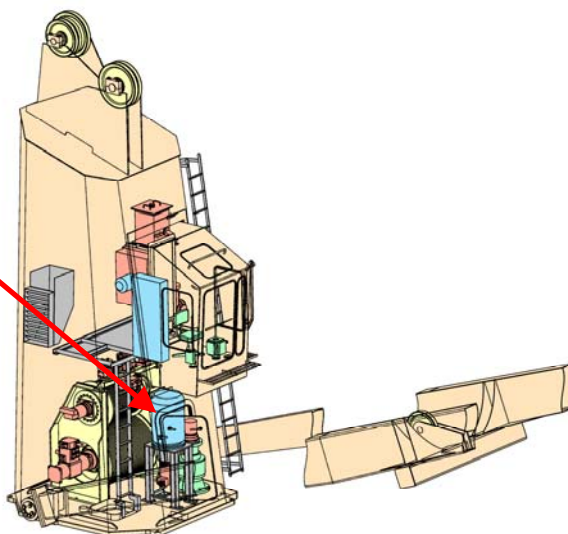
Inside of terminal box

For deck cranes of 30 tons
Size of bolts : M12
Tightening torque : 50Nm
* 6 pcs for outer cable and 6 pcs of internal cable
(total: 12pcs)

In the below mentioned cases, vibration during voyage and cargo work is considered to be a cause, and for the safe and stable operation of deck crane, please check tightness of bolts and nuts of every parts, and continue those check periodically, according to instruction in the manual.

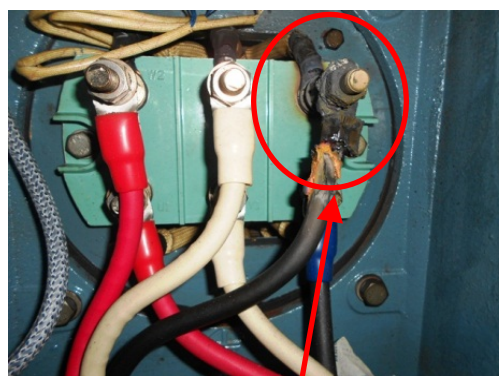
Example of burned terminal

Burned due to loose connection of crimping terminal

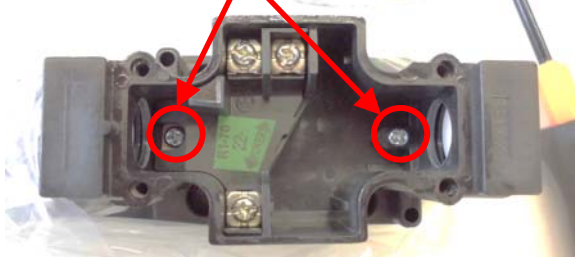
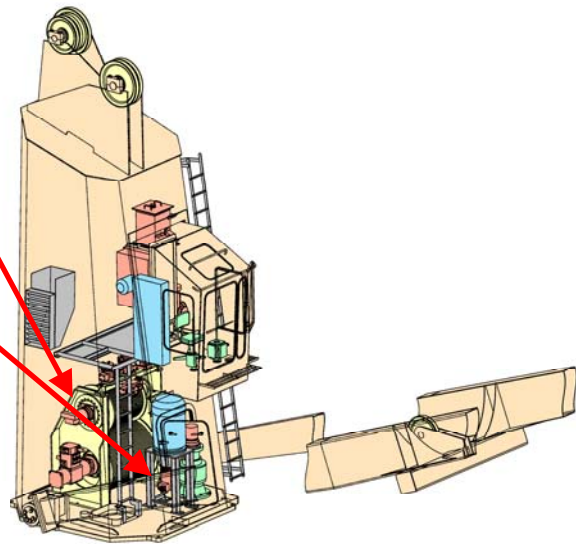
Solenoid valve for grab / hook change
(located at frame of winch)

Solenoid valve for brake release
(located at pump unit stand)

Fixing screw × 2 pcs
(cover of terminal is opened)
Tightening torque : 0.5N-m ± 10%

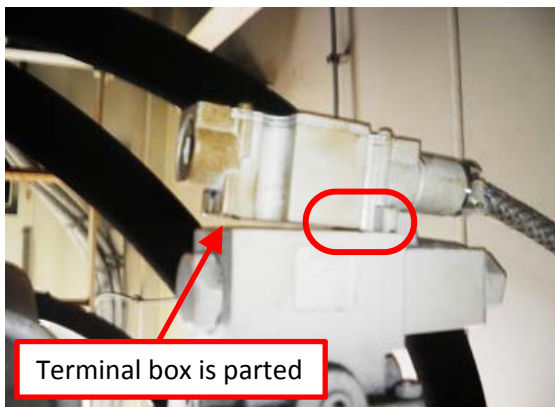
Example case of breakage

Terminal box is parted

Terminal was broken and fuse (F2)
blew out due to short circuit

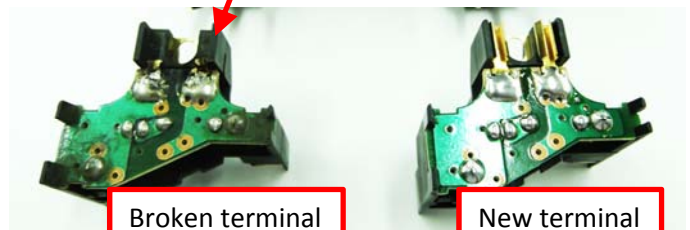
Broken terminal

New terminal
