## **SERVICE NEWS**

## INSPECTION & MAINTENANCE FOR STRUCTURE OF OPERATOR'S CABIN

AS-DC19-002E

Feb 2019

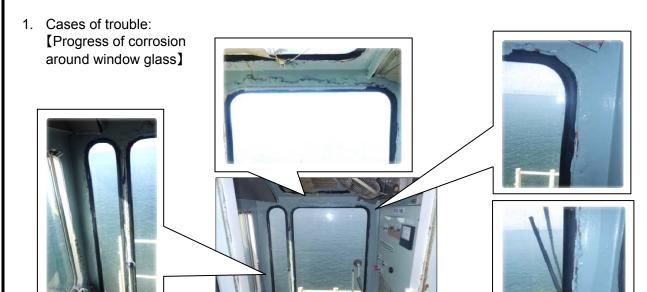
[Progress of corrosion of outer surface / handrail]

[Progress of corrosion, breakage of wiper]

[Progress of corrosion, breakage of fixing bolts]

Condition	Necessary measures
Rust / corrosion of steel structure of cabin	Removal of rust and re-painting
Water ingresses through rubber for window	Apply caulking on the edge of rubber packing (outer side of cabin) [Figure 1]
Water ingresses through gap between cabin and crane's body.	Apply caulking on gap of upper of cabin and crane's body [Figure 2]
Hole, damage on steel structure of cabin / handrail	Replacement of steel plate of damaged area (Material: SS400, thickness: 6mm) Replacement of handrail (Material: SGP20A, Outer dia. φ27.2mm, thickness: 2.8mm)
Breakage of fixing bolts of cabin	Replacement of bolts  * In case replacement of bolts is difficult due to accessibility, it can be altered by addition of stiffener from inside of crane's post.  【Refer to appendix】
Breakage of wiper	Replacement of wiper

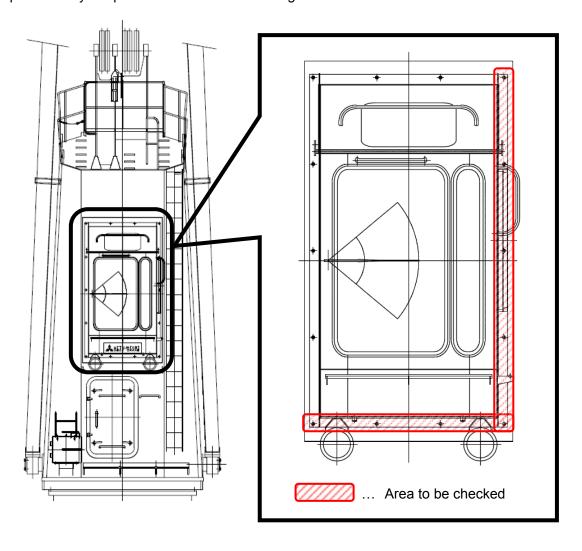
As for check of fixing bolts, access to upper & left side of cabin is difficult without scaffolding, so please carry out possible check for lower & right side as shown below.
