**MU-2**

# SERVICE BULLETIN

No. 107/57-005      DATE: May 3, 2016

Subject:      Wing Spacer Plate – Inspection and Replacement of

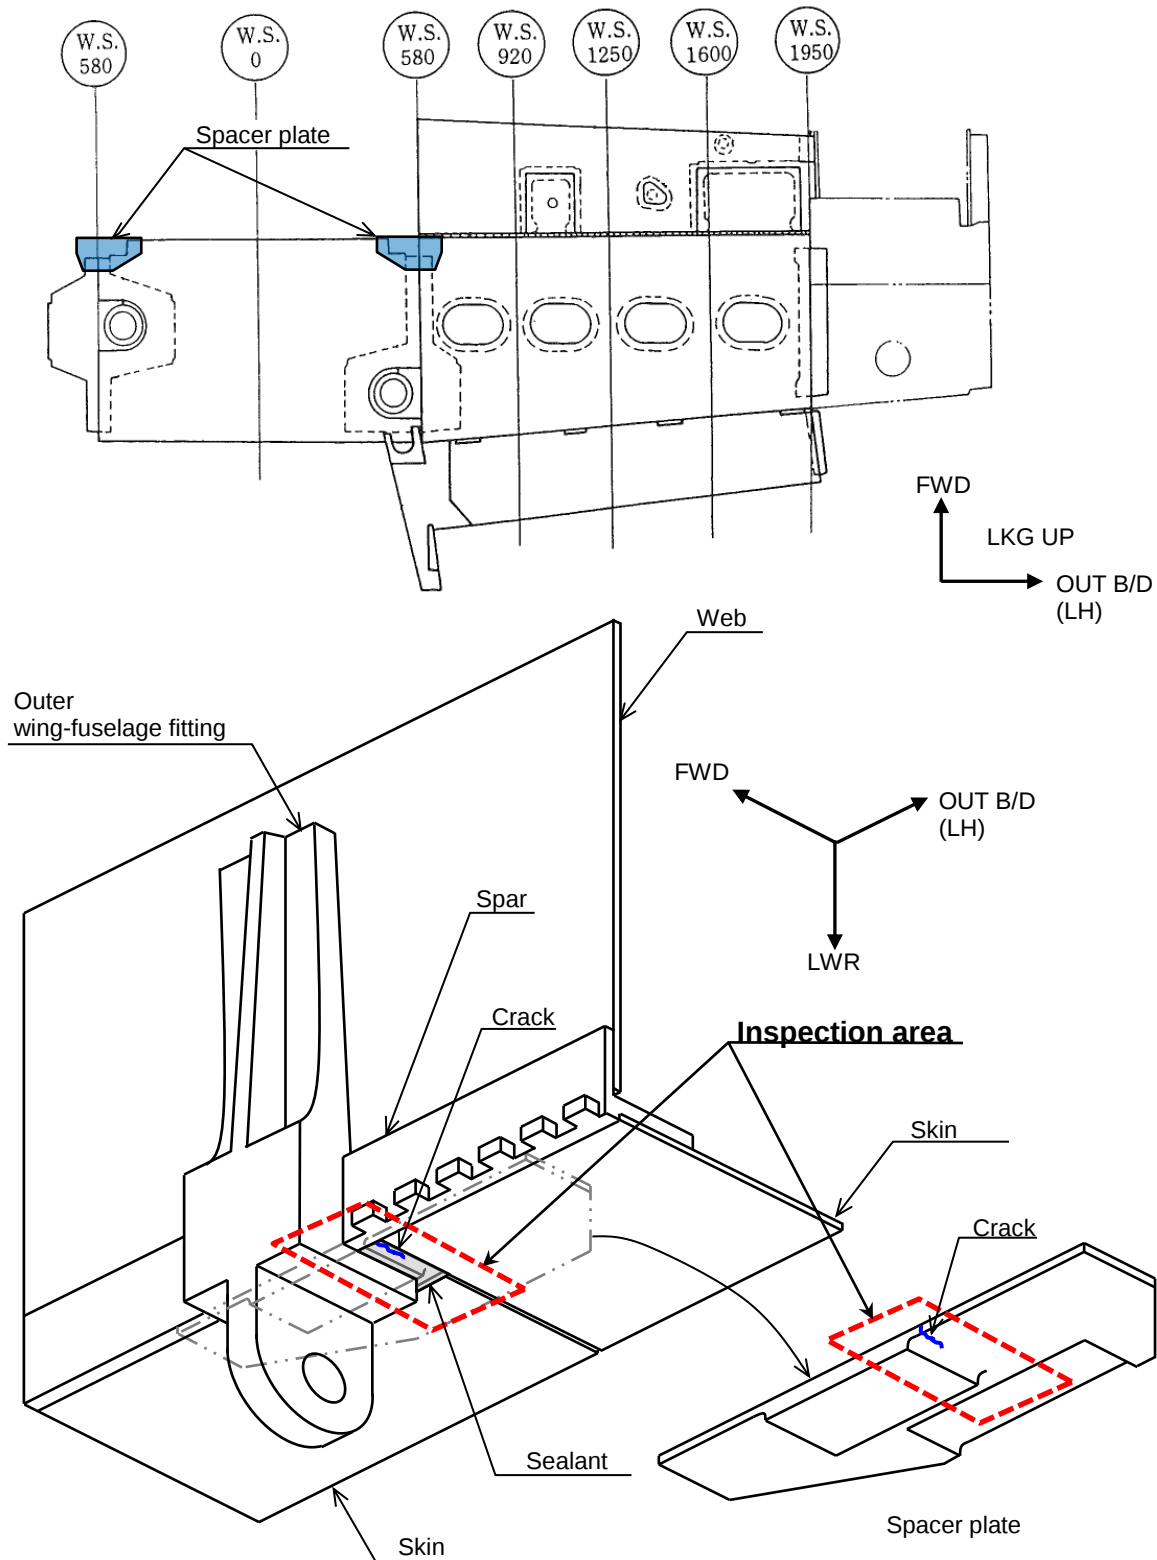
Figure 1: LOCATION OF SPACER PLATE INSPECTION  
(Typical, LH side shown, RH side opposite.)

Background:      As part of aging aircraft program, one-piece and three-piece main wings were subject of detailed teardown inspections, and cracks were found in the wing spacer plates attached to the forward lower spar at W.STA580. The cracks resulted from fatigue to be caused by flight load.

- (1) Conduct a fluorescent penetrant inspection to the inspection area shown in Figure 1 and 2 on both left and right sides of wing in accordance with applicable Maintenance Manual.

- (a) When a crack of 0.6 inches or greater is found  
Replace the discrepant spacer plate with a new improved spacer plate (P/N 017A-11102-13/-14) and scrap the discrepant spacer plate. Replacement procedure is instructed in Section 2.
- (b) When a crack of less than 0.6 inches is found  
It is allowed to monitor the crack growth by repetitive inspection at the interval of 600 hours. However, the spacer plate must be replaced when the crack length grows beyond 0.6 inches.

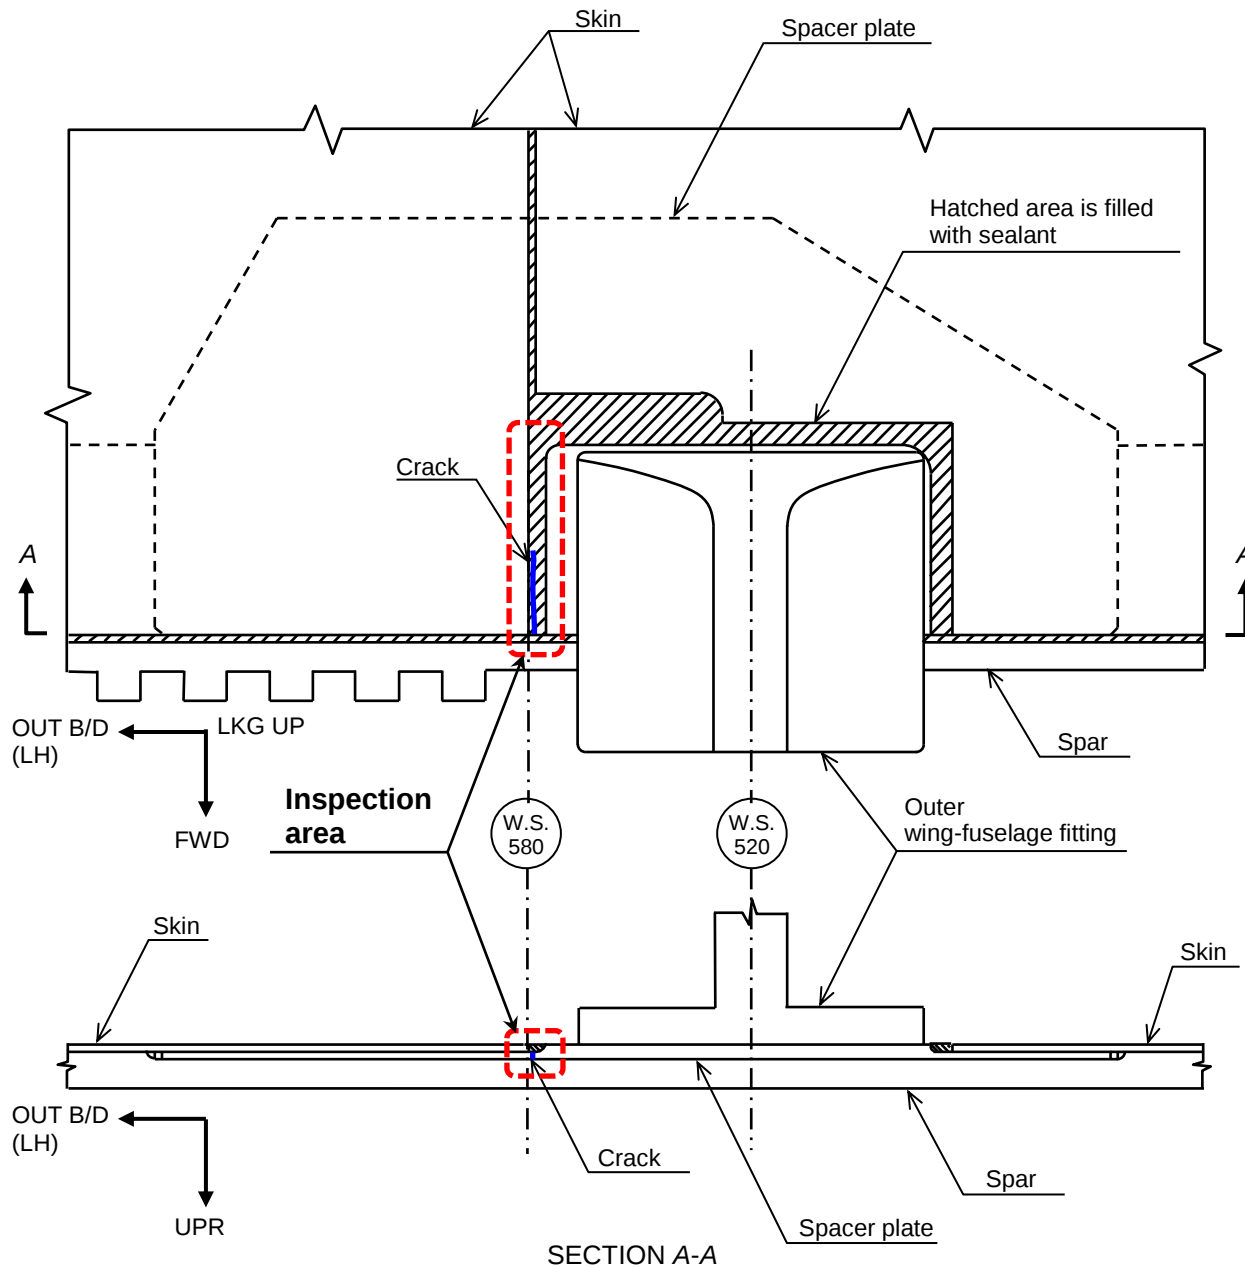
Figure 2: DETAILED INSPECTION AREA OF SPACER PLATE  
(Typical, LH side shown, RH side opposite.)

- (1) Electrically ground the aircraft.
- (2) Remove the wing center lower fillet and the inner wing leading edge in accordance with applicable Maintenance Manual.
- (3) Remove sealant and primer from the inspection area between the spacer plate and the skin with a nonmetallic scraper. See Figure 1 and 2.
- (4) Clean and expose the inspection surface.

- (16) Apply integral tank sealant and dry in accordance with applicable Maintenance Manual and the installation drawing (refer to Figure 5).
- (17) Apply sealant to fill the gaps between the spacer plate and the skin shown by the hatched area in Figure 2 in accordance with applicable Maintenance Manual.

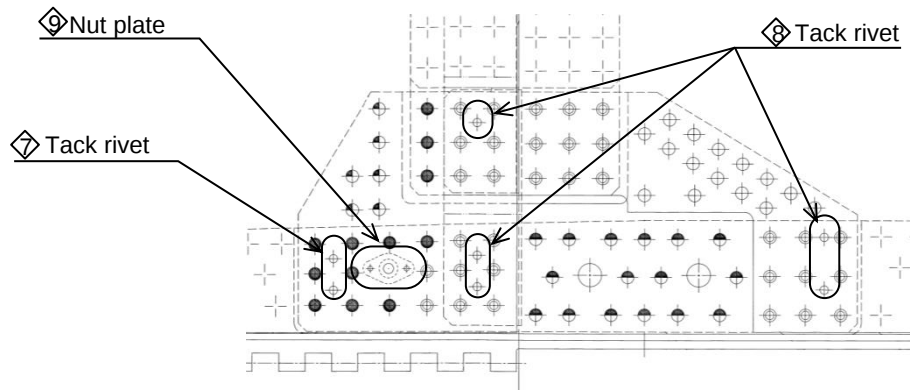
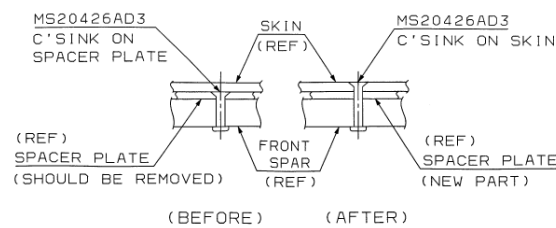
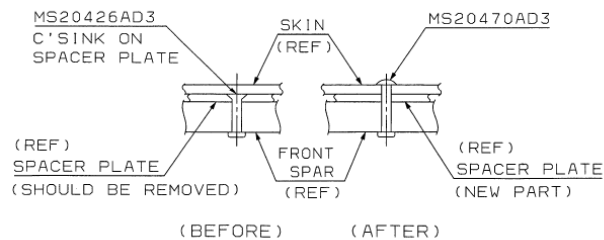
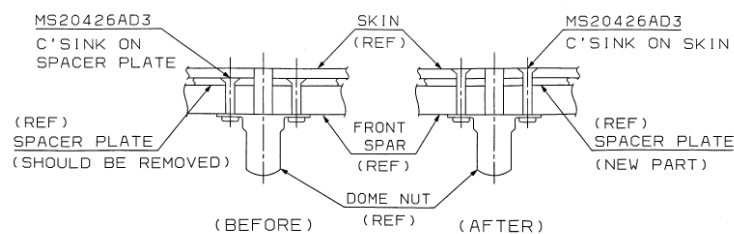
Figure 4: INSTALLATION OF TACK RIVET AND NUT PLATE  
(Typical, LH side shown, RH side opposite.)

Several tack rivets and a nut plate are hidden under the skin and sealant as shown in Figure 4. Be careful not to damage adjacent structural components when removing the spacer plate.

Note: Tack rivets and a nut plate are installed under the skin originally.

7 : INSTALL RIVET MS20426AD3 AS SHOWN.

8 : INSTALL RIVET MS20470AD3 AS SHOWN.

9 : INSTALL RIVET MS20426AD3 AND DOME NUT AS SHOWN.
