**MU-2**

# SERVICE BULLETIN

No. 245  
Subject: Wing Spacer Plate – Inspection and Replacement of  
Effectivity: MU-2B-20/-25/-26: S/N 102 and 121 through 347 except 313 and 321  
MU-2B-30/-35/-36: S/N 502 through 696 except 652 and 661  
Purpose: To ensure the continued airworthiness of the wing structures, conduct a one-time fluorescent penetrant inspection for the wing spacer plates and replace them, if necessary.  
Background: As part of aging aircraft program, one-piece and three-piece main wings were subject of detailed teardown inspections, and cracks were found in the wing spacer plates attached to the forward lower spar at W.STA580. The cracks resulted from fatigue to be caused by flight load.  
Compliance: Mandatory  
Approval: JCAB Approved  
Time of Compliance: a) For aircraft with flight time 7,500 hours or over

No. 245

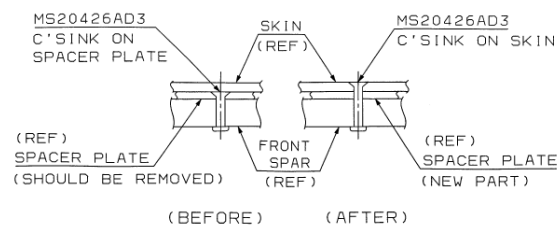
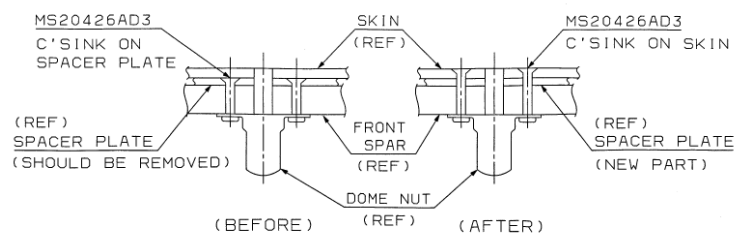
Figure 4: INSTALLATION OF TACK RIVET AND NUT PLATE  
(Typical, LH side shown, RH side opposite.)

Several tack rivets and a nut plate are hidden under the skin and sealant as shown in Figure 4. Be careful not to damage adjacent structural components when removing the spacer plate.

Note: Tack rivets and a nut plate are installed under the skin originally.

7 : INSTALL RIVET MS20426AD3 AS SHOWN.

8 : INSTALL RIVET MS20470AD3 AS SHOWN.

9 : INSTALL RIVET MS20426AD3 AND DOME NUT AS SHOWN.
