# **MITSUBISHI HEAVY INDUSTRIES AMERICA INC.**

# SERVICE LETTER

**SUBJECT:** PPG Heated Windshield Seal

**MODELS AFFECTED:** All MU-2B Airplanes with PPG Heated Windshields

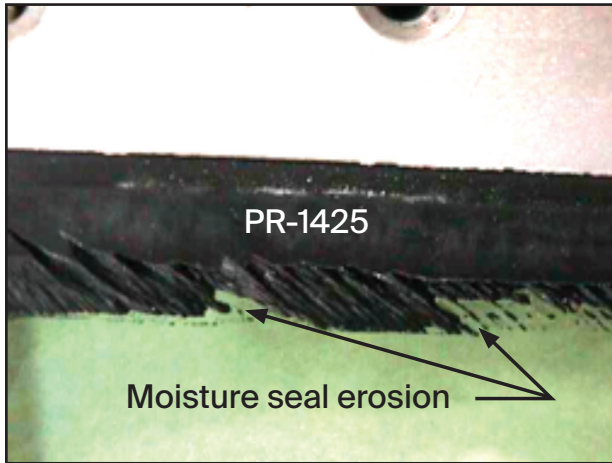
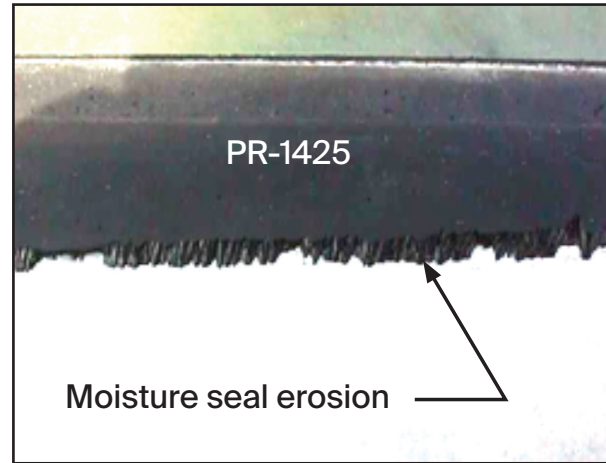
- The windshield's outboard moisture seal, also referred to as a "hump" seal because of its shape, is the primary barrier to prevent moisture from entering the laminate. If moisture gets inside the laminate, while not a structural issue, delamination and degradation of the electrical heating system can occur, reducing windshield service life.

- Regularly inspect the windshield's outer moisture seal for evidence of sealant erosion, cracking or separation from glass, plastic or metal. A typical inspection interval is every four months or 1,000 flight hours. Refer to appropriate AMM/CMM for specific inspection requirements.

- Give particular attention to areas where the seal appears worn. If the sealant has eroded more than 25% of its original width or if the sealant has cracked or debonded, the moisture seal should be repaired at the next opportunity.

- Information about PPG Hump Seal Repair Kits is posted online at [www.ppgaerospace.com](http://www.ppgaerospace.com). Under "Products," click on "Transparencies" and then "Transparency Repair Services."

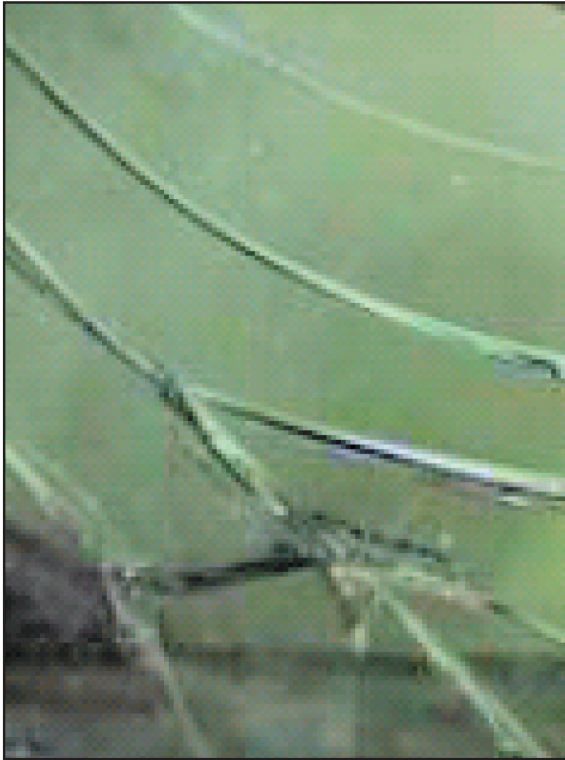
Typical fracture pattern  
fragment size of  
chemically strengthened glass

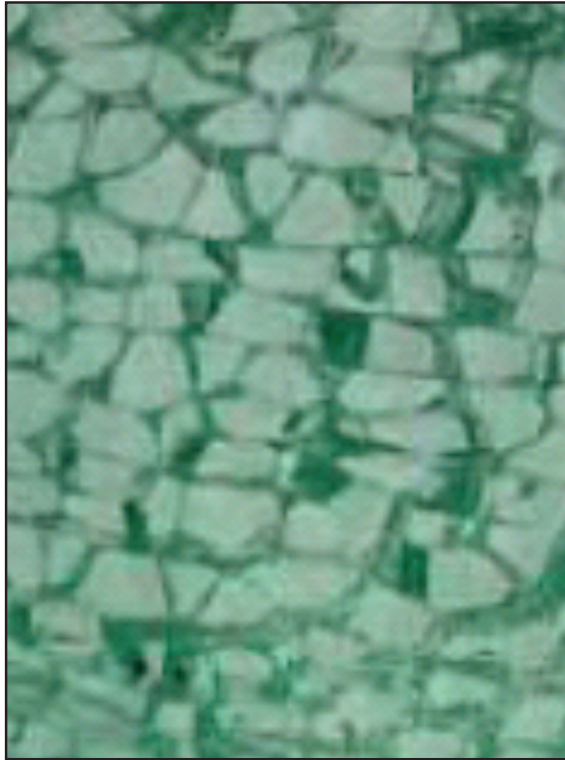
Typical fracture pattern  
fragment size of  
thermally tempered glass

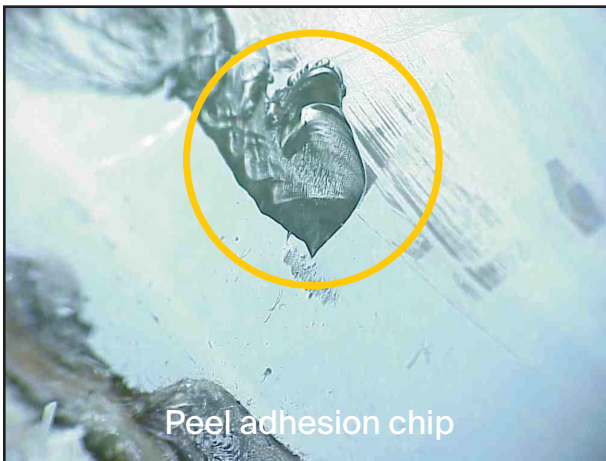
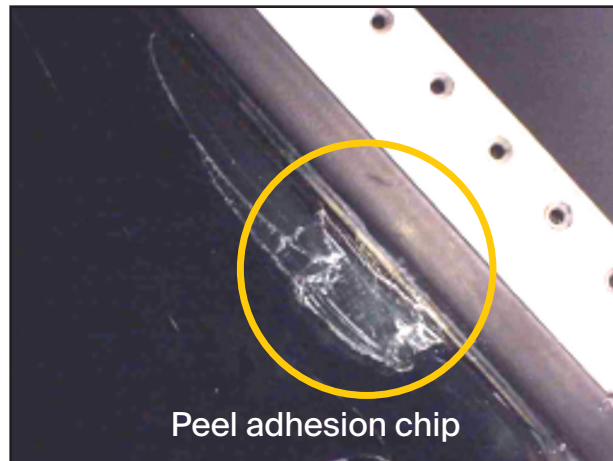
## Electrical arcing, peel adhesion chip

- Heated glass plies may fracture as a result of the overheat condition caused by electrical arcing at the bus bar/conductive film interface. The extreme heat generated by the electrical arcing causes damage to the glass that propagates from mechanical and thermal stresses encountered in service. The damage propagates until the center tension area of the thermally tempered or chemically strengthened glass is penetrated, causing spontaneous fracture.

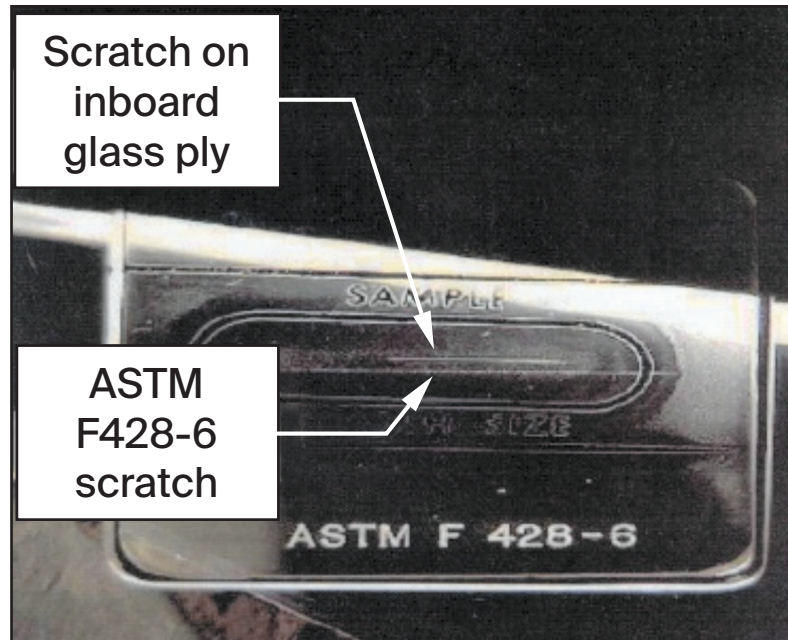
## Structural glass ply visual inspection

A scratch is acceptable if the visible scratch intensity is equal to or less than the F428-6 scratch standard.

A scratch is unacceptable if the visible scratch intensity is greater than the F428-6 scratch standard.

- Scratches may occur on the outer surface of the nonstructural outboard glass ply. Scratches on the outer glass surface are structurally acceptable. The windshield may remain in service as long as visibility through the windshield is not impaired.

- Scratches on the inboard surface of the inner structural glass ply shall be compared to the ASTM F428-6 Aerospace Scratch Standard for Glass. Note: Aerospace Scratch Standards illustrate scratch severity as reflected light intensity. The greater the intensity, the more severe the scratch. This is a visual evaluation and does not indicate the actual depth of the scratch.

- Any scratch on the inboard surface of the inner structural glass ply with an appearance intensity equal to or less than the ASTM F428-6 standard or having a depth equal to or less than 0.002 inch (0.05 mm) shall be allowed no matter what the accumulated length as long as the pilot's visibility is not impaired.

- Any scratch on the inboard surface of the inner structural glass ply appearing to have an intensity greater than the ASTM F428-6 Aerospace Scratch Standard or a depth greater than 0.002 inch (0.05 mm) requires replacement of the window.
