# SERVICE LETTER

**SUBJECT:** FAA SAIB CE-19-13 – Flight Control Cables and Terminals

## **SPECIAL AIRWORTHINESS INFORMATION BULLETIN**

**SUBJ:** Flight Controls; Cable Terminals Used on 14 CFR Part 23 and CAR  
Part 3 Airplanes with Mechanical Flight Control Cables

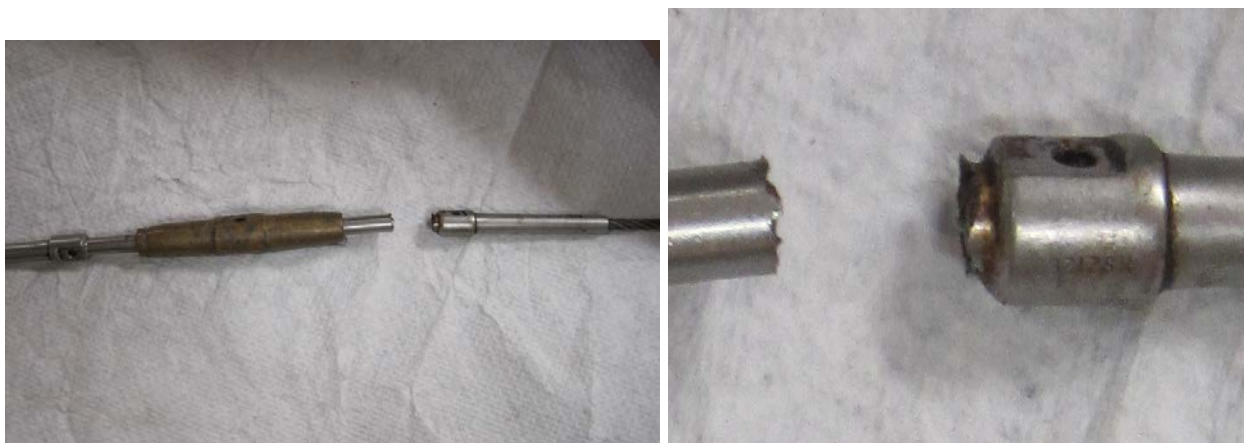
The specific focus of this SAIB is on the connecting fittings that are attached (swaged) to the flight control cables and threaded onto the turnbuckles. These fittings are typically manufactured from a type of stainless steel that is susceptible to stress corrosion cracking under certain conditions over time. Based on multiple part examinations, the stress corrosion cracking originates at general corrosion pits on the surface of the parts. Because the cracks are primarily below the surface, they can be extremely difficult to detect. Because stress corrosion cracking is usually preceded by or accompanied with visible corrosion, any presence of even light or moderate corrosion on these fittings is cause for concern.

Factors that contribute to stress corrosion cracking for stainless steel fittings of this type are exposure to contamination (chlorides) along with being under sustained tensile stress. Heat is also a contributing factor. It is therefore likely to occur more quickly in a warm, humid, salt air environment, and progresses based on calendar time rather than flight time. A number of failures have occurred in areas of the airplane adjacent to heating and ventilating ducts, thus raising the possibility that elevated temperatures and/or condensation associated with the ducting was an aggravating factor. Owners and operators of certain Beechcraft Bonanza and Debonair airplane models should be aware that multiple failures of an aileron cable terminal have occurred in a location just forward of the rear spar and underneath a ventilation/heating duct. This applies to most airplane Models 33, 35, and 36 manufactured between approximately 1964 and 1977, after which the aileron

A picture from a recent incident involving failure of such a fitting is shown in the photographs below. Note the small amount of corrosion adjacent to the fracture location.

- b. Replace any removed safety wire with new safety wire in accordance with normal procedures.
3. If any sign of corrosion, pitting or cracking is present on any fitting, replacement of the associated fitting and/or cable assembly is recommended.

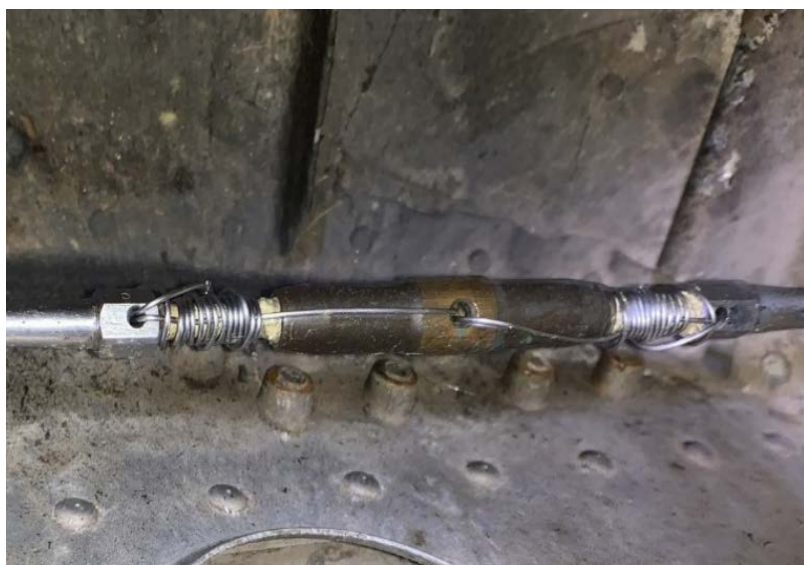
Depending on whether safety wire or a safety clip is used to secure the turnbuckle, any corrosion such as this may be hidden from view by the safety wire, which needs to be removed in order to perform an adequate inspection. The following photograph shows a typical safety wire configuration.

- a. If safety wire is installed such as to prevent examination of the fitting surface, the safety wire must be removed.  
**Caution:** Care should be taken to avoid any adjustment of the turnbuckle relative to the fittings. Otherwise, re-rigging of the affected flight control cables per the manufacturer's instructions should be done before further flight.

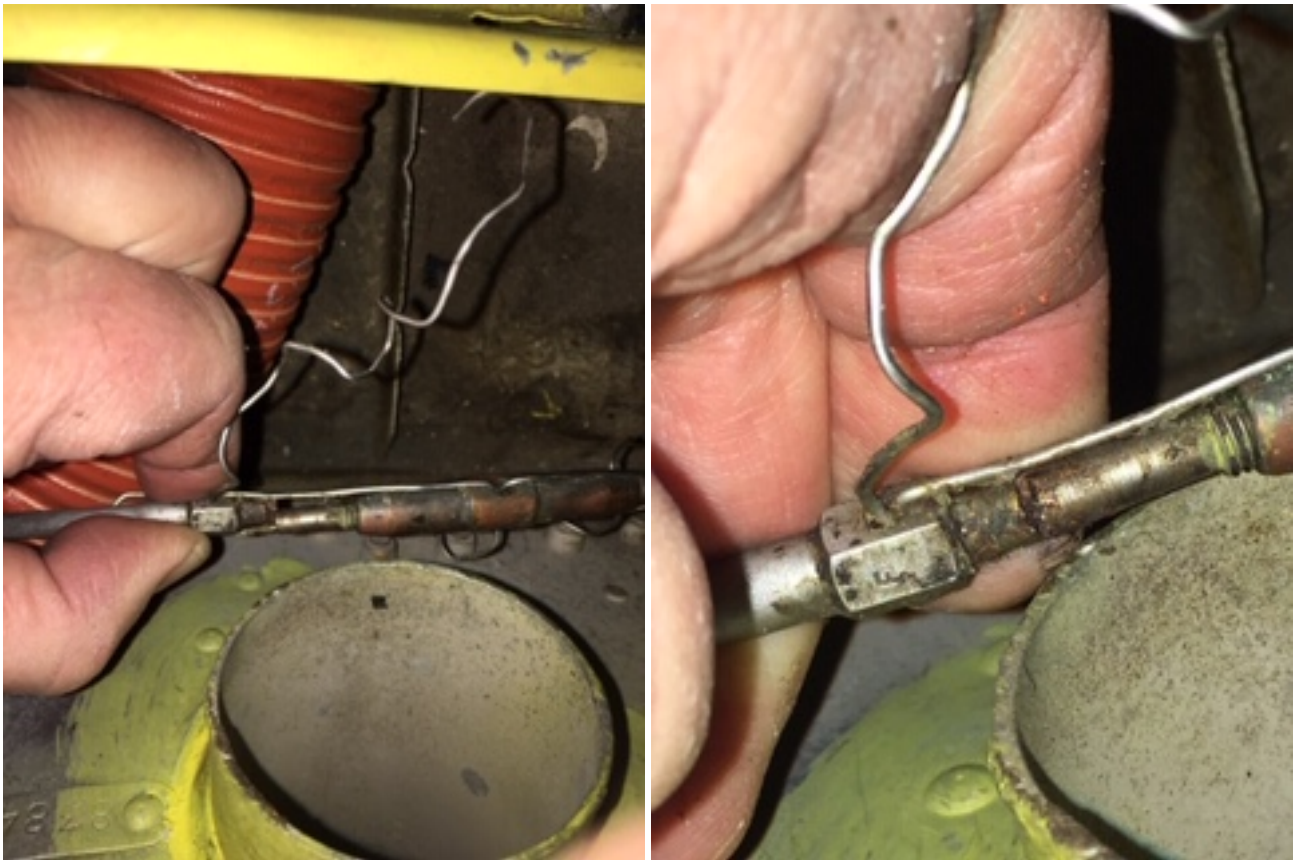
The following photograph shows a failure that occurred on a cable fitting located under a ventilation/heating duct on a Beechcraft Bonanza airplane.

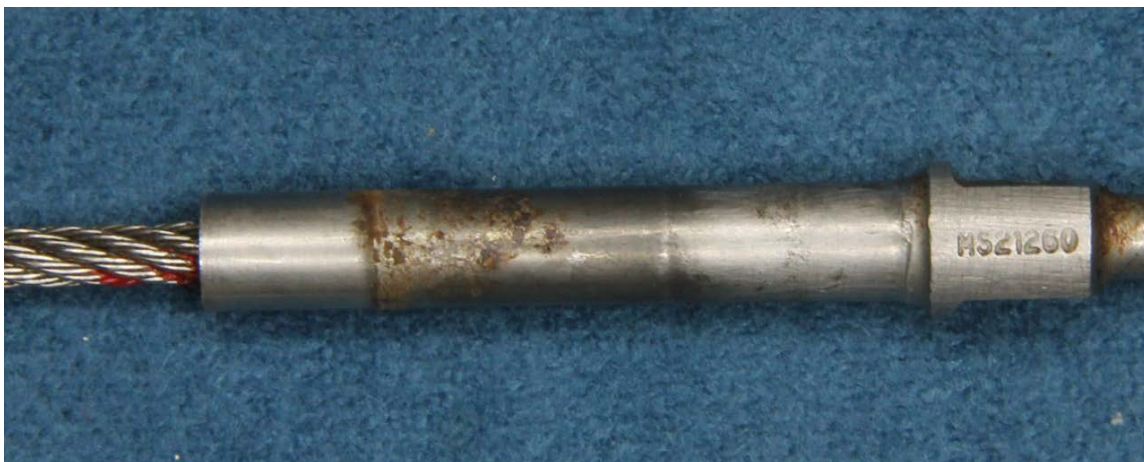
Another aggravating factor is the presence of sleeving or tape that is sometimes installed on the fitting shank for identification as an aid during initial airplane assembly. Corrosion can form more quickly underneath this material and be hidden from view during an inspection as shown in the following photograph. This material has no functional purpose on an assembled airplane.

- b. Examine underneath any sleeving or tape that is installed on the fitting shank.
    - i. Remove and discard any such tape or sleeve material while exercising care not to gouge or scratch the fitting surface. Removal of this material is considered a minor alteration to the airplane and should be documented by an appropriate logbook entry.
