## SERVICE LETTER

**SUBJECT:** NTSB Safety Alert No. 082 – Flight in Snow

**MODELS AFFECTED:** All MU-2B Airplanes

# Flight in Snow

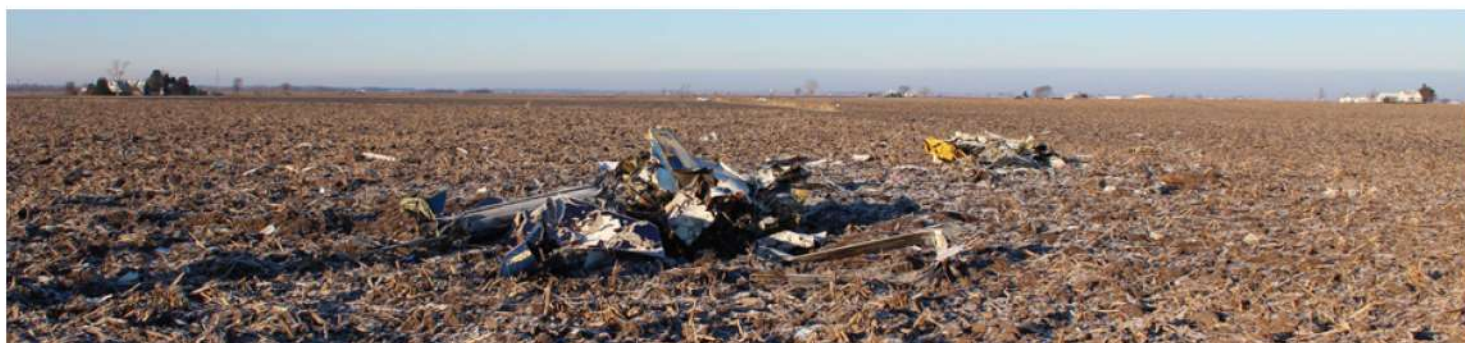
**Figure 5.** CEN13FA096 accident scene

- A medical transport helicopter, on a night VFR flight to pick up a patient, inadvertently encountered inclement weather (including snow, supercooled-liquid water, and reduced visibility conditions) and impacted terrain (see figure 5). The computer-based weather information available to the pilot showed marginal VFR ceilings and visibility with snow before departure. Available weather data and reports from first responders to the accident site indicated that the flight likely encountered areas of freezing drizzle, supercooled liquid water, and snow. (CEN13FA096)
