**SL 113A  
SL 086/25-003A**

**FAA AD 2021-07-13, Global AMOC and Meggitt Service Bulletin -  
Pacific Scientific Company Seat Restraint System Rotary Buckle  
Assemblies**

**SUBJECT:** FAA AD 2021-07-13, Global AMOC and Meggitt Service Bulletin – Pacific Scientific Company  
Seat Restraint System Rotary Buckle Assemblies

**MODELS AFFECTED:** All MU-2B Airplanes equipped with shoulder harness restraint systems installed per  
STC No. SA1751SW

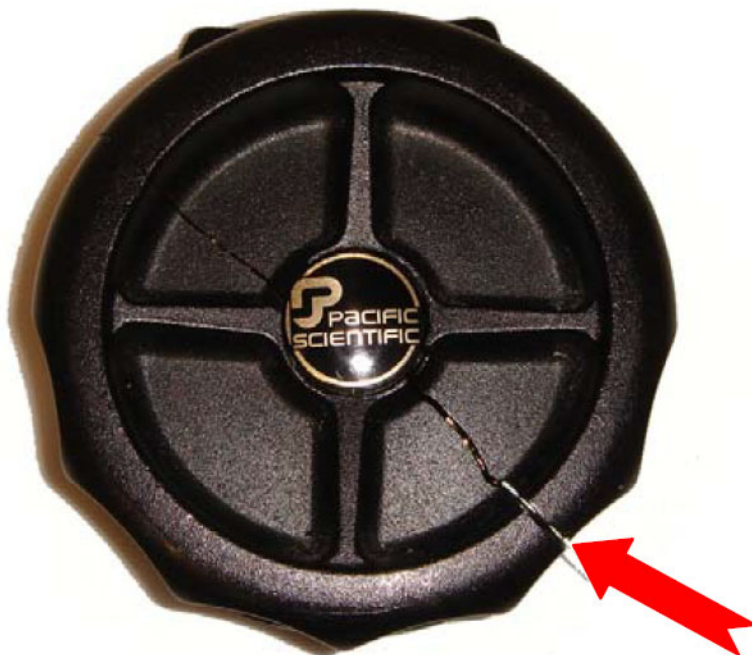
**Figure 1**  
*PNR 1111430-XX and PNR 1111475-XX Suspect Buckle Assembly*

This AD defines the unsafe condition as a cracked rotary buckle handle, which could prevent a strap from releasing as intended when the buckle is rotated.

NOTE 1 : Suspect handles may also be identified by measuring the thickness of the handle vane. Refer to Figure 1 as an example of a suspect buckle assembly with a crack.

NOTE : Any buckle assemblies with a cracked handle vane should be removed from service immediately.

- (1) Remove and replace the restraint system with a spare.
- (2) Refer to the paragraph 4.D. and 4.E. for disassembly and assembly of restraint system to repair the removed restraint system :
  - (a) Remove the buckle assembly in accordance with Figure 6 on page 22.
  - (b) Replace the suspect buckle assembly with a new and compliant unit.

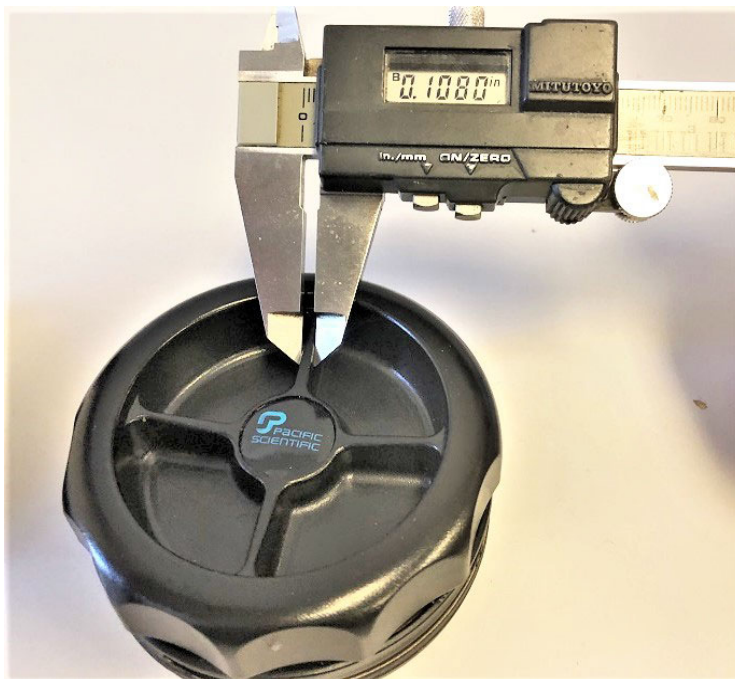
**Figure 3**  
*Correct Buckle Measurement*

(2) Within 12 months, measure the thickness of the buckle handle vane as depicted in Figure 3 of SB 25-1111432. If the handle vane thickness is 0.125 inch or greater, before further flight, remove the buckle from service and replace it with an airworthy buckle.

- (d) Inspect the buckle for one or more of the following conditions :
- 1 The thickness of the handle vane is greater than 0.125 inches at the top edge
  - 2 The buckle assembly is cracked
  - 3 The buckle assembly is not cracked, but contains a GOLD or YELLOW center logo with handle vane greater than 0.125 inches in thickness at the top edge
- (e) If the buckle meets one or more of the conditions in step (d), the following actions are required :
- 1 Remove the buckle assembly and return to Meggitt for Overhaul/SB Application. Refer to paragraph 4.D. for disassembly.
  - 2 Remove the restraint assembly and return to Meggitt for Overhaul/SB Application.
  - 3 Replace the buckle assembly or restraint assembly with a spare, new, or repaired compliant buckle assembly or restraint assembly.
  - 4 Contact Meggitt for return instructions.

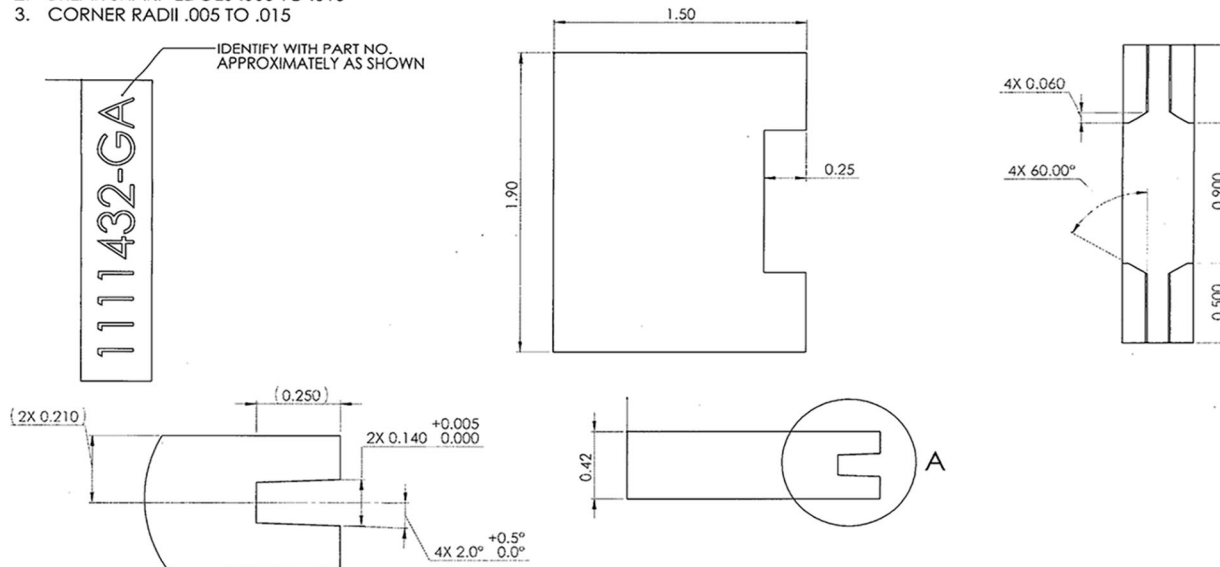
**Figure 5**  
*Optional Inspection Tool PNR 111432-GA*

### OPTIONAL INSPECTION TOOL FITS OVER VANES CENTER IS FLUSH TO BUTTON

1. MATERIAL: NYLON, DELRIN, ASA, OR OTHER SIMILAR 3D PRINTED MATERIAL
2. BREAK SHARP EDGES .005 TO .015
3. CORNER RADII .005 TO .015
