**FAA AD 2025-16-09 – Pacific Scientific Company Seat Restraint  
System Rotary Buckle Assemblies**

# SERVICE LETTER

**SUBJECT:** FAA AD 2025-16-09 – Pacific Scientific Company Seat Restraint System Rotary Buckle Assemblies

**MODELS AFFECTED:** All MU-2B Airplanes

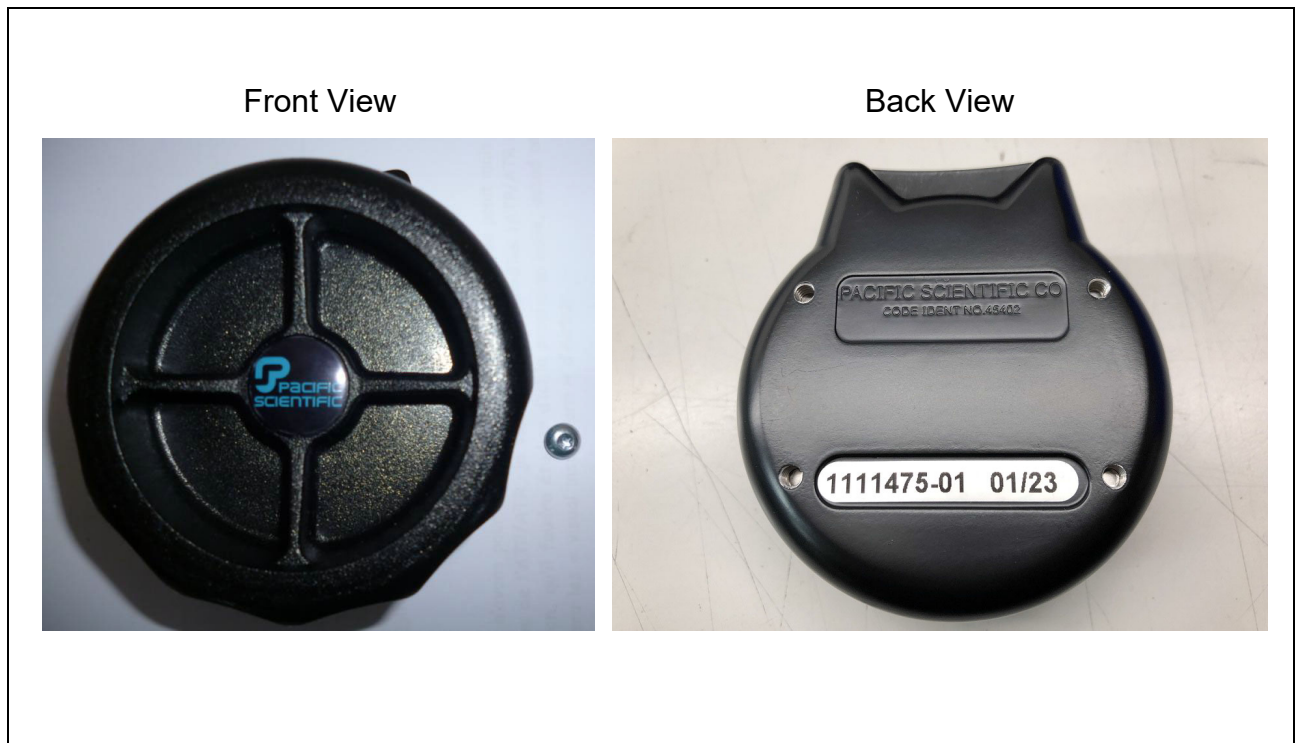
**Figure 1**  
*PNR 1111475 Series Rotary Buckle and Broken Screw Head*

- (1) In 2012 a specific lot of PNR 0901101-123 screws were improperly zinc chromate plated. This manufacturing issue resulted in the screws becoming brittle. Evidence has shown that the screw heads can break-off under load creating an unsafe condition and improper function of the rotary buckle used on the restraint system.
- (2) Screws (PNR 0901101-123) used on rotary buckles (PNR 1111475 Series) are susceptible to premature failure of the screw.
- (3) Parker Meggitt has received field reports of cracked and missing screw heads. Figure 1 on page 7 shows an example of a PNR 1111475 Series buckle with a broken screw head.

This image is for reference only. In most cases, the broken screw head will be missing and not immediately obvious. Inspection per section 4.B. is required to determine whether a buckle has broken screws.

NOTE : Any buckle assemblies with a missing screw head should be removed from service immediately.

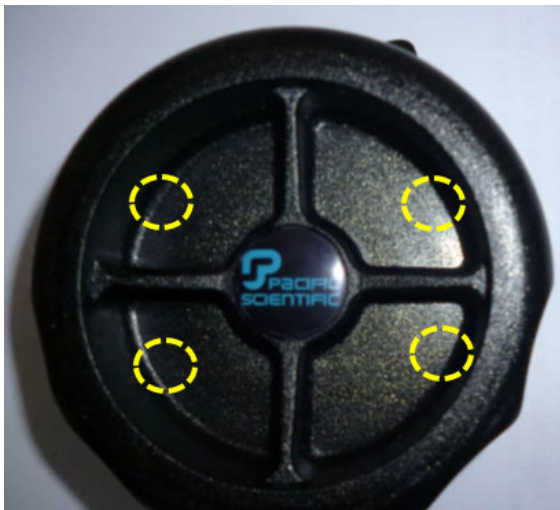
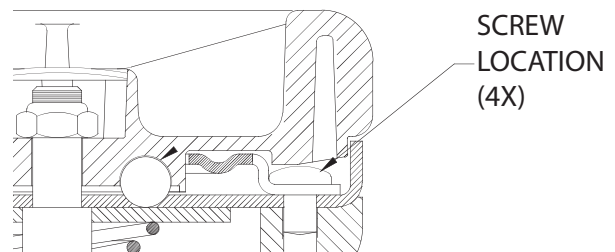
**Figure 3**

- (1) Use an inspection light to look through the belt openings in the rotary buckle. Refer to Figure 3 and Figure 4 on page 16 to locate the screws.
- (2) Inspect for the presence of 2 screw heads each on the left side and the right side of the buckle. Refer to Figure 5 on page 16.

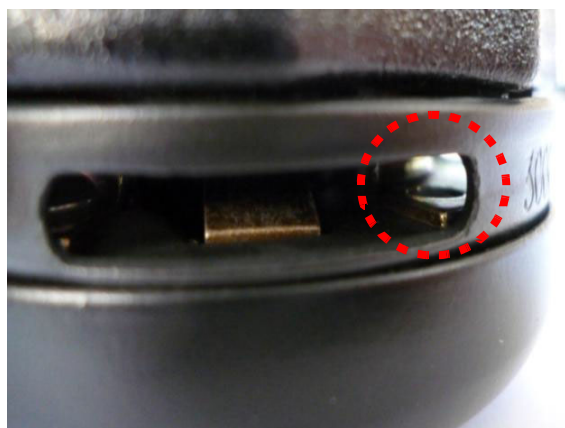
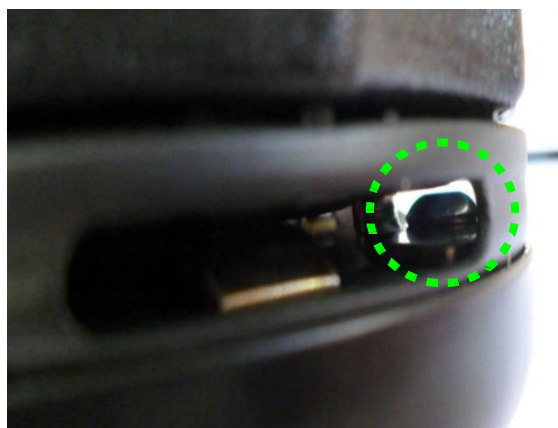
**Figure 5**  
*PNR 1111475 Series Rotary Buckle Screw Head*

Missing Screw Head

Intact Screw Head

- (3) If any screw head is not present or is separated or not attached to the screw shank in the buckle :
- (a) Remove the buckle from service immediately. Refer to the procedure in section C. to remove the buckle from the restraint system.
  - (b) Replace the buckle with a new item. Refer to the procedure in section E. to install the new buckle in the restraint system.
  - (c) Send the damaged buckle back to Parker Meggitt for repair. Refer to section F. for contact information.
- (4) If the screw heads are intact, do one of the three following methods to determine if the screws are Torx head (alloy steel) or hex head (stainless steel) screws :

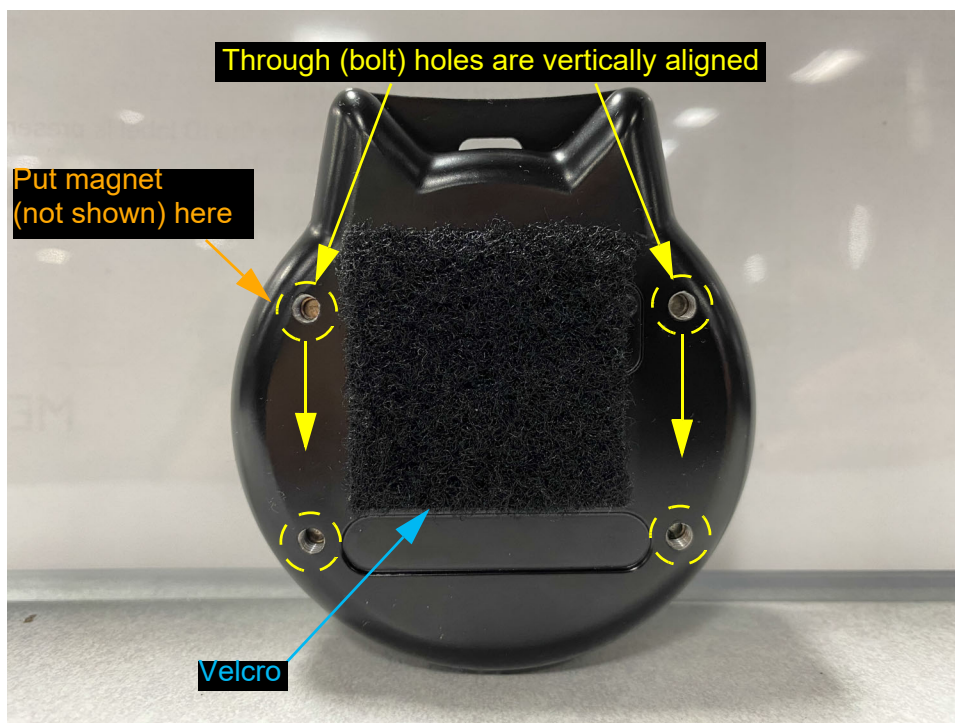
**Figure 6**  
*Magnet Test on PNR 1111475 Series Rotary Buckle with Velcro*

- 1 Use a disc magnet (recommended 3/8 inch diameter by 1/8 inch thick) [9,5 mm diameter by 3,2 mm thick] to check the magnetism of the alloy versus stainless steel screws.

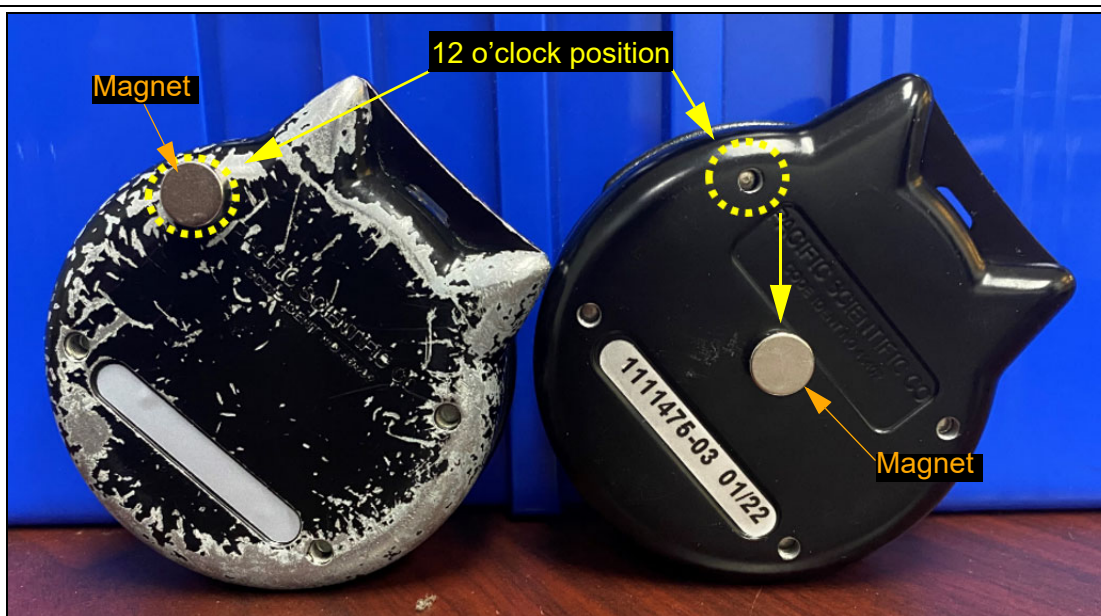
- 5 Interpret results for each of the following :
  - a If the magnet stays in place over the through (bolt) hole, this shows that the buckle has the Torx head (alloy steel) screws installed. The buckle WILL need the screws replaced. An example of this is shown in the left image of Figure 7 on page 18.

- b If the magnet slips down to and stops at the center of the buckle, this shows that the buckle has the hex head (stainless steel) screws. The buckle will NOT need the screw replaced. An example of this is shown in the right image of Figure 7 on page 18.

Magnet is over the through (bolt) hole.  
Left rotary buckle uses Torx head (alloy steel).

Magnet slips to the center of the buckle.  
Right rotary buckle uses hex head (stainless steel).

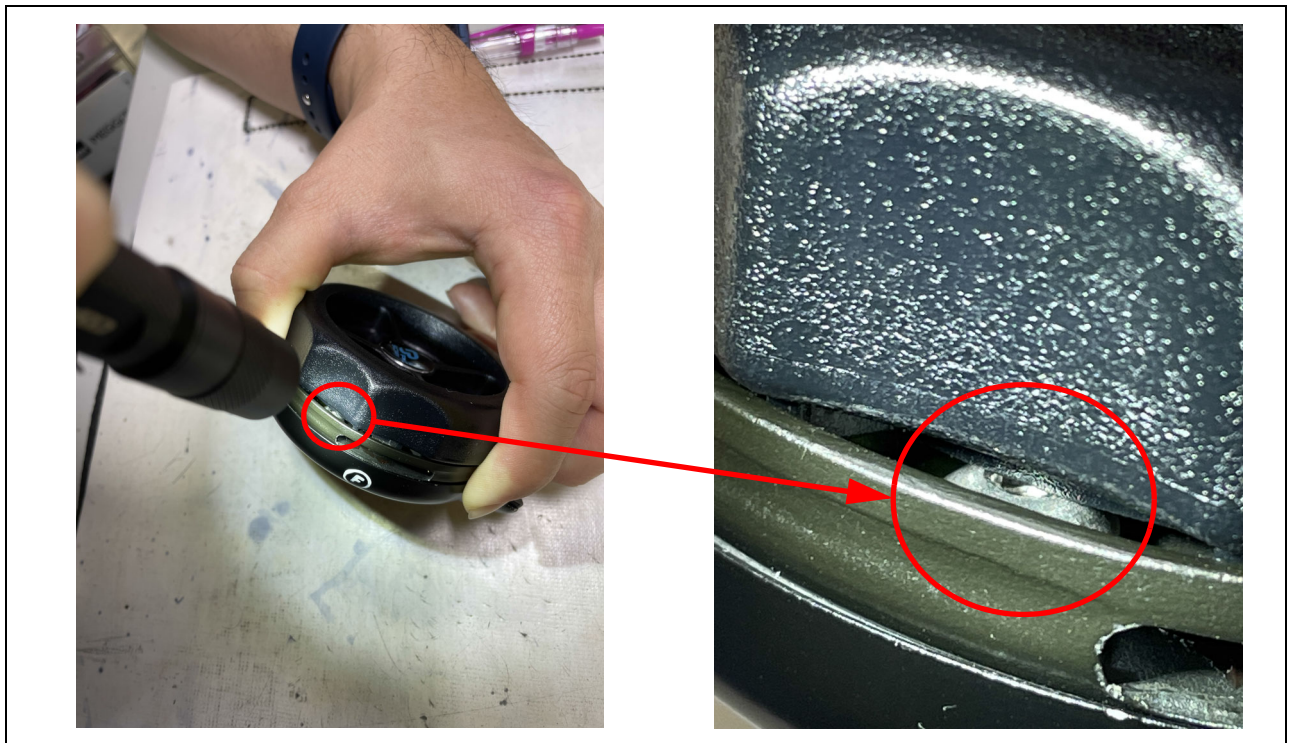
**Figure 8**  
*Side Belt Opening Inspection*

- 1 Use an inspection light (100+ lumens light with eye loupe recommended) to look through the aperture between the handle and the non-rotating portion of the buckle (Figure 8) and inspect the screws to determine whether they have Torx heads or hex heads. The handle will need to be rotated slightly to provide the best view of the two lower screws and rotate fully to view the top screws. All screws will be in the same configuration within the affected production window. Refer to Figure 9 on page 20 to distinguish the screw head types.

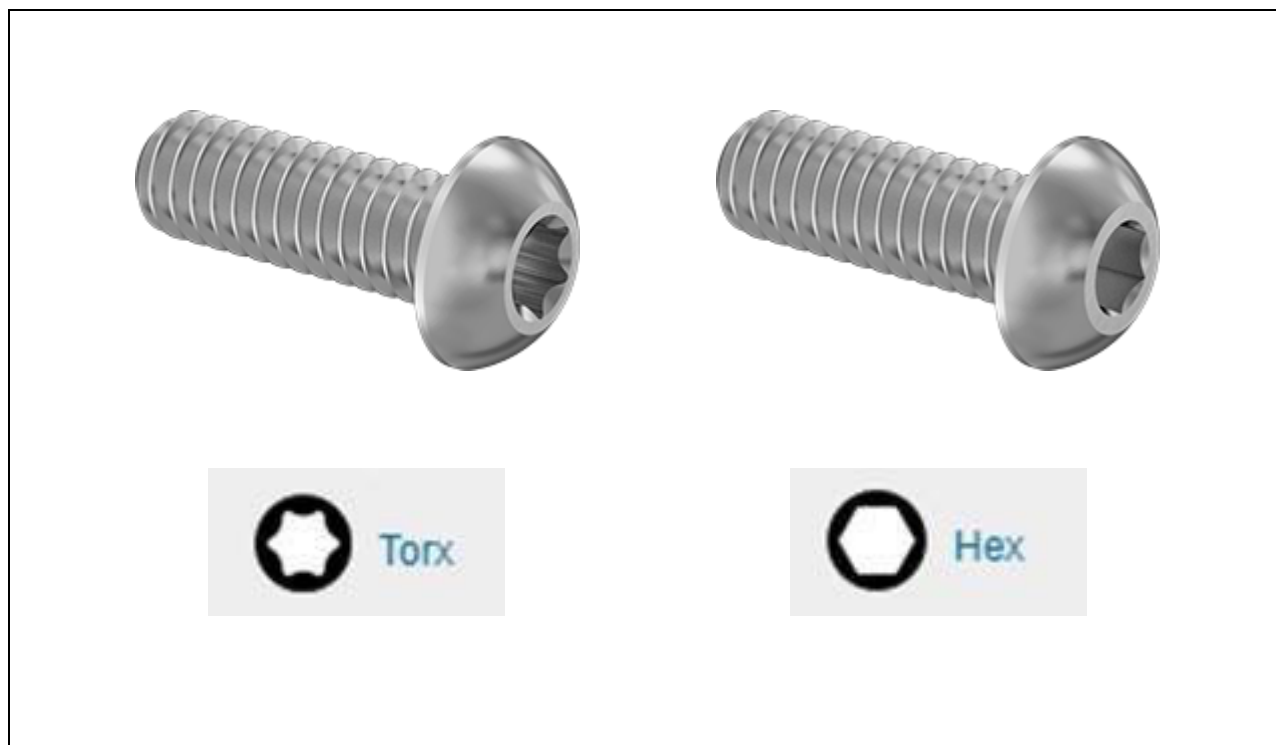
**Figure 9**  
*Torx Head Screws vs. Hex Head Screws*

- (6) If the screws have hex heads, then they are the newer stainless steel type (PNR 0901101-149) and do not need to be replaced. Re-identify the buckle as follows :

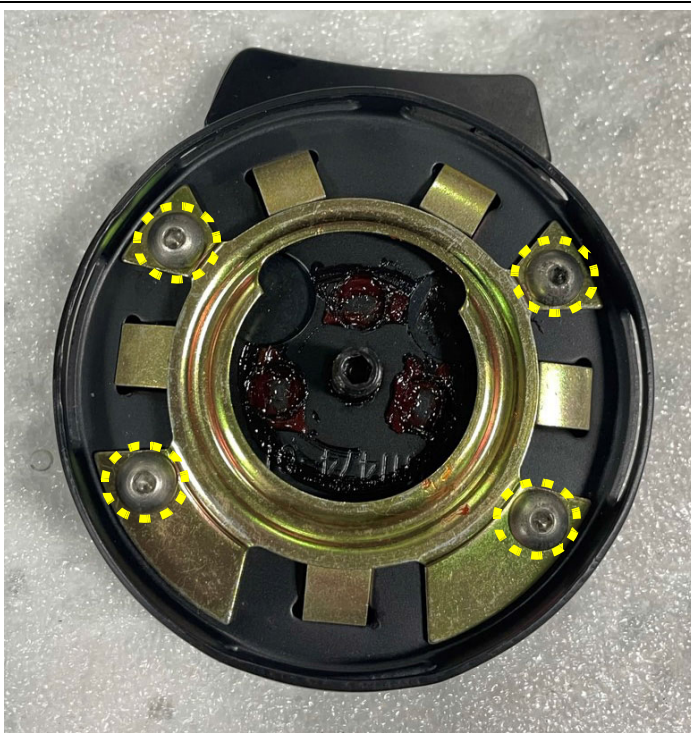
**Figure 13**  
*Disassembled Rotary Buckle with Suspect Torx Head Screws*

- (e) If the screws are the Torx head type (PNR 0901101-123) (as shown in Figure 13), then replace the screws with the new stainless steel hex head type (PNR 0901101-149) as follows :

- 4**      Torque the four screws (PNR 0901101-149) to 15 to 25 in-lbs (1.69 to 2.82 N-m).
