**SL 104  
SL 077/56-001  
PPG Heated Windshield Seal**

# SERVICE LETTER

**SUBJECT:** PPG Heated Windshield Seal

**MODELS AFFECTED:** All MU-2B Airplanes with PPG Heated Windshields

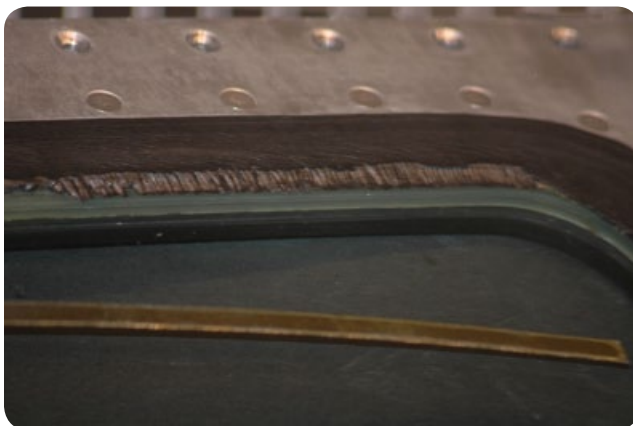
This hump seal shows evidence of wind and rain erosion, and it should be repaired.

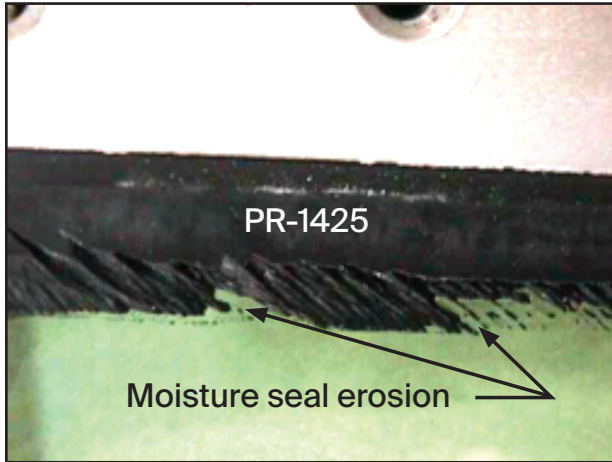
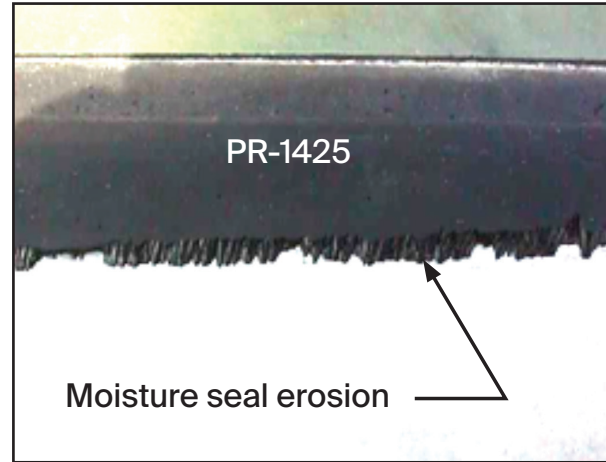
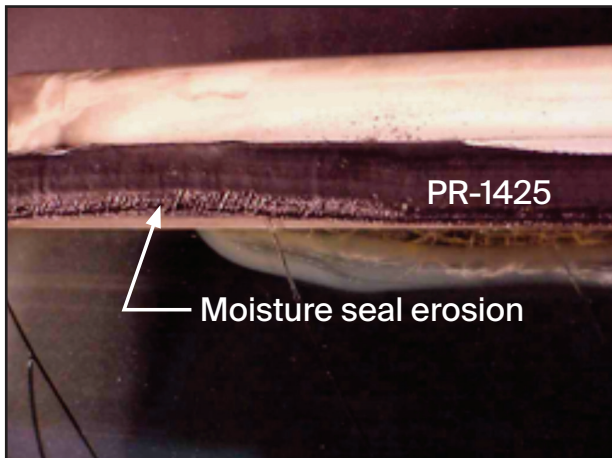
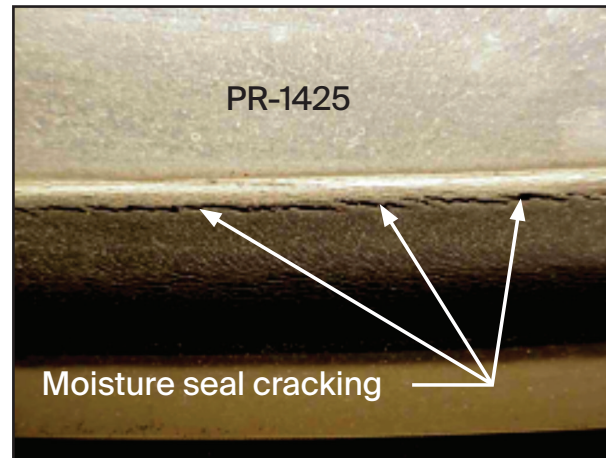
- The windshield's outboard moisture seal, also referred to as a "hump" seal because of its shape, is the primary barrier to prevent moisture from entering the laminate. If moisture gets inside the laminate, while not a structural issue, delamination and degradation of the electrical heating system can occur, reducing windshield service life.

- Regularly inspect the windshield's outer moisture seal for evidence of sealant erosion, cracking or separation from glass, plastic or metal. A typical inspection interval is every four months or 1,000 flight hours. Refer to appropriate AMM/CMM for specific inspection requirements.

- Give particular attention to areas where the seal appears worn. If the sealant has eroded more than 25% of its original width or if the sealant has cracked or debonded, the moisture seal should be repaired at the next opportunity.

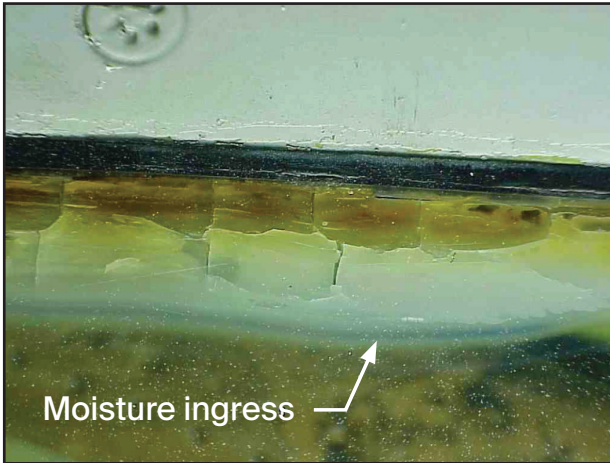
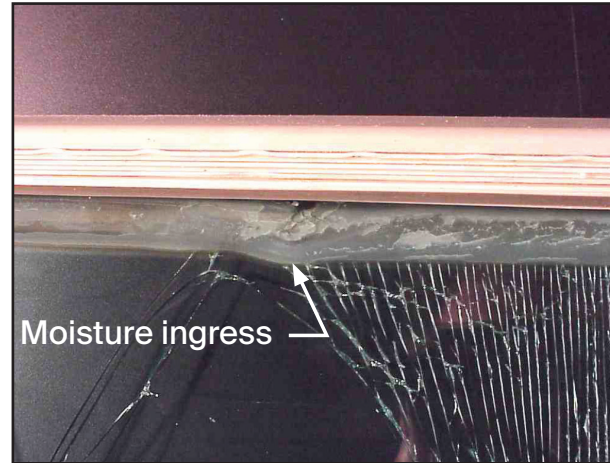
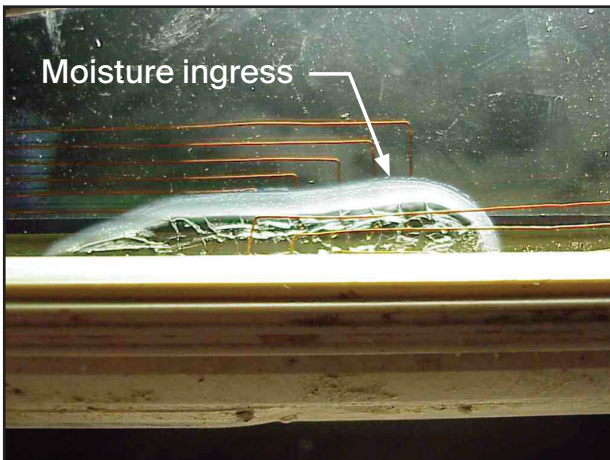
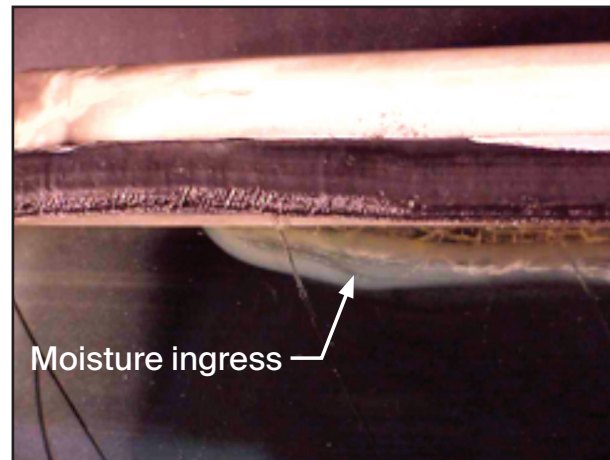
- Moisture ingress can occur from wind erosion, rain erosion, cracking or separation of the outboard moisture seal, or from damage to the windshield vertical edge seal or edge attachment.
- The first sign of moisture ingress is a change in the appearance of the interlayer from optically clear to hazy, cloudy or translucent. Interlayer may also begin to delaminate or separate from the glass or plastic substrate without discoloration.
- Long-term effects of moisture ingress include interlayer degradation (crackling and discoloration), interlayer delamination (separation from glass or plastic substrate) and bus bar degradation (discoloration and cracking), which can lead to electrical arcing at the junction of the bus bar and conductive heating film and subsequent glass fracture.

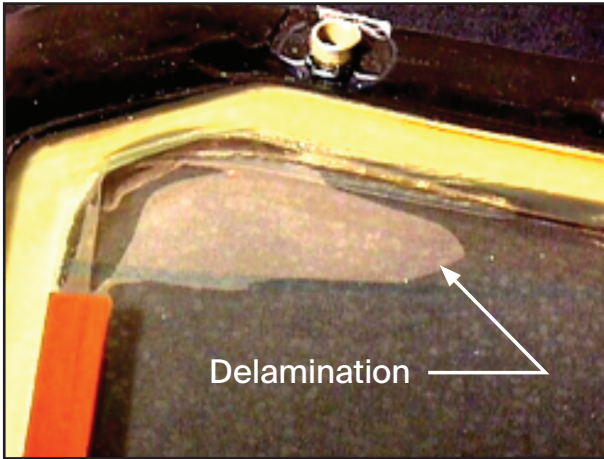
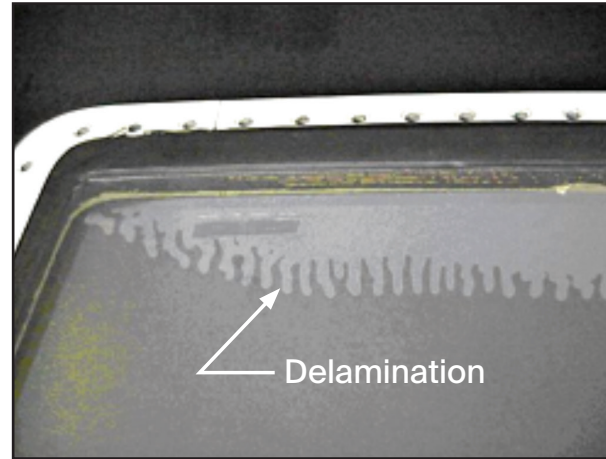
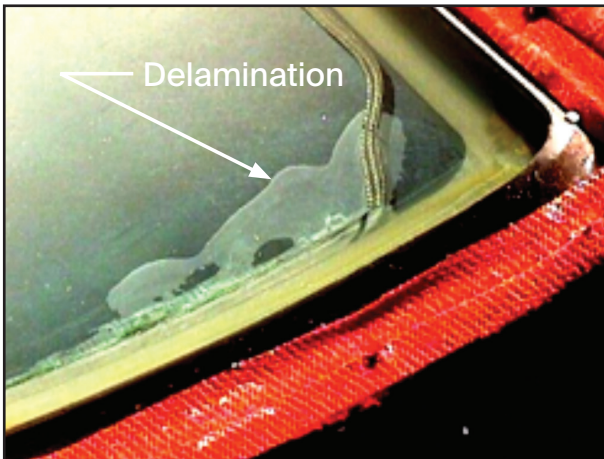
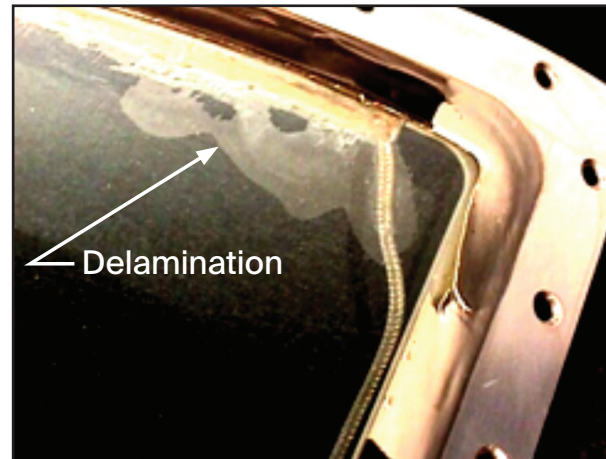
- Delamination is defined as the reduced adhesion of the interlayer to the glass or plastic or separation of the interlayer from any of the glass or plastic surfaces within the windshield laminate.
- Delamination within the specified limits is not considered a structural issue, but can be an optical issue.
- Delamination can appear to be visibly clear or cloudy depending on the type of interlayer and exposure conditions. It normally appears around the window periphery.
- Typical allowable limits for delamination are 2 inches (51 mm) from the edge of the vision area, with 4 inches (102 mm) allowed in corners. Localized areas of delamination may exceed these limits if visibility is not affected. Consult your maintenance manual for aircraft specific limits.
- Delamination is typically related to time in service such that older transparencies are more likely to experience the condition.

**CAUTION:** PPG does not recommend or approve “re-laminating” or injecting liquid polymer to remove or repair areas of delamination. These procedures do not address the reason for the original delamination and typically do not significantly extend service life.

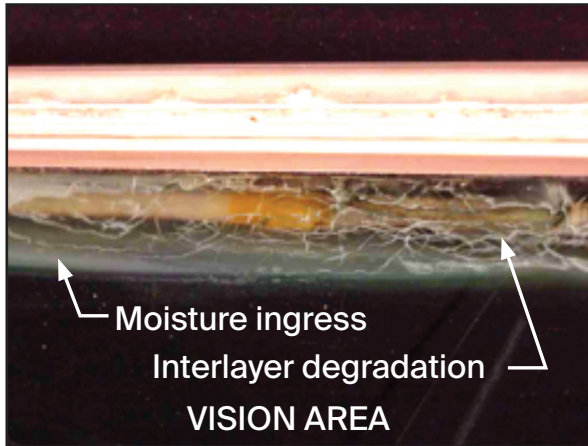
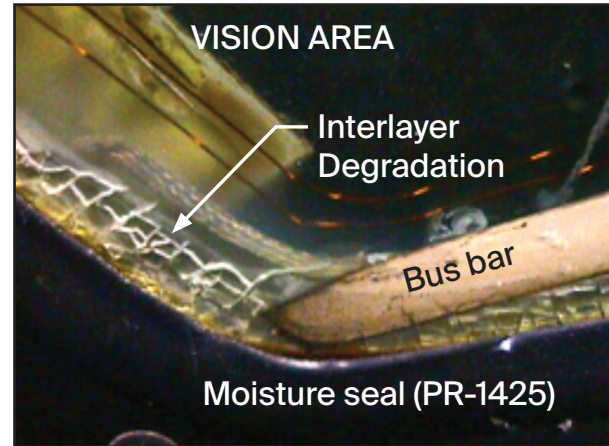
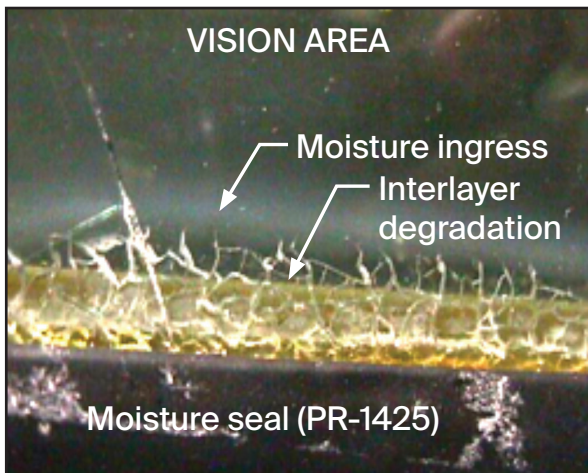
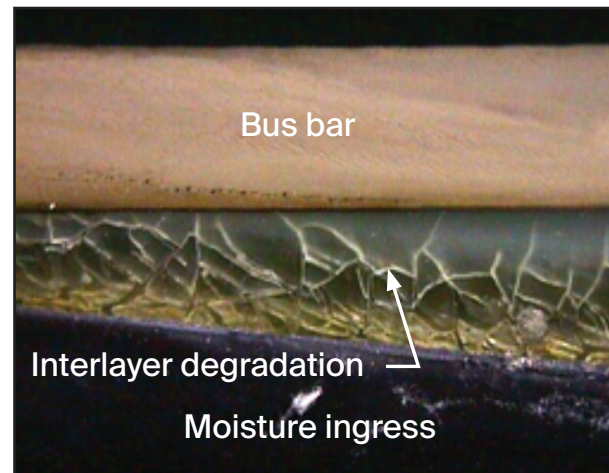
- Two types of interlayers are used in PPG's aircraft windshields:  
(1) Polyurethane (urethane) and (2) Polyvinyl Butyral (PVB or vinyl). The interlayer sections between the glass or acrylic plies can be all PVB, all urethane, or a combination of the two.

- Interlayer degradation can occur because of outboard moisture seal failure, allowing moisture to enter the laminate and interact with the interlayer, while being exposed to UV under normal operating conditions. Degradation of either interlayer is not considered a structural issue.

- Interlayer degradation occurs around the windshield periphery, becoming visible at the inner edge of the vision area, or daylight opening. The interlayer can change from optically clear to hazy and cloudy. Continued exposure to moisture can cause the interlayer to change color to a yellow/amber tint with small cracks resembling "mud-cracking" or "dry lakebed." Do not confuse this degradation with glass fracturing.

- Interlayer degradation results in a weakened or failed bond with the glass or plastic substrate and is considered to be delaminated where present. Limits for interlayer degradation are the same as delamination.

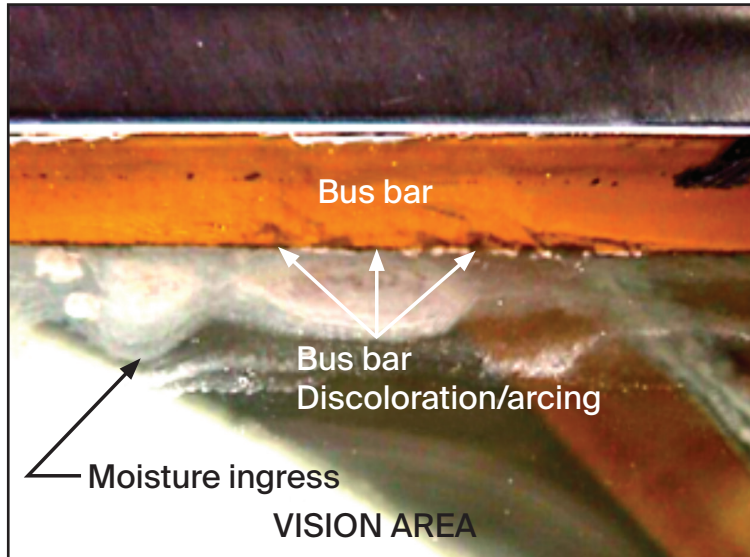
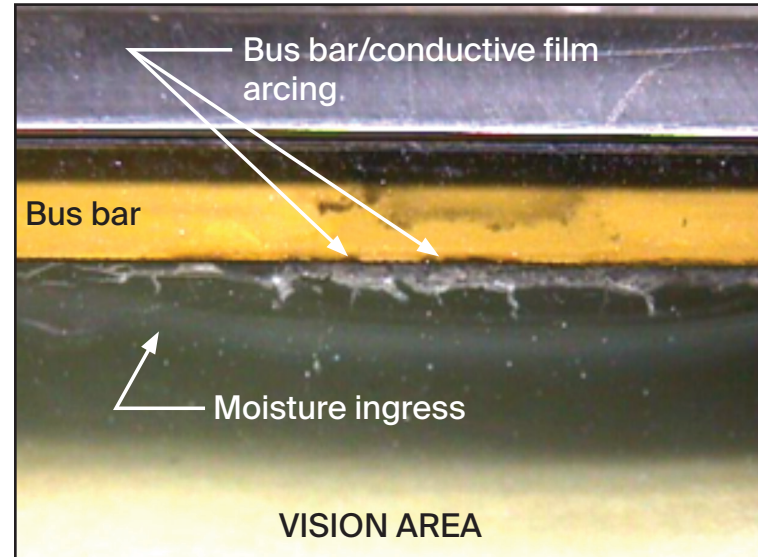
## Bus bar discoloration:

Caused by moisture ingress resulting in bus bar/conductive heating film arcing and localized "hot spots."

- **Moisture ingress** – This can result in oxidation, corrosion, degradation, debonding and cracking of the bus bar material. Discoloration alone is not a reason to remove the window, unless it occurs along the edge of the bus bar at the connection to the heated area (an indication of arcing).

- **Bus bar/conductive film arcing** – Moisture ingress can result in degradation of the electrical system and lead to electrical arcing. This can cause discoloration (amber, brown or black) along the inner edge of the bus bar as a result of the overheating condition. If the heating film bus-to-bus resistance is outside the allowable limits defined in the AMM or applicable CMM/ACMM, the window should be removed.

- On programs with UV stabilized interlayer, the bus bars will degrade the same as all other windshields. Special attention should be given to inspecting the bus bars since the interlayer will not break down and show moisture ingress. Discoloration along the edge of the bus bar at the connection to the heated area is an indication of a potential failure and the part should be scheduled for removal.

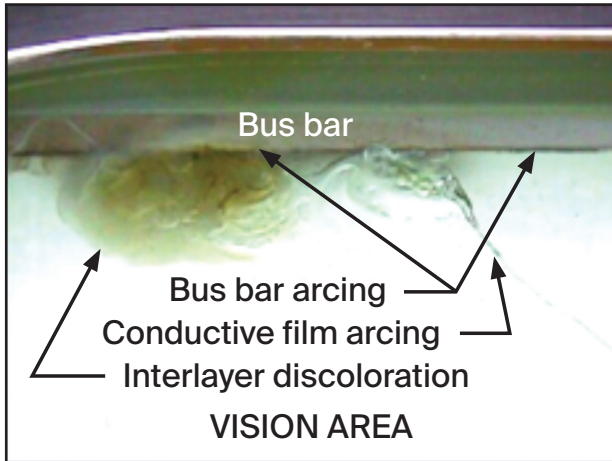
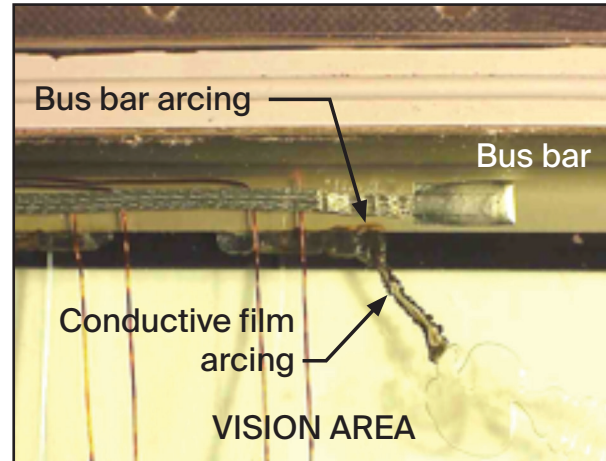
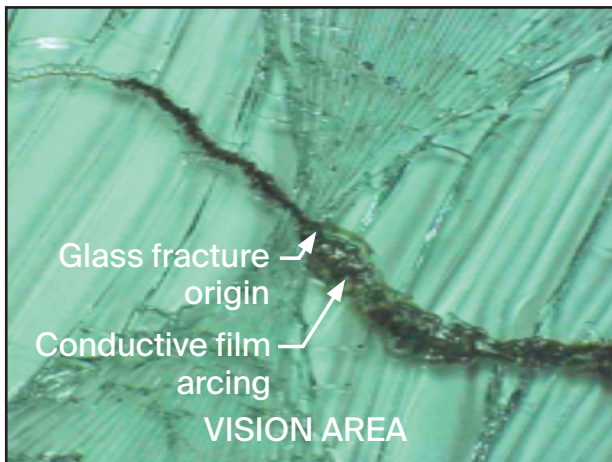
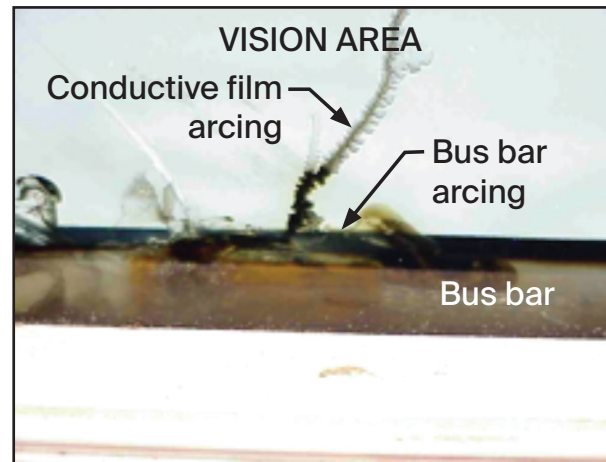
The electrically conductive heating system of an aging aircraft window may not function properly as a result of a variety of failure modes:

- **Arcing** – Arcing is an electrical discharge across a discontinuity in a wire, bus bar or electrical conductor. Structural integrity of the windshield is not affected, but the heating system may become inoperative as a result of an arcing condition. Electrical arcing may occur along the inner edge of the bus bar at the bus bar/conductive film interface. Arcing may progress across the heating film into the vision area. Continued application of the operating voltage to the windshield will likely result in fracture of the outer nonstructural glass ply as a result of an overheat condition. Arcing of the electrically conductive film, lead wires or terminal connections is cause for windshield replacement.

- **Heating system failure** – If an arcing condition exists or the windshield does not heat properly, deactivate the windshield circuit breaker and consult the AMM or applicable CMM/ACMM. The bus-to-bus resistance of the conductive heating film must be within the design tolerance range. Remove the windshield if the resistance of the heating film is outside this range.

- **Sensing element and controller failure** – If bus-to-bus resistance of the windshield heating film is within design specification, check resistance of the controlling temperature-sensing element, aircraft controller or both for an out-of-tolerance or fault condition.

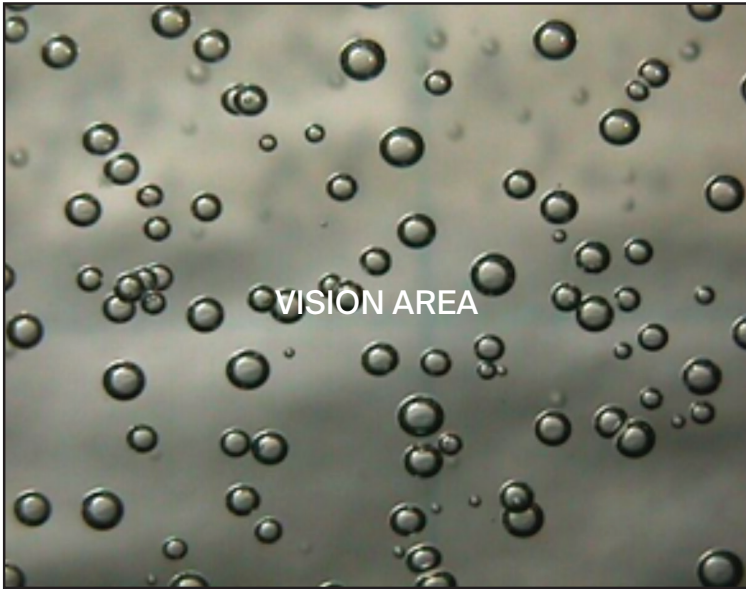
Overheat condition

- Bubbles may form within the window interlayer as a result of an overheating condition or from edge “pinch” caused by overclamping or overtorquing fasteners during windshield installation.
- Bubbles in the interlayer are not considered a structural issue.
- Bubbling of the interlayer may indicate a problem with the electrical heating system of the windshield or the aircraft controller.
- To determine if there is a problem with the windshield heating system:
  - Check the bus-to-bus resistance of the heating element.
  - Check the resistance of the controlling temperature-sensing element.
- If either of these checks indicates an out-of-tolerance condition, consult the AMM for recommendations.
- For instructions on how to check the windshield heat control system, refer to the applicable AMM.

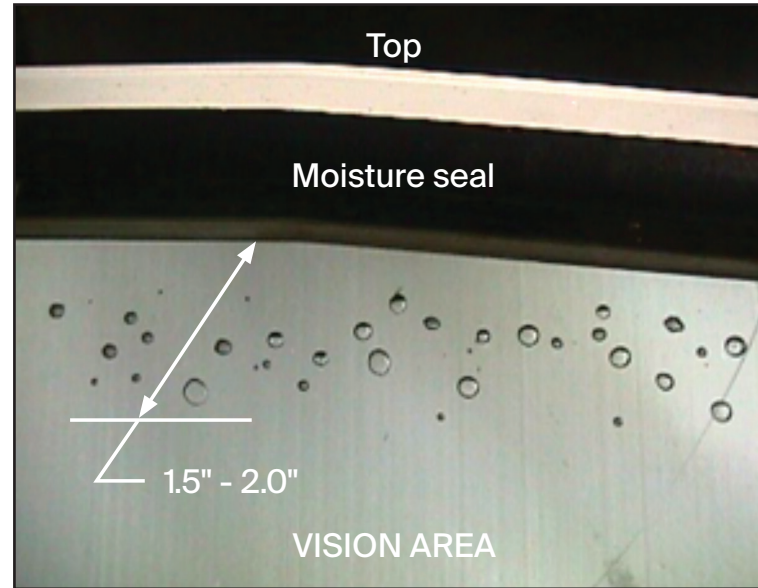
Overtorque condition

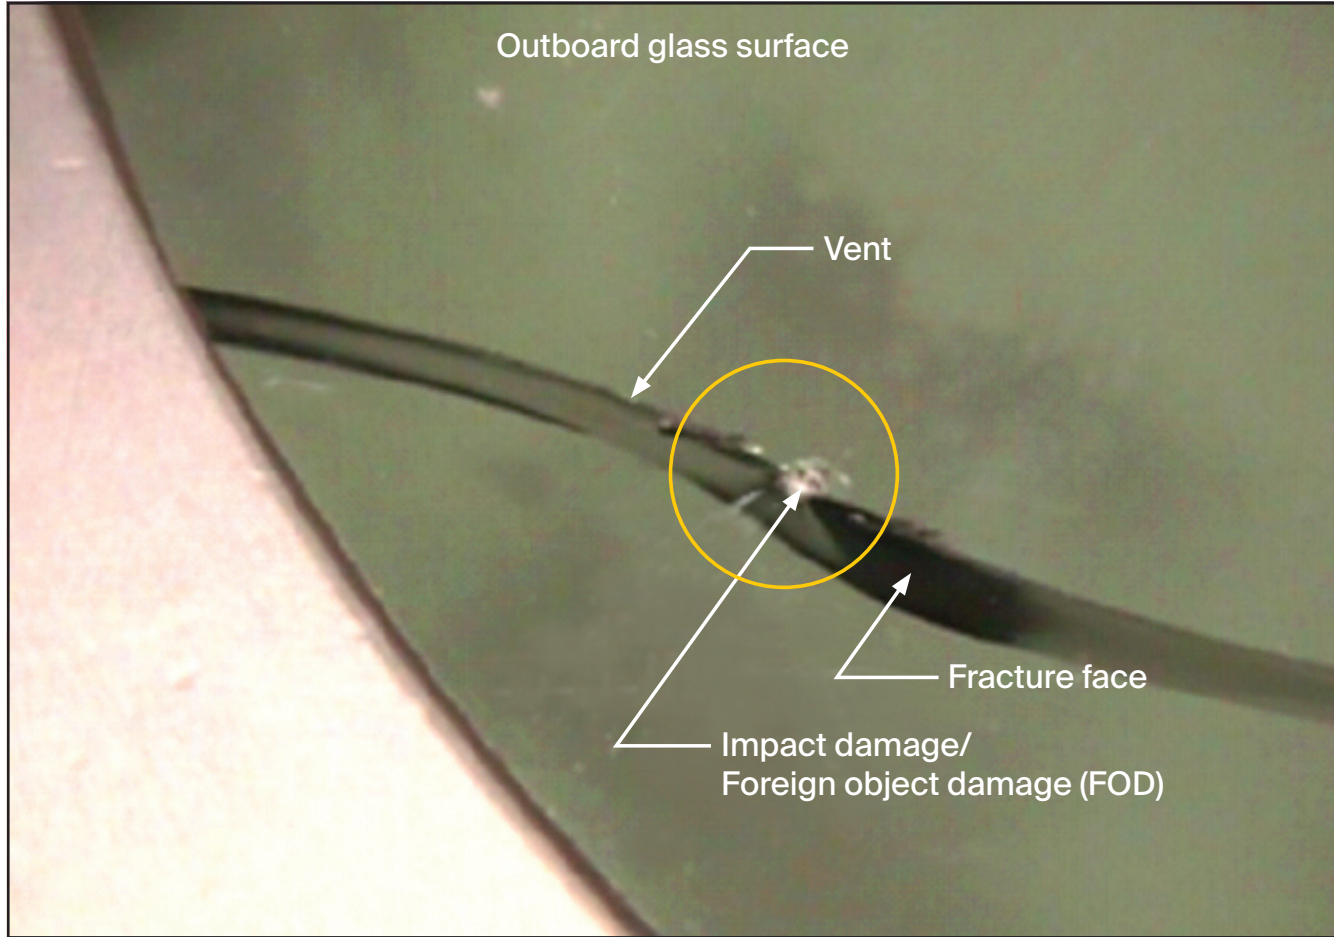
## Impingement, foreign object damage (FOD)

- Glass fracture can result from impingement, impact, foreign object damage (FOD), glass ply edge damage, surface scratches, electrical arcing or peel adhesion chip.

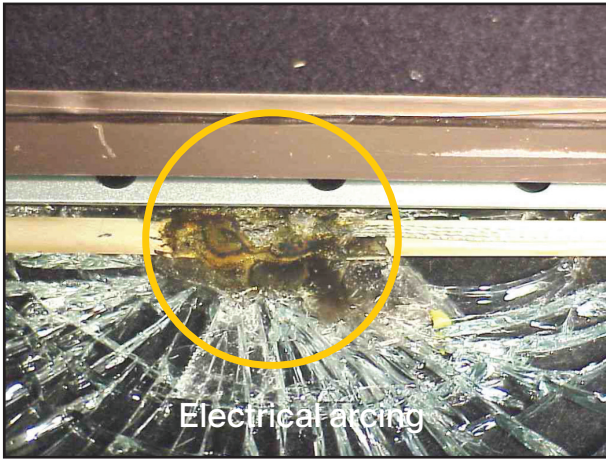
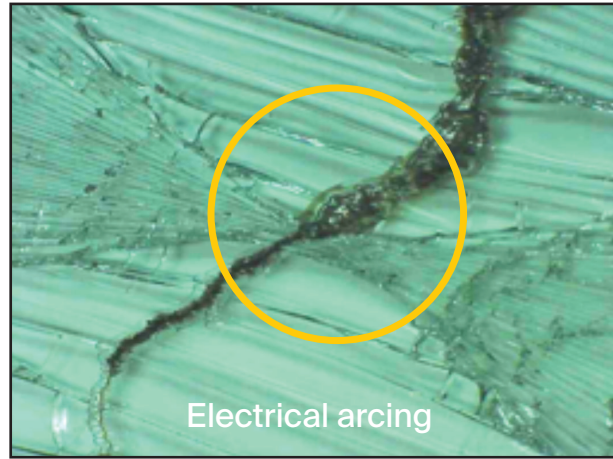
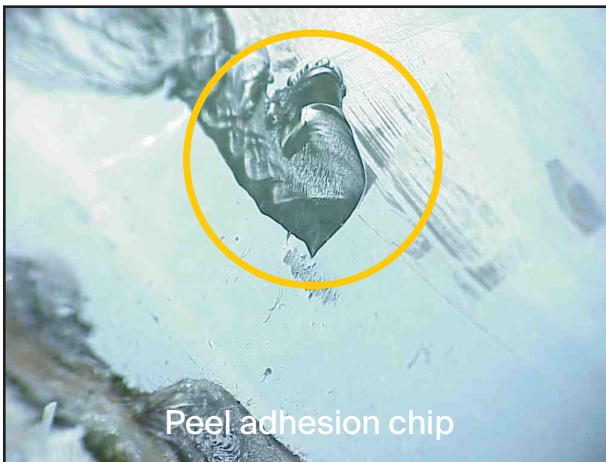
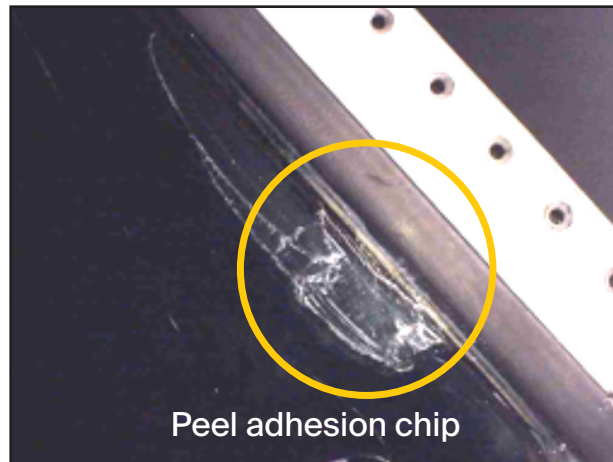
## Electrical arcing, peel adhesion chip

- Heated glass plies may fracture as a result of the overheat condition caused by electrical arcing at the bus bar/conductive film interface. The extreme heat generated by the electrical arcing causes damage to the glass that propagates from mechanical and thermal stresses encountered in service. The damage propagates until the center tension area of the thermally tempered or chemically strengthened glass is penetrated, causing spontaneous fracture.

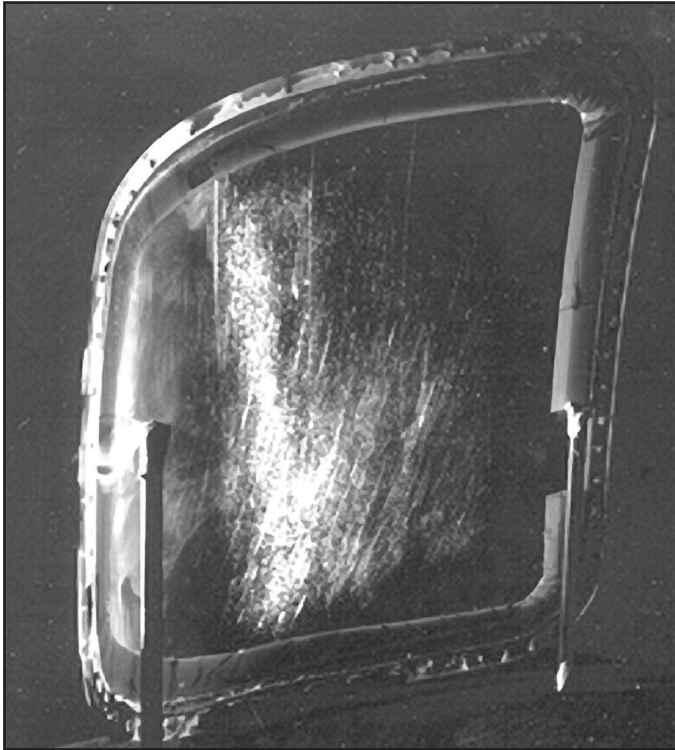
- Scratches may occur on the outer surface of the nonstructural outboard glass ply. Scratches on the outer glass surface are structurally acceptable. The windshield may remain in service as long as visibility through the windshield is not impaired.

- Scratches on the inboard surface of the inner structural glass ply shall be compared to the ASTM F428-6 Aerospace Scratch Standard for Glass. Note: Aerospace Scratch Standards illustrate scratch severity as reflected light intensity. The greater the intensity, the more severe the scratch. This is a visual evaluation and does not indicate the actual depth of the scratch.

Overall view  
With reflected light

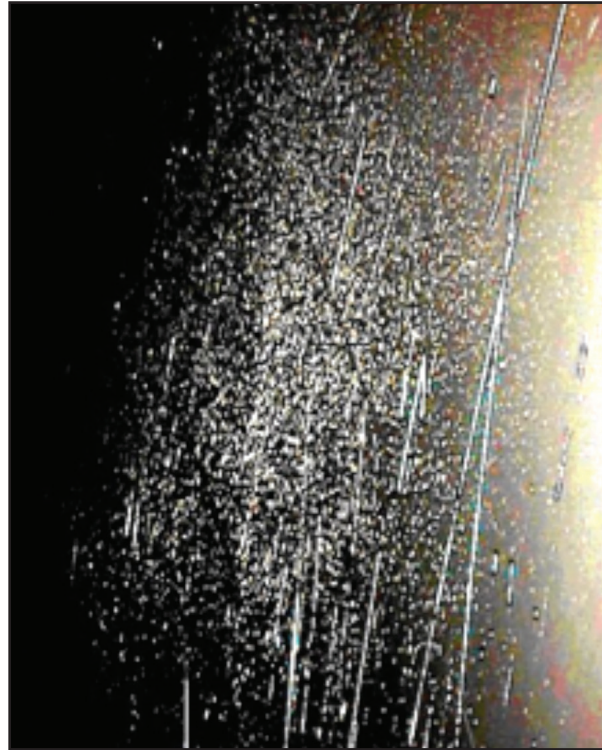
Close-up view  
With reflected light

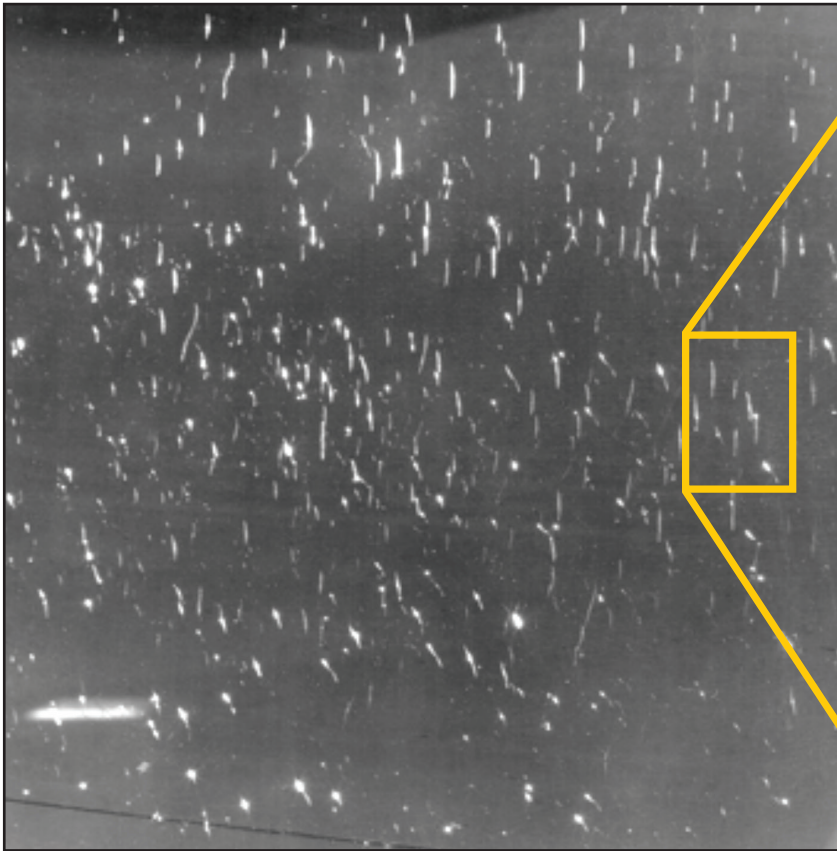
Surface crazing

- Acrylic and polycarbonate surface scratches and crazing can occur from improper cleaning procedures, impingement (foreign object damage) or chemical attack.
- Crazing refers to the microscopic surface cracks that occur as a result of localized stresses which are relieved by the physical separation of the acrylic or polycarbonate surface.
- The effect of scratches and crazing is an increase in light scattering, resulting in objectionable glare under certain lighting conditions (i.e., reflected light).
