# SERVICE LETTER

**SUBJECT:** Goodrich Service Bulletin – Propeller De-Icer Timer Repair (SB 3E1150-30-01)

**MODELS AFFECTED:** All MU-2B Airplanes

## PROPELLER DE-ICER TIMER REPAIR – GOODRICH P/N 3E1150-10 AND 3E1150-12

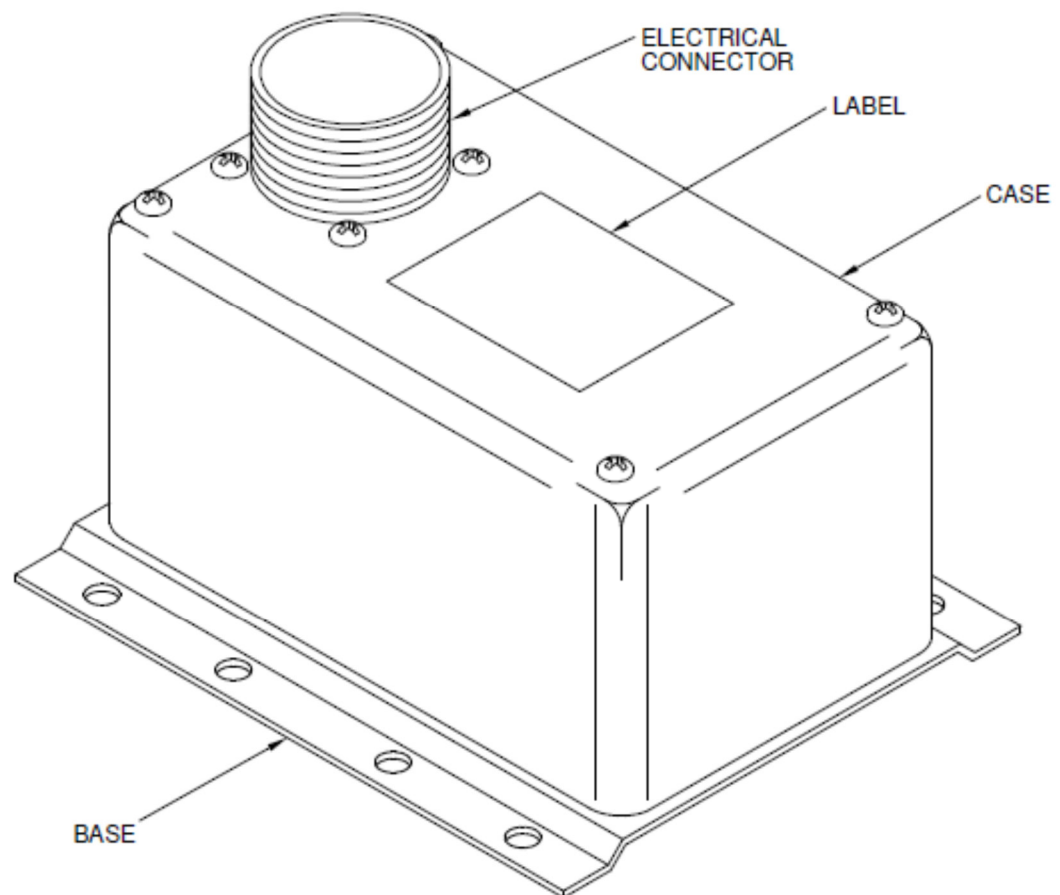
**Figure 1: Propeller De-icer Timer Assembly**

Some propeller de-icer timers may have experienced, or may be susceptible to experiencing failures due to a foam cushion, which may degrade over time in service. This Service Bulletin identifies actions necessary to:

- replace the foam cushion with a new cushion that will not degrade
- repair any damage that may have occurred due to the degradation
- apply protective coating to the printed circuit board to minimize the possibility of future malfunction.
