# SERVICE LETTER

**SUBJECT:** FAA SAIB CE-19-13 – Flight Control Cables and Terminals

## **SPECIAL AIRWORTHINESS INFORMATION BULLETIN**

**SUBJ:** Flight Controls; Cable Terminals Used on 14 CFR Part 23 and CAR  
Part 3 Airplanes with Mechanical Flight Control Cables

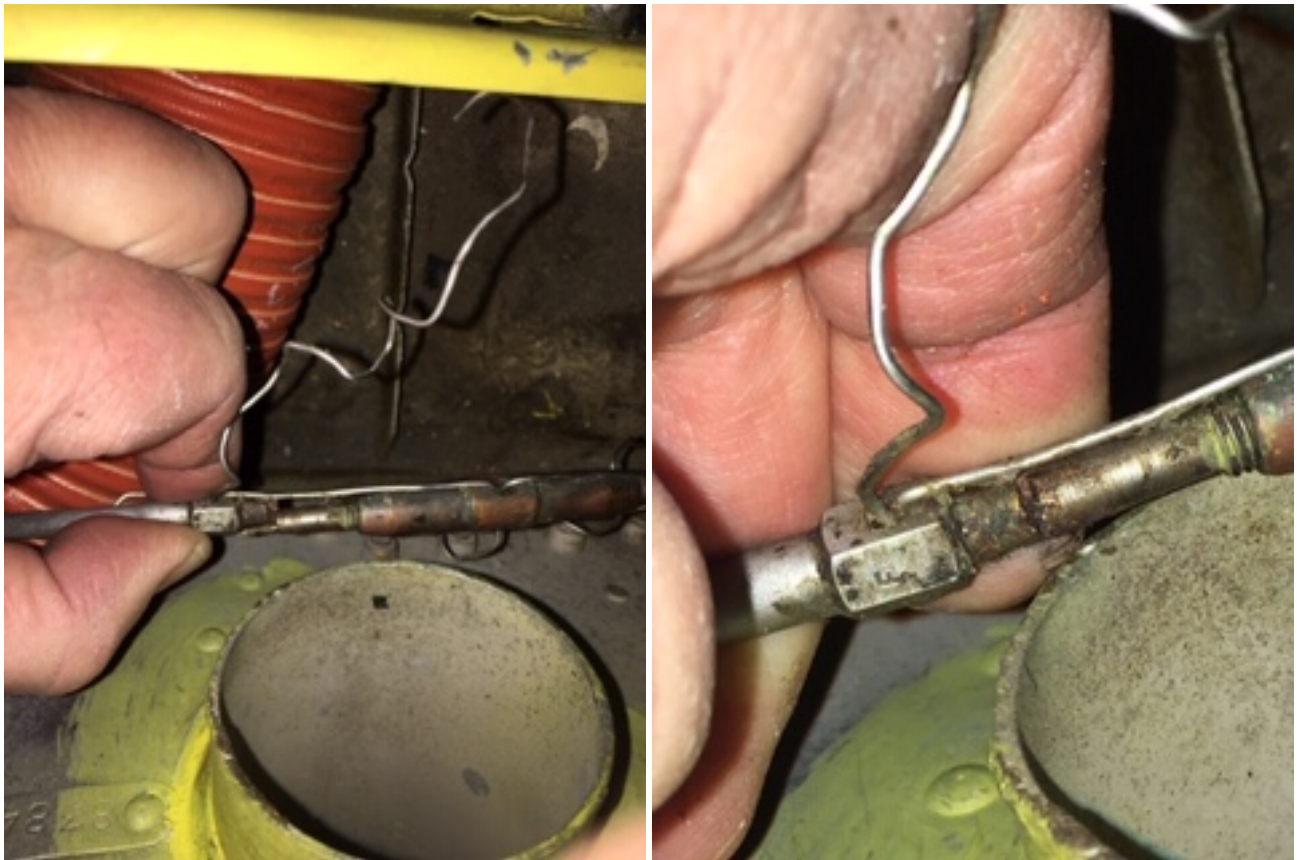
The following photograph shows a failure that occurred on a cable fitting located under a ventilation/heating duct on a Beechcraft Bonanza airplane.

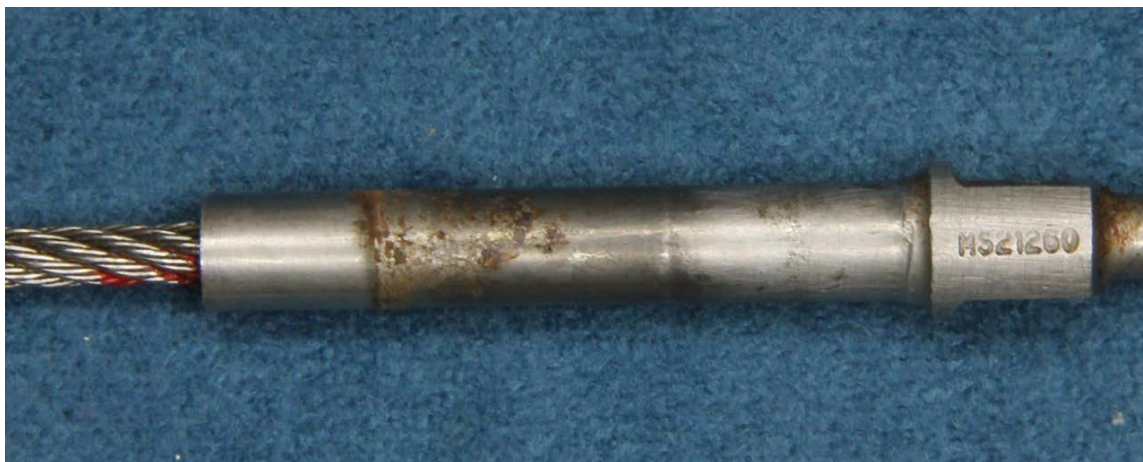
Another aggravating factor is the presence of sleeving or tape that is sometimes installed on the fitting shank for identification as an aid during initial airplane assembly. Corrosion can form more quickly underneath this material and be hidden from view during an inspection as shown in the following photograph. This material has no functional purpose on an assembled airplane.

- b. Examine underneath any sleeving or tape that is installed on the fitting shank.
    - i. Remove and discard any such tape or sleeve material while exercising care not to gouge or scratch the fitting surface. Removal of this material is considered a minor alteration to the airplane and should be documented by an appropriate logbook entry.
