# SERVICE LETTER

**SUBJECT:** NTSB Safety Alert No. 082 – Flight in Snow

**MODELS AFFECTED:** All MU-2B Airplanes

# Flight in Snow

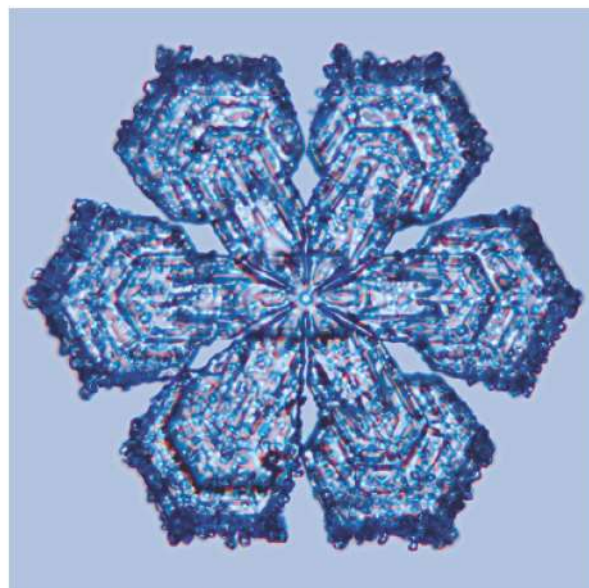
**Figure 1.** A snowflake containing liquid particles

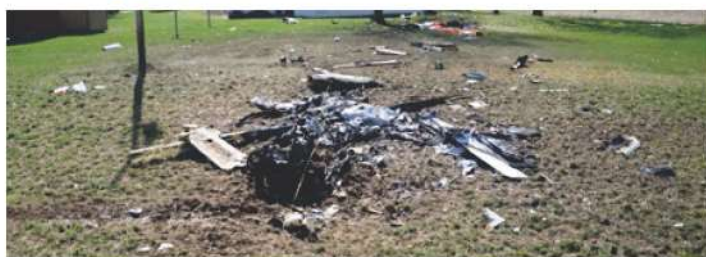
**Figure 2.** CEN18FA144 accident scene

- A Cirrus SR22 airplane was destroyed after the pilot reported ice accumulation and subsequently impacted terrain (figure 2). The pilot received a weather briefing the night before the accident and filed a flight plan. Weather information for the time of the accident revealed that the pilot was operating in IMC and icing with light snow, mist, and light rain observed at the surface. At the time of the accident, an active weather advisory was in effect for moderate icing, instrument flight rules/mountain obscuration, and low-level turbulence near the accident site. (CEN18FA144)

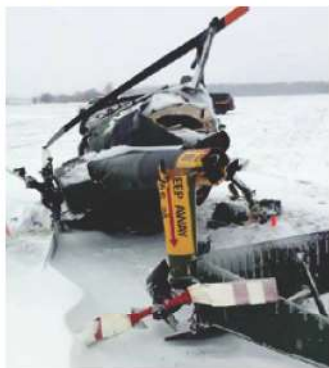
**Figure 3.** CEN18FA074 accident scene

- An aerial observation flight impacted terrain after departing in snow, icing, and IMC (figure 3). Satellite, radar, and weather observations near the accident site reported low clouds and visibility with light to moderate snowfall at the time of the accident. Weather models and advisories supported the probability of structural icing in the area at the time of the accident. Despite accessing the NOAA Doppler radar loop weather imagery depicting these conditions before the accident flight, the accident pilot elected to depart in snow, which illustrates his incomplete understanding of the hazard. The NTSB determined that the probable cause was a loss of engine power due to snow or ice ingestion at an altitude that was insufficient to allow for engine re-ignition. (CEN18FA074)

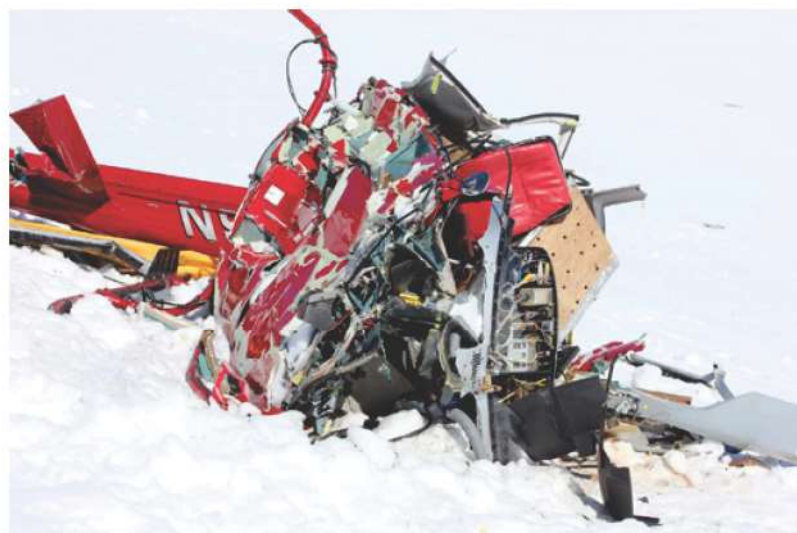
**Figure 4.** ANC16FA023 accident scene

- A helicopter on a visual flight rules (VFR) flight returning from a glacier dog camp encountered IMC, snow, icing, and gusting wind and impacted terrain near the departure location (figure 4). On a flight earlier that day, the pilot reported in-flight icing caused by "wet snow;" he decided to continue the mission and evaluate conditions on subsequent flights. The operator did not maintain operational control following the icing report and allowed the pilot to continue flying in the icing conditions despite it being prohibited in the rotorcraft flight manual. (ANC16FA023)

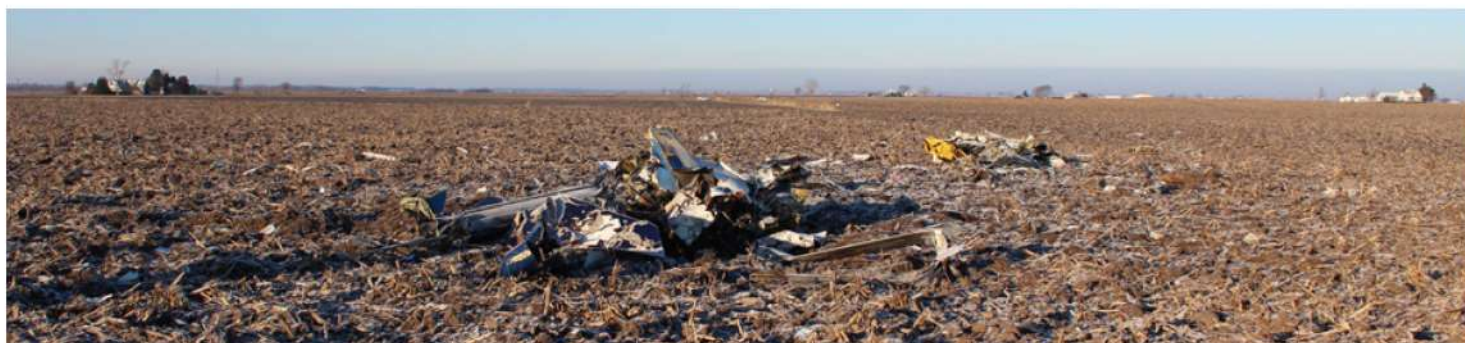
**Figure 5.** CEN13FA096 accident scene

- A medical transport helicopter, on a night VFR flight to pick up a patient, inadvertently encountered inclement weather (including snow, supercooled-liquid water, and reduced visibility conditions) and impacted terrain (see figure 5). The computer-based weather information available to the pilot showed marginal VFR ceilings and visibility with snow before departure. Available weather data and reports from first responders to the accident site indicated that the flight likely encountered areas of freezing drizzle, supercooled liquid water, and snow. (CEN13FA096)
