# SERVICE NEWS

**SUBJECT:** MLG Oleo Strut Bracket Attached Clip on Short Body Airplane

**MODELS AFFECTED:** All MU-2B Short Body Airplanes

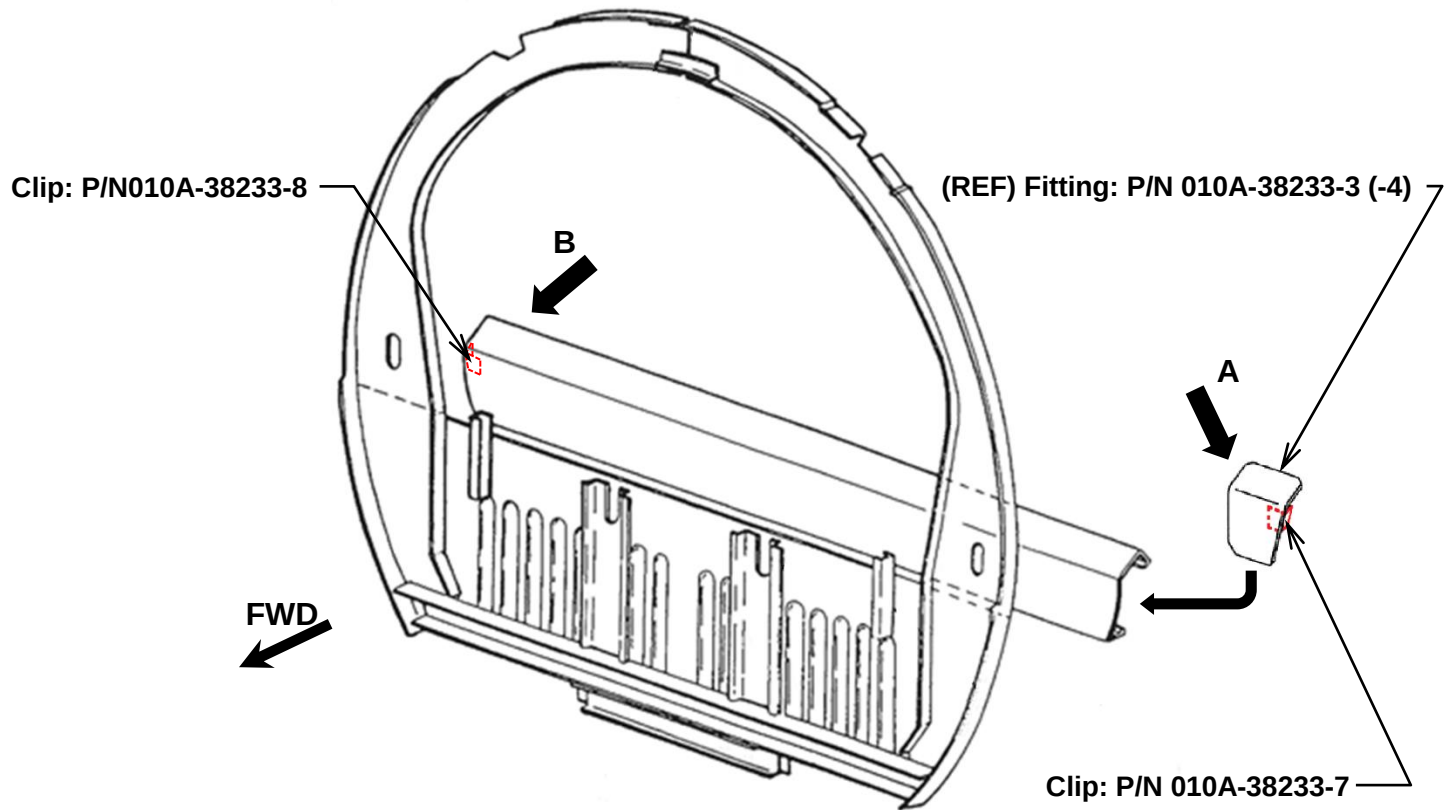
Figure 1: Bulkhead F.STA 4930

Several reports of cracked clips, P/N 010A-38233-7/-8, were received at MHIA. These clips are installed on the main landing gear oleo strut bracket located at F.STA 4930. See Figure 1.

MHIA advises owner/operators to visually inspect the condition of these clips during the next routine maintenance at one of the Mitsubishi MU-2 Authorized Service Centers. If a crack is found, the clip should be replaced with a new one. Also, it is recommended to further inspect the surrounding structure and look for loose rivets. If any discrepancy is found, replace the part with a new one or repair in accordance with MU-2 Structural Repair Manual (SRM).

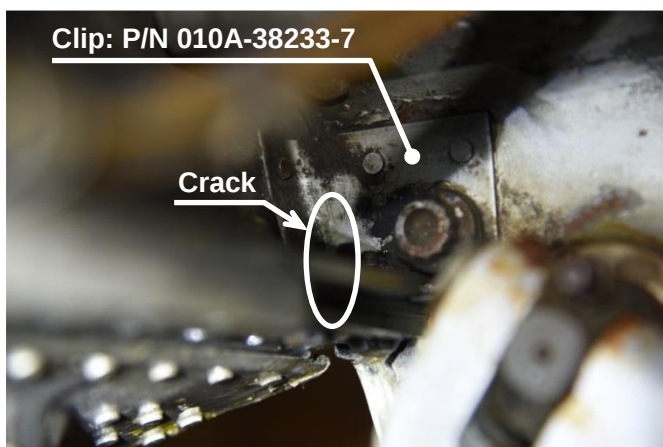
View A: Cracked Clip (L/H)

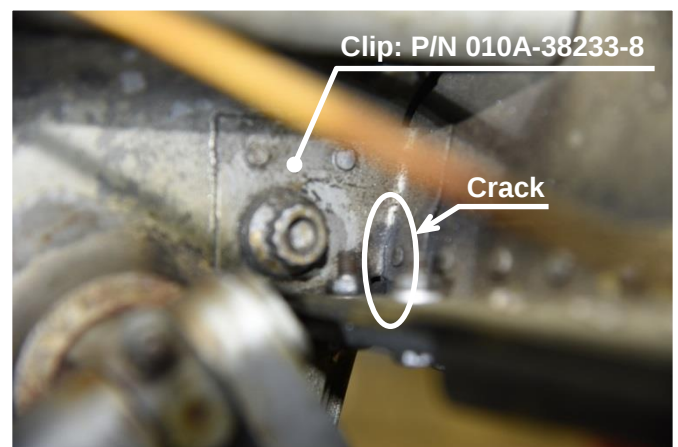
View B: Cracked Clip (R/H)
