**SN 215**

**SN 162/32-021**

**Main Landing Gear Leg Fitting Lugs Detail Inspection**

**MODELS AFFECTED:** All MU-2B Long Body Aircraft

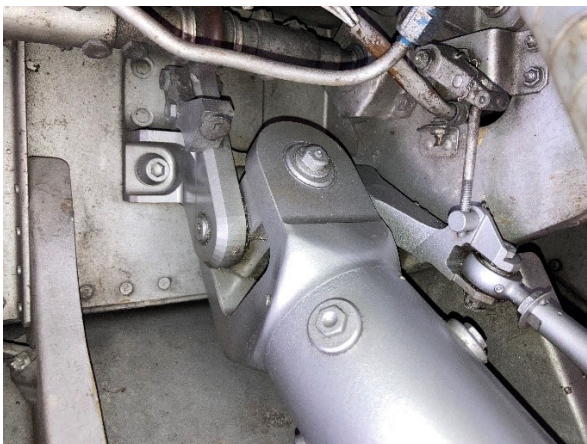
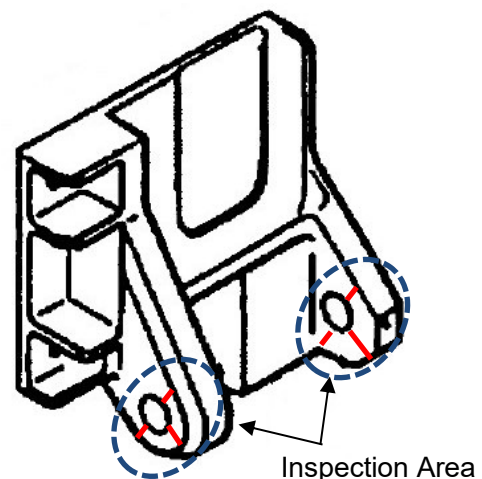
Figure 1: LH MLG Leg Fitting (P/N 030A-32315-1)

Mitsubishi Heavy Industries, Ltd. (MHI) issued Service News No. 211 (JCAB / A2PC) and No. 160/32-020 (FAA / A10SW), dated July 1, 2024, encouraging visual inspection of main landing gear (MLG) leg fittings, P/N 030A-32315-1/-2, on long body aircraft during periodic inspections. Since the release of the Service News, MHI has received additional reports of cracked fitting lugs found during routine inspections. Substantial damage to the fuselage can result from failure of fitting lugs during normal operations.

While a non-destructive inspection method is being prepared, MHI requests that each long body airplane owner and/or operator perform a detailed visual inspect and a dye penetrant inspection for any cracks in or around the lug portion of the fittings before the next flight and during the next periodic inspection. Areas to be inspected are indicated in Figure 1 below. Additional potential crack locations are highlighted. Also, it is important to apply lubrication to the fittings through grease ports in accordance with instructions in the applicable Maintenance Manuals.
