**MU-2**

# SERVICE RECOMMENDATION

No.046/32-004                      DATE: February 28, 2017

Subject:                              Nose Landing Gear System Inspection

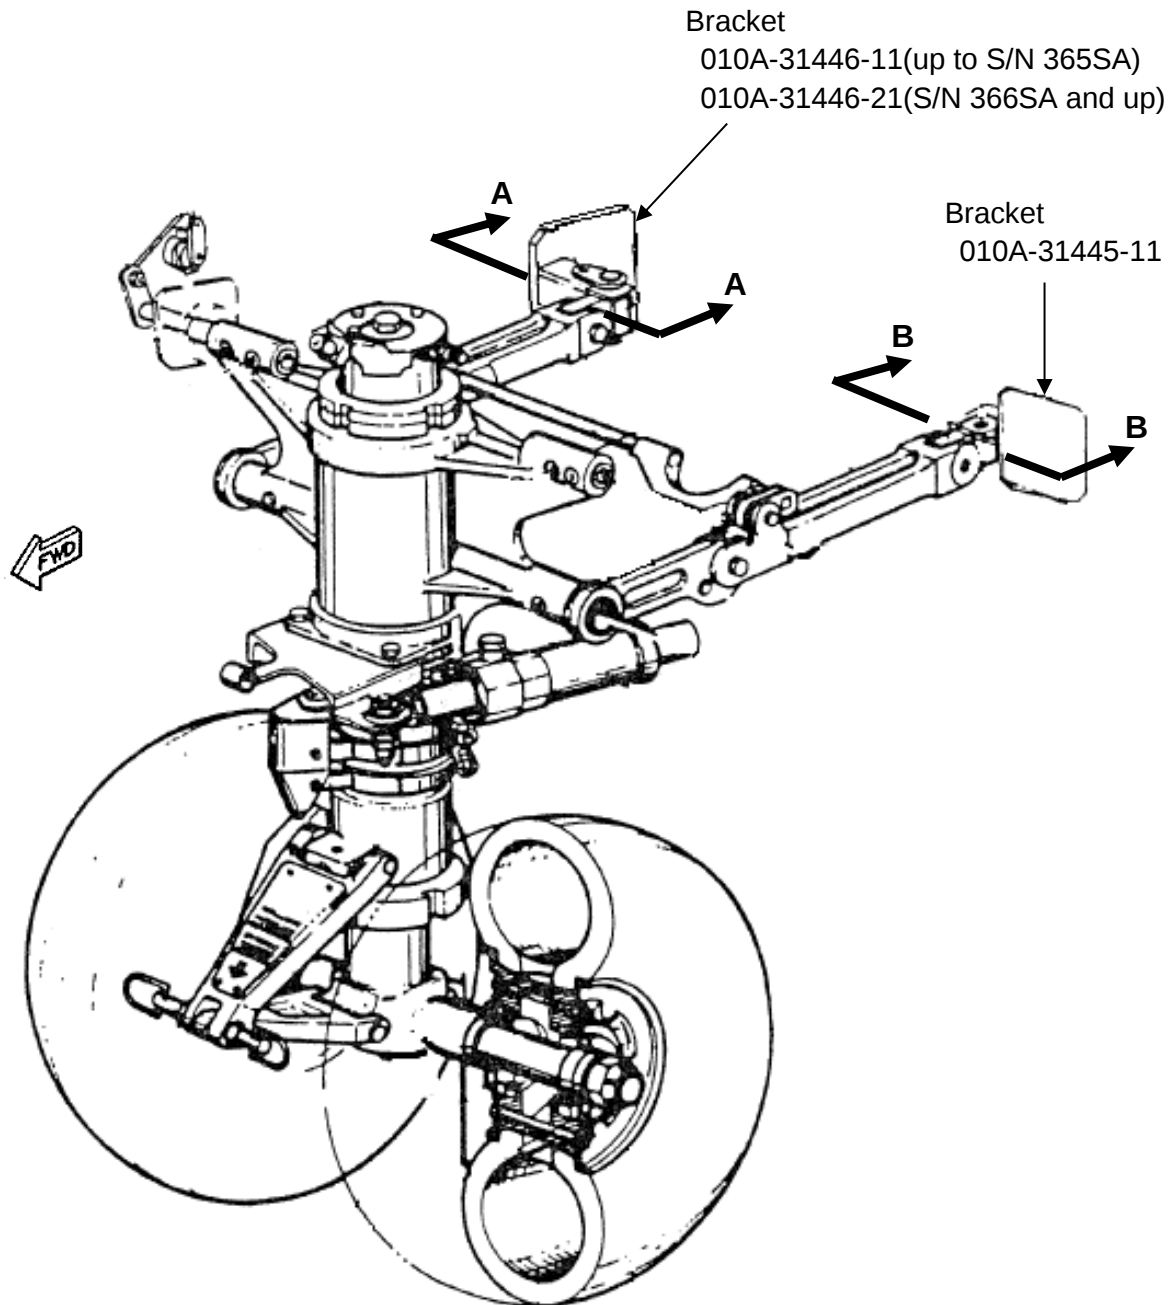
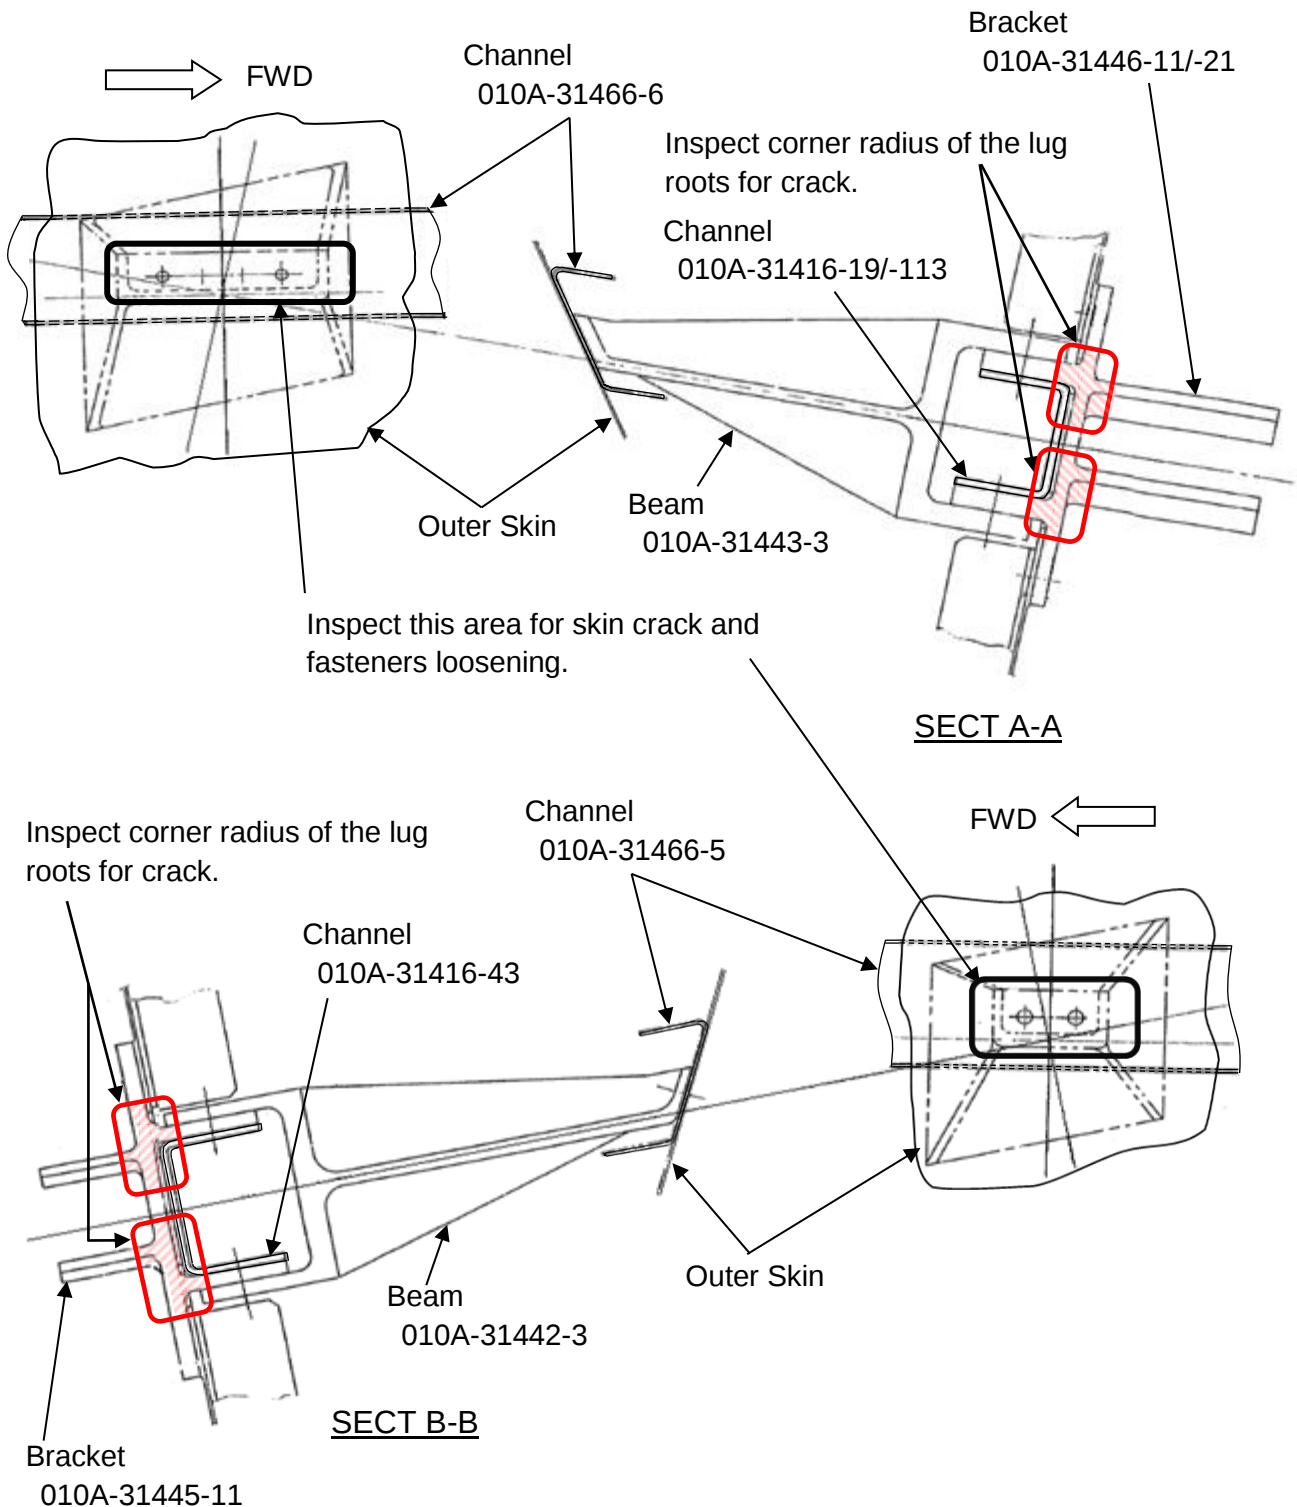
Figure 4: Drag Strut to Fuselage Bracket Location

- (1) Visually inspect NLG Drag Strut to Fuselage Brackets (010A-31445-11, 010A-31446-11 (up to S/N 365SA) and 010A-31446-21 (S/N 366SA and up)) for crack in the area shown in Figure 4 and 5.
  - (a) If any crack is found, replace the bracket with new one.

- (2) Visually inspect Outer Skins around fasteners which are installed common to Outer Skin, Channel and Beam for crack and loosening fasteners in the area shown in Figure 5.
  - (a) If any crack is found, repair the skin in accordance with the MU-2 Structural Repair Manual.
  - (b) If any loosening fastener is found, replace the fasteners in accordance with the MU-2 Structural Repair Manual.
- (3) Visually inspect Channels (010A-31466-5/-6) between Outer Skin and Beam, and Channels (010A-31416-19 (S/N 313SA and 321SA only), 010A-31416-113/-43) attaching to outboard lugs of Brackets for crack and deformation shown in Figure 5.
  - (a) If any crack or deformation is found, replace the channel with new one.

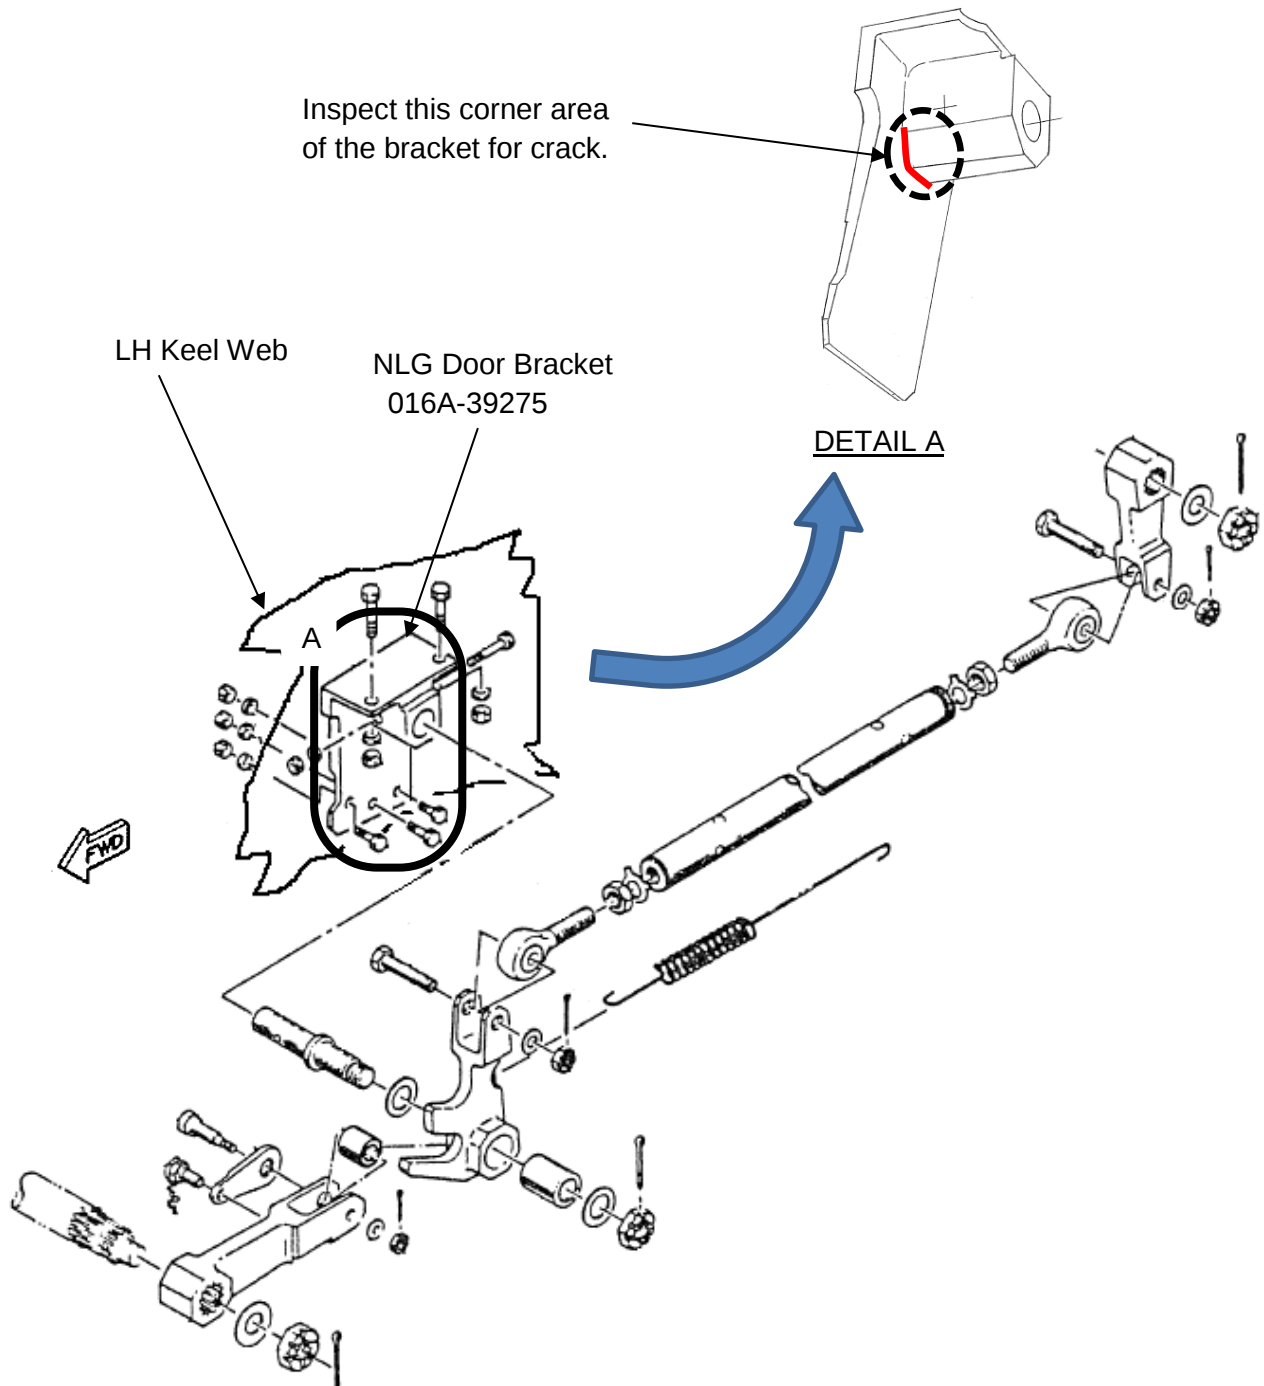
Figure 6: NLG Door Bracket

- (1) Visually inspect NLG Door Bracket (016A-39275) for cracks. (Figure 6)
  - (a) If any crack is found, replace the bracket with new one and check/adjust the door in accordance with the applicable MU-2 Maintenance Manual.

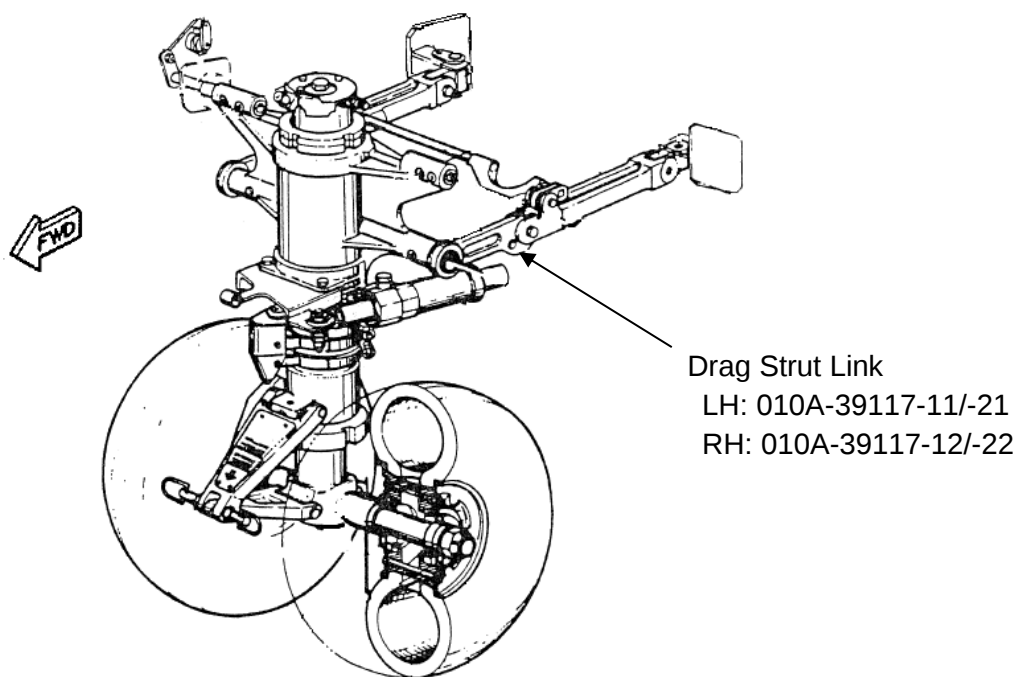
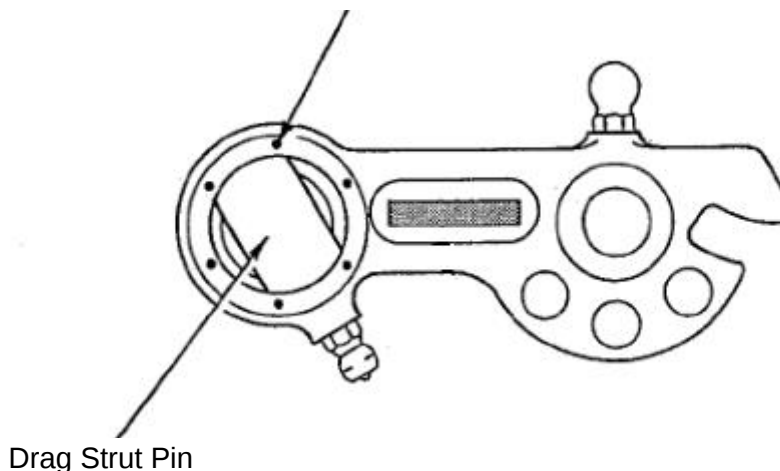
Figure 8: Drag Strut Link Identification

- (2) Visually inspect the existence of staking marks on the outboard side of Drag Strut Link for correct installation. (Figure 7 and 8)
  - (a) If the Drag Strut Link installation is incorrect (abnormal condition), install the correct Drag Strut Link identified in Figure 8.

If the replacement of Drag Strut Links is necessary, remove Drag Strut Links from Drag Strut Assembly. Install Drag Strut Links to the correct side of Drag Strut Assembly. Staking marks shall be on outboard side. Grease the NLG system per the applicable MU-2 Maintenance Manual.

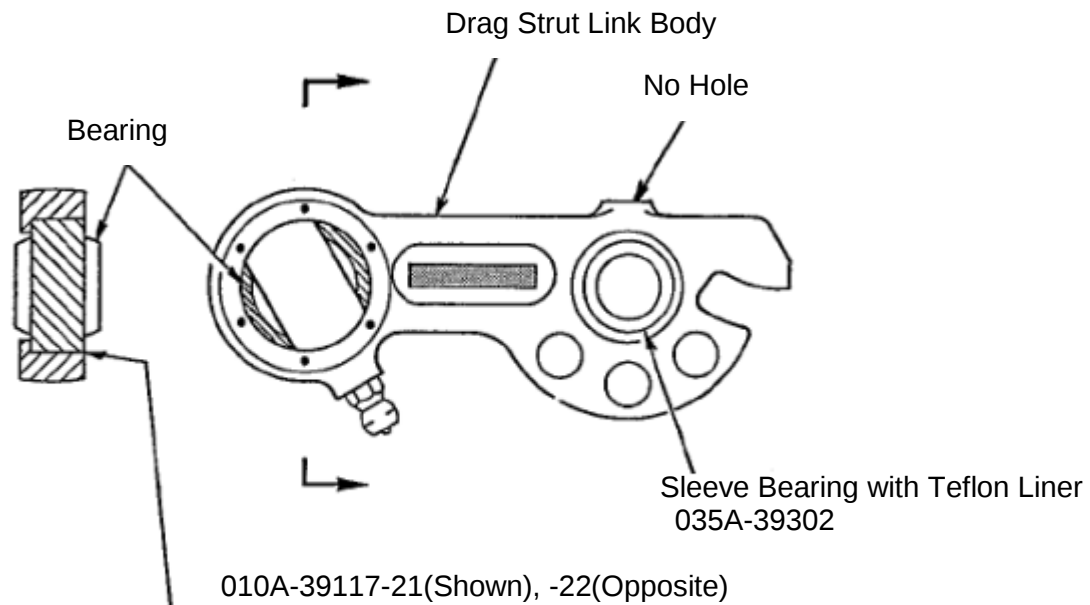
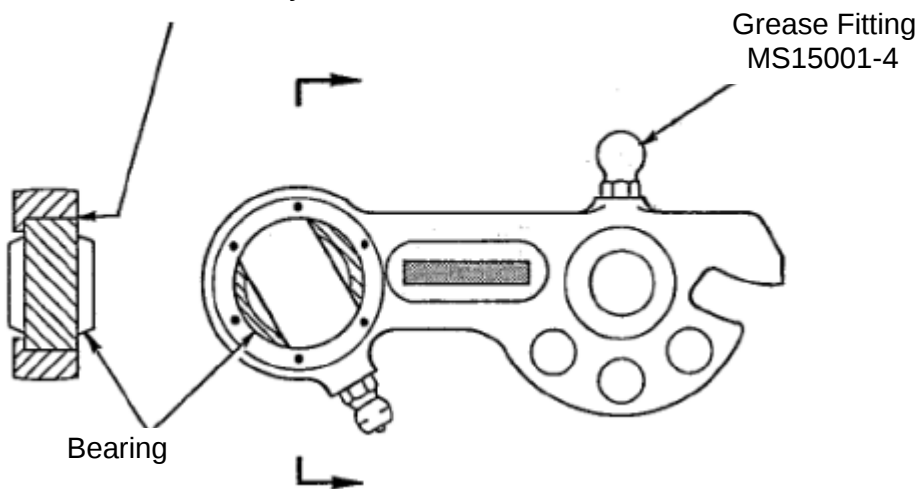
Figure 9: Drag Strut Link Free Play

- (5) Inspect Drag Strut Links for free play between the link body and outer bearing race. There should be no free play. (Figure 9)
- (a) If any free play is found, replace the Drag Strut Links with new 010A-39117-21/-22 Links; staking marks shall be on outboard side when installed.

There should be no free play between the outer bearing race and the link body.

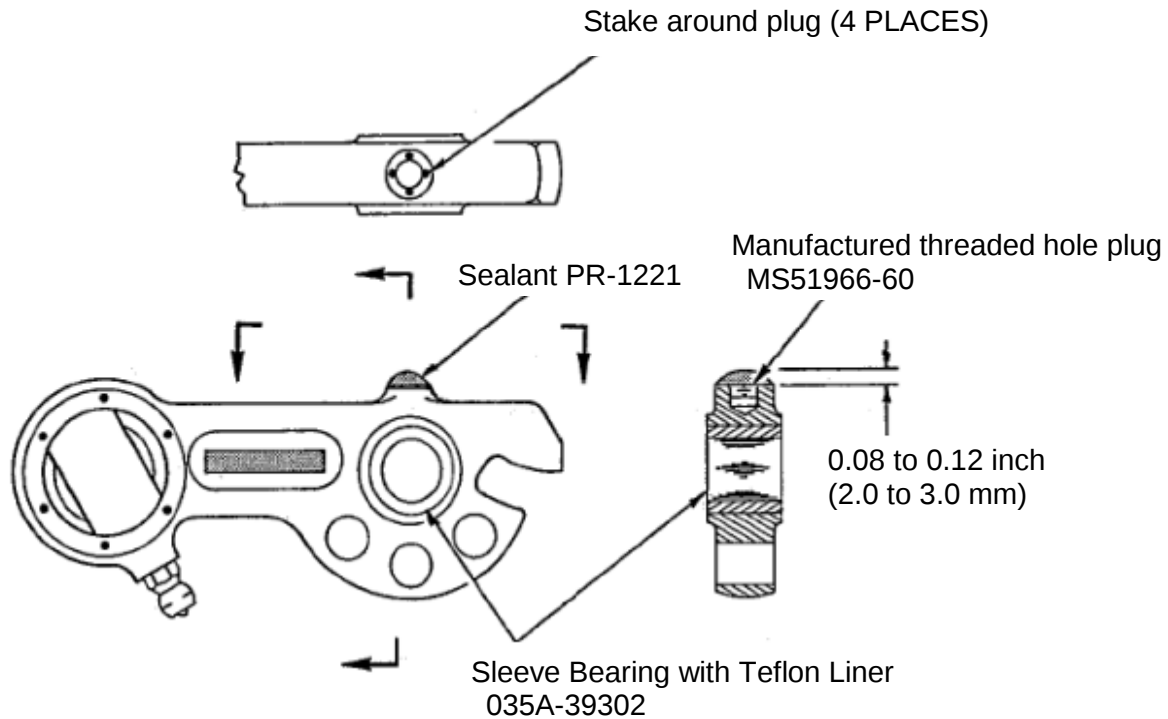
Figure 10: Drag Strut Link (S/N 366SA thru 374SA only)

- (b) If none of these conditions are found, install a Grease Fitting (MS15001-4) and proceed to 4.1 (5).
  - (c) If the Link is 010A-39117-21/-22, install the plug (MS51996-60). Stake the plug four places and apply sealant (PR-1221) over the threaded hole and plug. (Figure 10)(SN 366SA thru 374SA)

Note: Plug (MS51966-60) is necessary only for P/N 010A-39117-21/-22 Links with manufactured threaded hole and must be secured by staking and sealant (PR-1221).

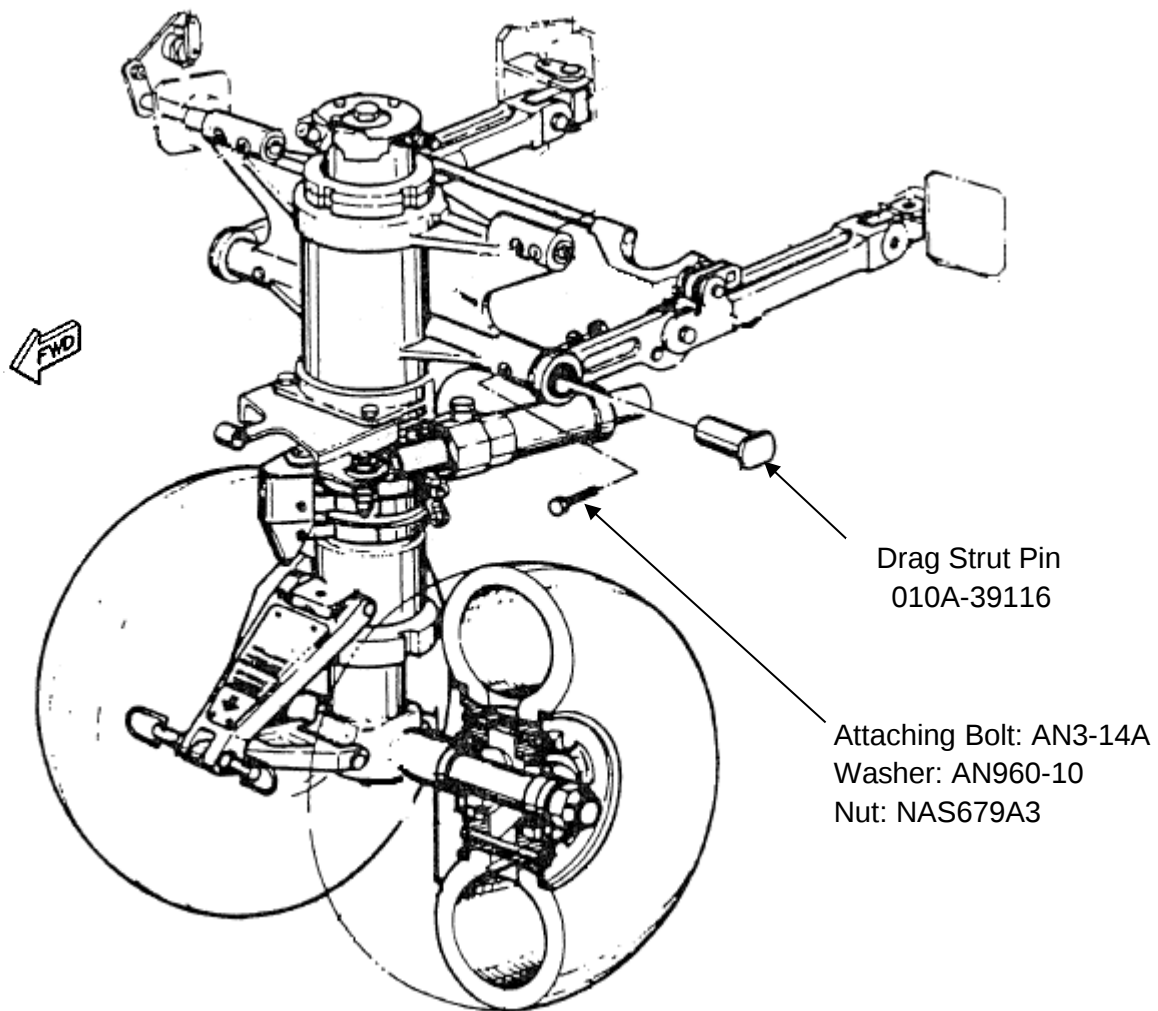
Figure 11: Drag Strut Pins and Attaching Bolts

- (1) Clean LH and RH Drag Strut Pins and visually inspect for wear, crack, deformation or corrosion. (Figure 11)
  - (a) If any of these conditions are found, replace the Drag Strut Pin with new one.

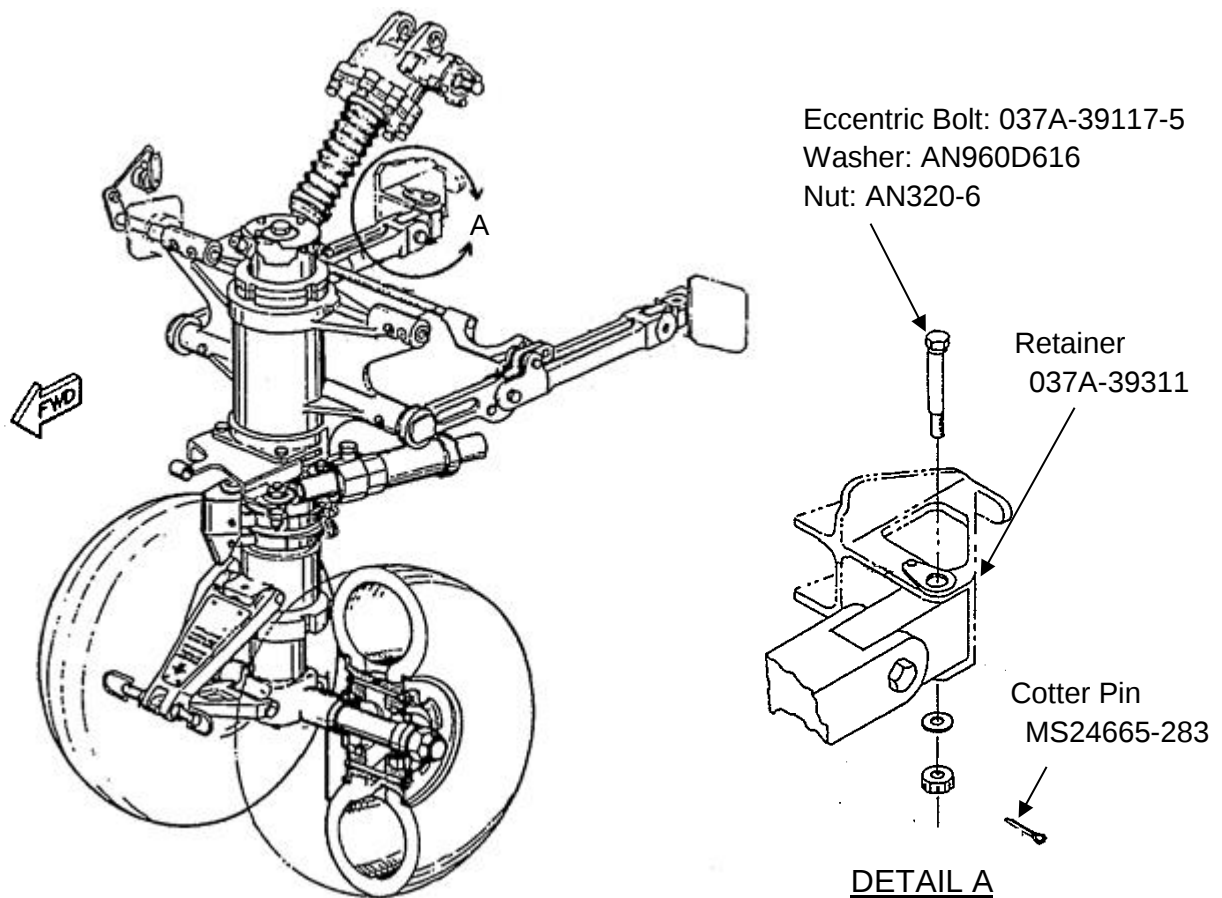
Figure 12: Eccentric Bolt

- (3) Visually inspect Eccentric Bolt for crack, deformation or corrosion.
  - (a) If any of these conditions are found, replace the Eccentric Bolt with new one.

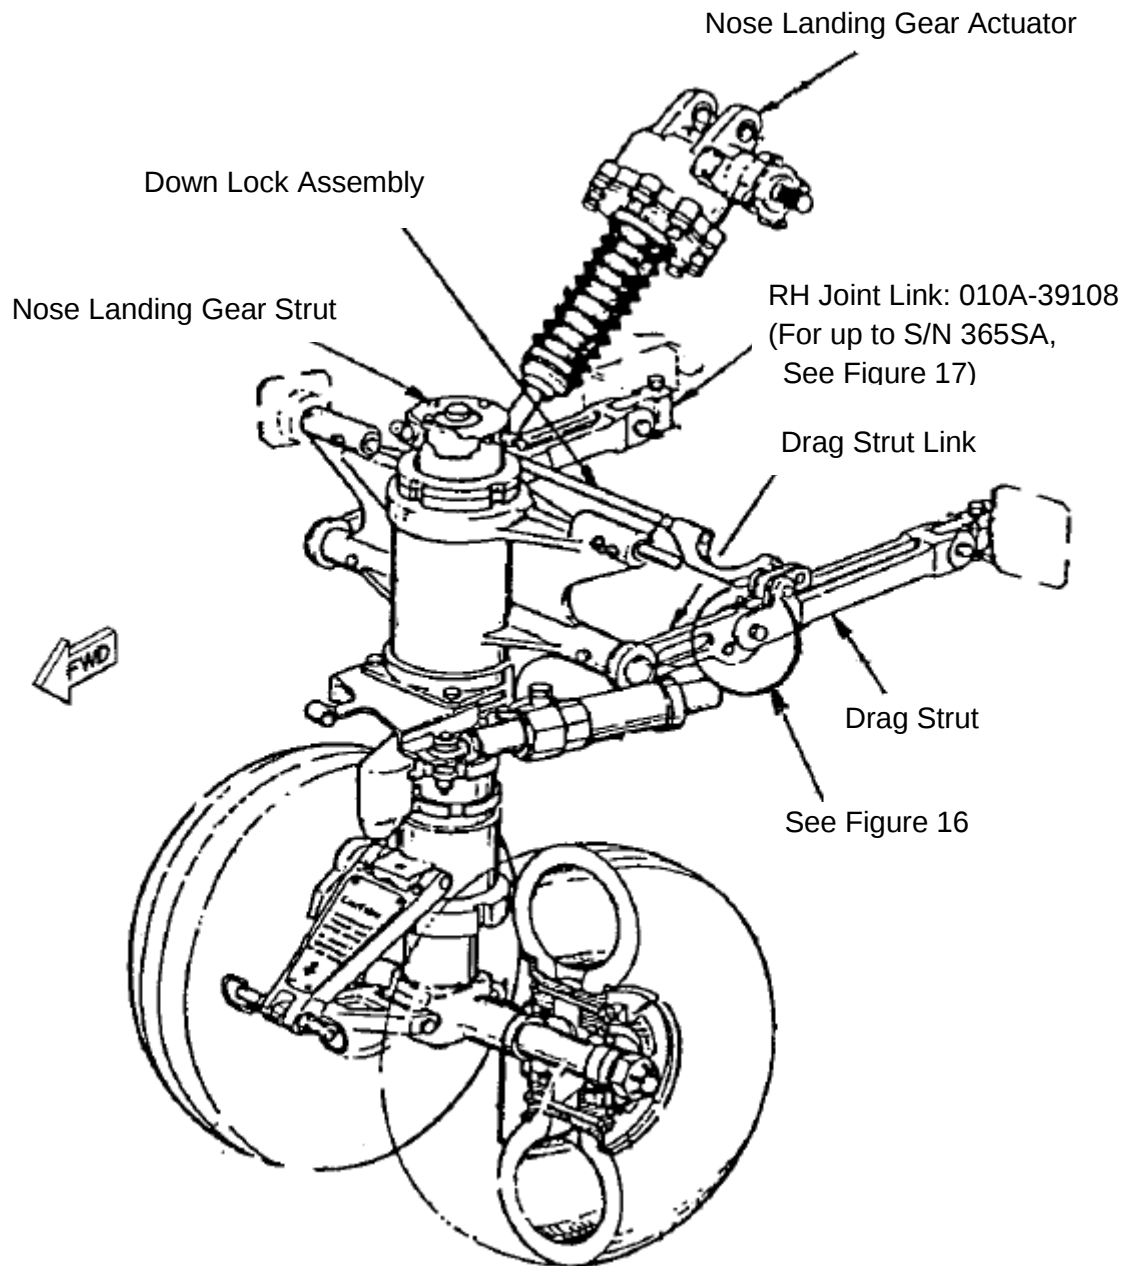
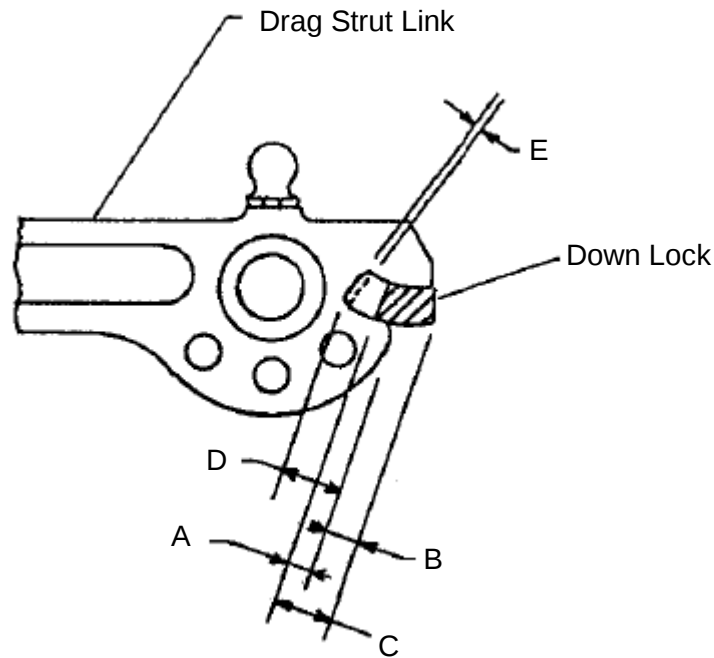
- (1) Turn electrical power on.
- (2) Retract Nose Landing Gear until Down Locks are disengaged.
  - (a) Measure LH and RH Down Lock width “C” and groove depth “D”. (Figures 15 and 16)

- (c) The RH engagement dimension “A” must be less than 0.12 inch (3.0 mm). Replace the Down Lock Assembly if the dimension “A” is not within the specified value.

- (c) Check the difference between LH and RH Down Lock engagement dimension “A”. The RH engagement dimension must be greater than the LH by 0.00 to 0.06 inch (0.0 to 1.5 mm). Replace the Down Lock Assembly if not within the specified value.
