# MU-2

## SERVICE RECOMMENDATION

No.078                      DATE: February 28, 2017

Subject:                      Nose Landing Gear System Inspection

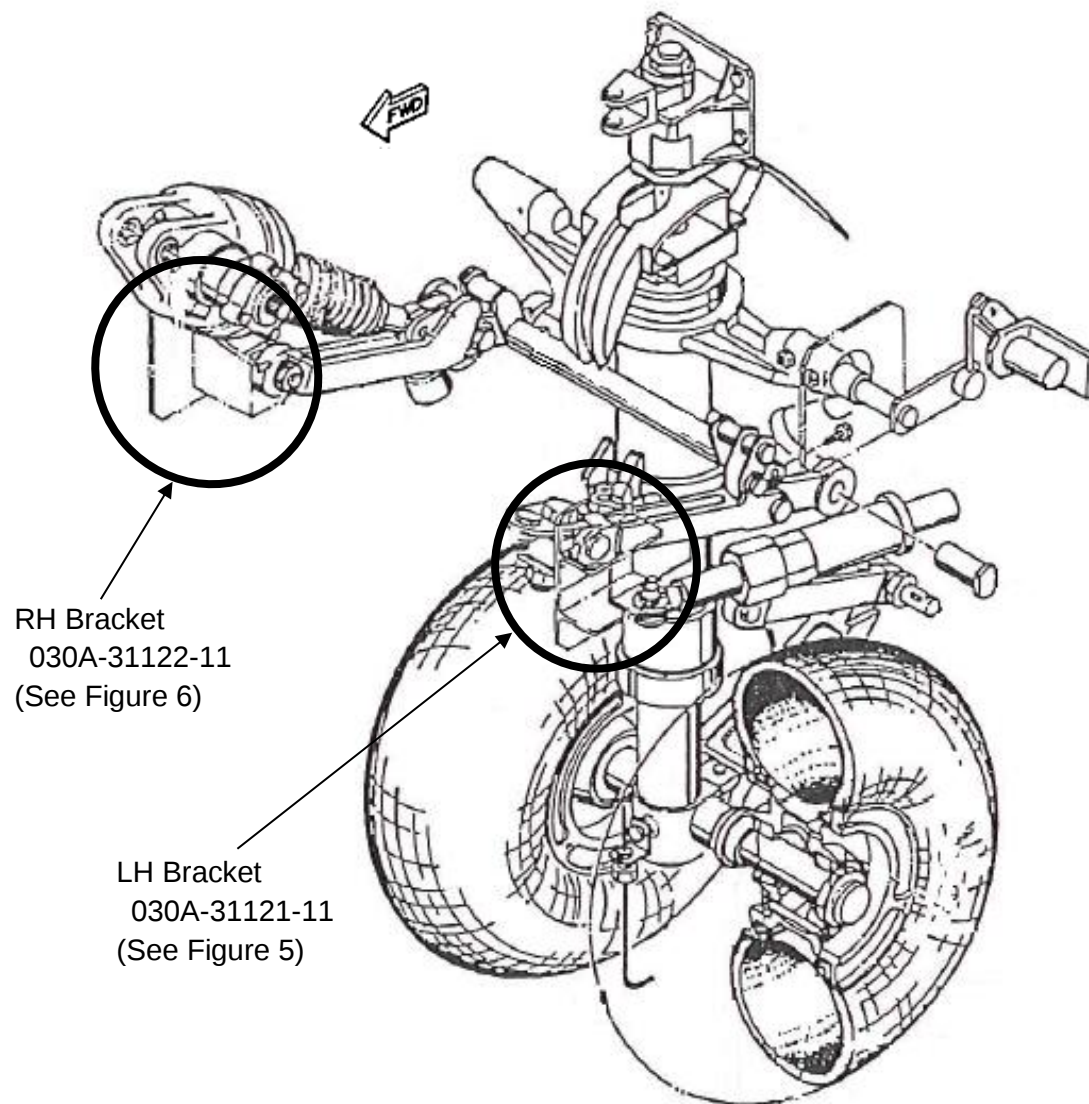
Figure 4: Drag Strut to Fuselage Bracket Location

- (1) Confirm the part number of LH NLG Drag Strut to Fuselage Bracket. If the part number is 030A-31121, perform SB No. 195.
- (2) Visually inspect LH and RH Drag Strut to Fuselage Brackets (030A-31121-11 and 030A-31122-11) for cracks in the area shown in Figure 4, 5 and 6.
  - (a) If any crack is found, replace the bracket with new one.

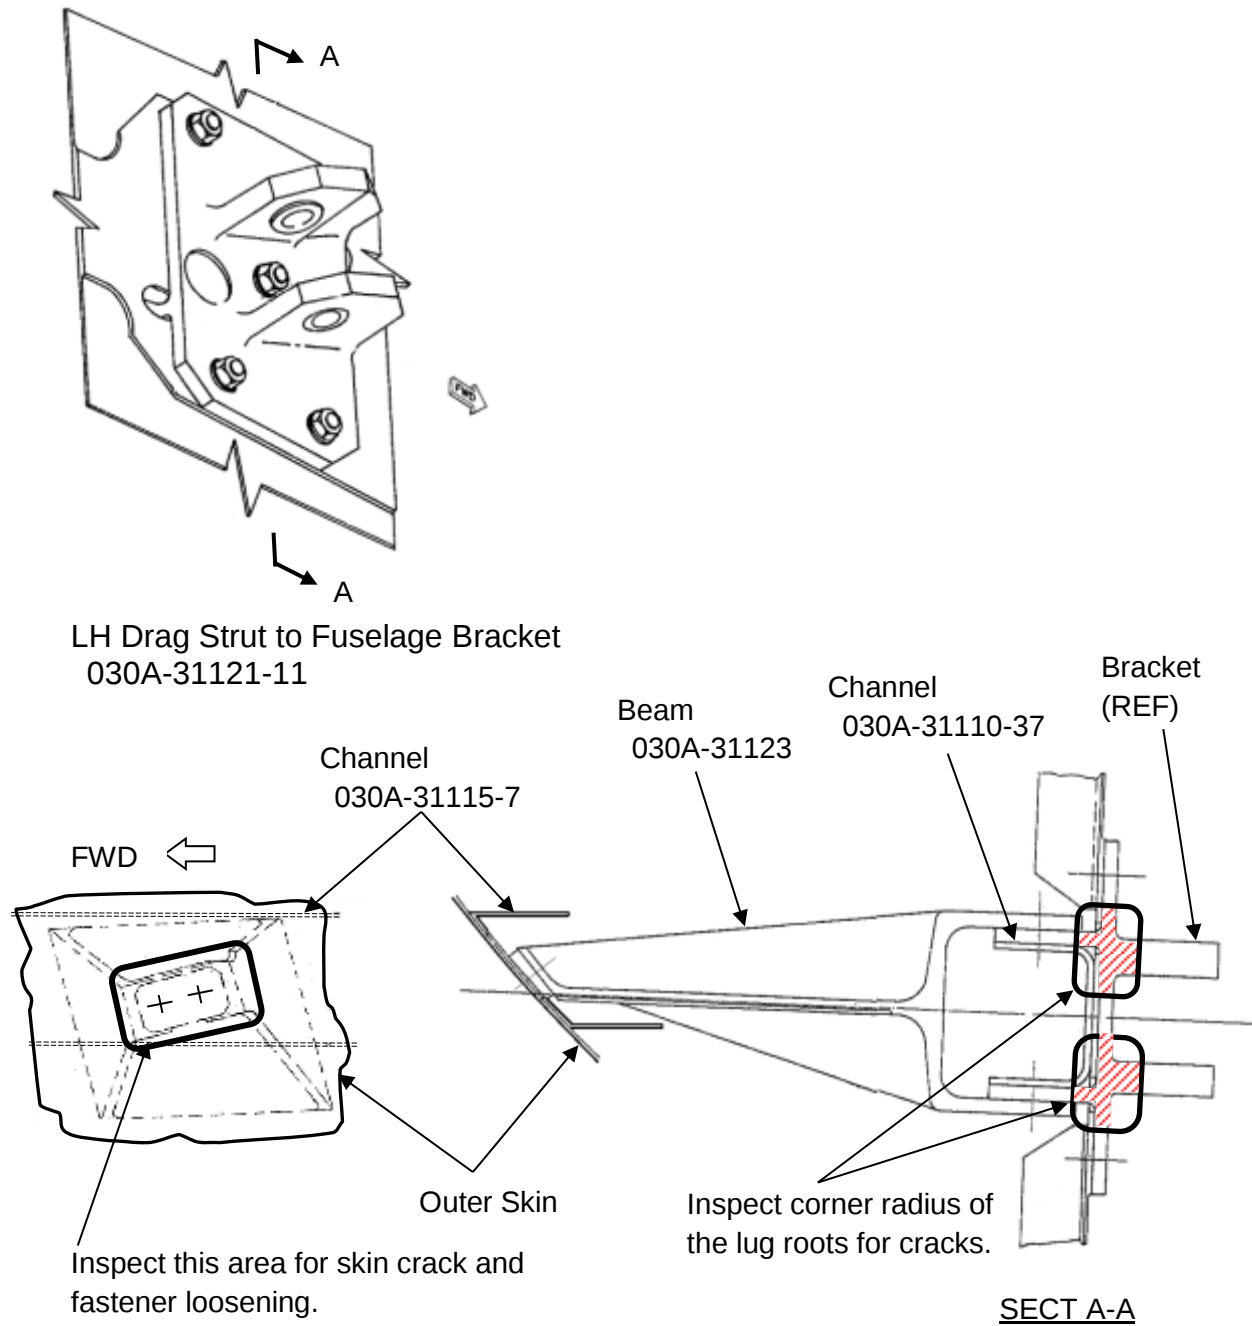
Figure 5: LH Drag Strut to Fuselage Bracket, Outer Skin and Channels

- (3) Visually inspect Outer Skins around fasteners which are installed common to Outer Skin, Channel and Beam for cracks and loosening fasteners in the area shown in Figure 5 and 6.
  - (a) If any crack is found, repair the skin in accordance with the MU-2 Structural Repair Manual.
  - (b) If any loosening fastener is found, replace the fasteners in accordance with the MU-2 Structural Repair Manual.
- (4) Visually inspect Channels (030A-31115-7/-9) between Outer Skin and Beam, and Channels (030A-31110-37 and 030A-31147) attaching to outboard lugs of Bracket for cracks and deformation shown in Figure 5 and 6.
  - (a) If any crack or deformation is found, replace the channel with new one.

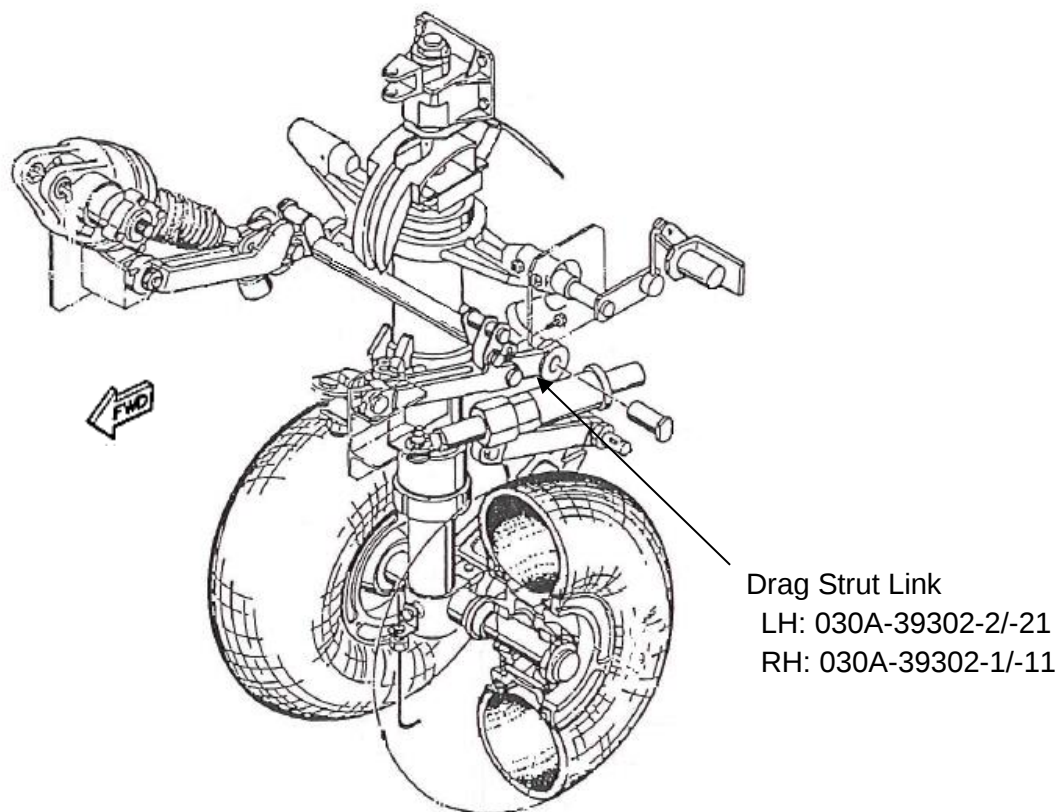
Figure 7: Drag Strut Link Location

- (1) Visually inspect LH and RH Drag Strut Links for crack, deformation, nick, gouge, rust, wear of the groove and corrosion. (Figure 7)
  - (a) If any of these conditions are found, replace the Drag Strut Links with new 030A-39302-11/-21 Links; staking marks shall be on outboard side when installed.

- (2) Visually inspect the existence of staking marks on the outboard side of Drag Strut Link for correct installation. (Figure 7 and 8)
  - (a) If the Drag Strut Link installation is incorrect (abnormal condition), install the correct Drag Strut Link identified in Figure 8.

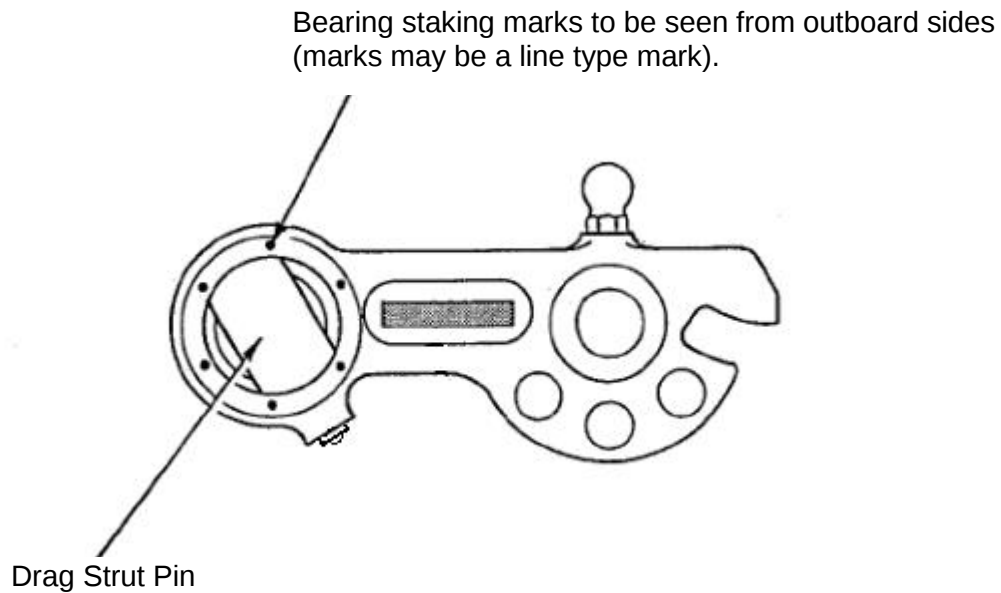
Figure 8: Drag Strut Link Identification

If the part number is not legible, check Drag Strut Down Lock Sleeve Bearing for a Teflon Liner (035A-39302). If a Teflon Liner is found, the part is 030A-39302-11/-21 Drag Strut Link. (Figure 8)

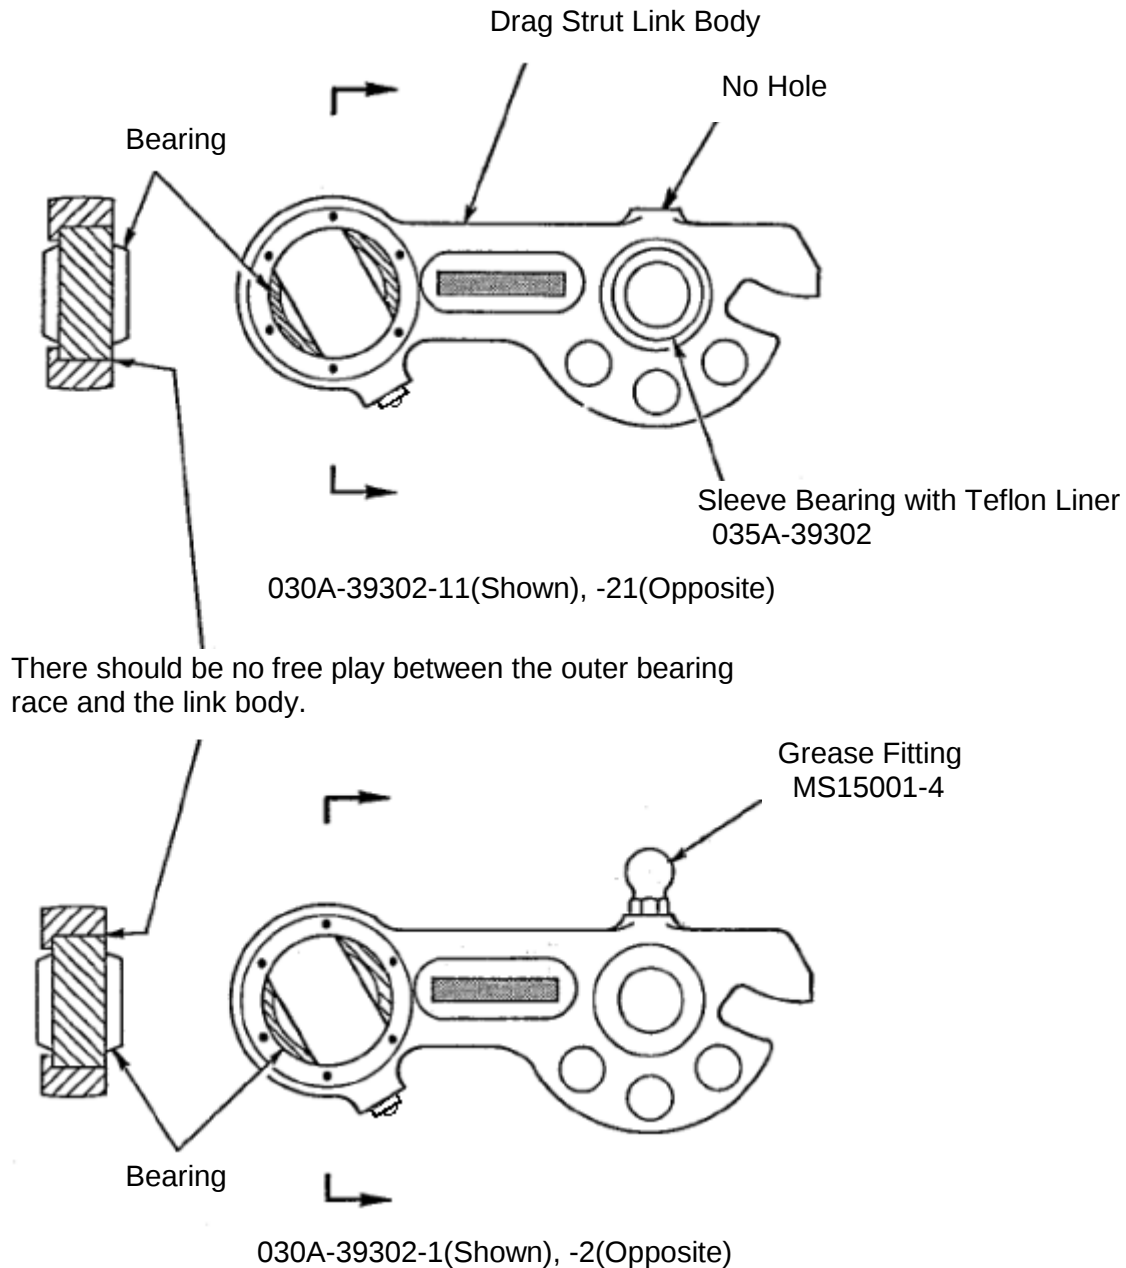
Figure 9: Drag Strut Link Free Play

- (5) Inspect Drag Strut Links for free play between the link body and outer bearing race. There should be no free play. (Figure 9)
  - (a) If any free play is found, replace the Drag Strut Links with new 030A-39302-11/-21 Links; staking marks shall be on outboard side when installed.

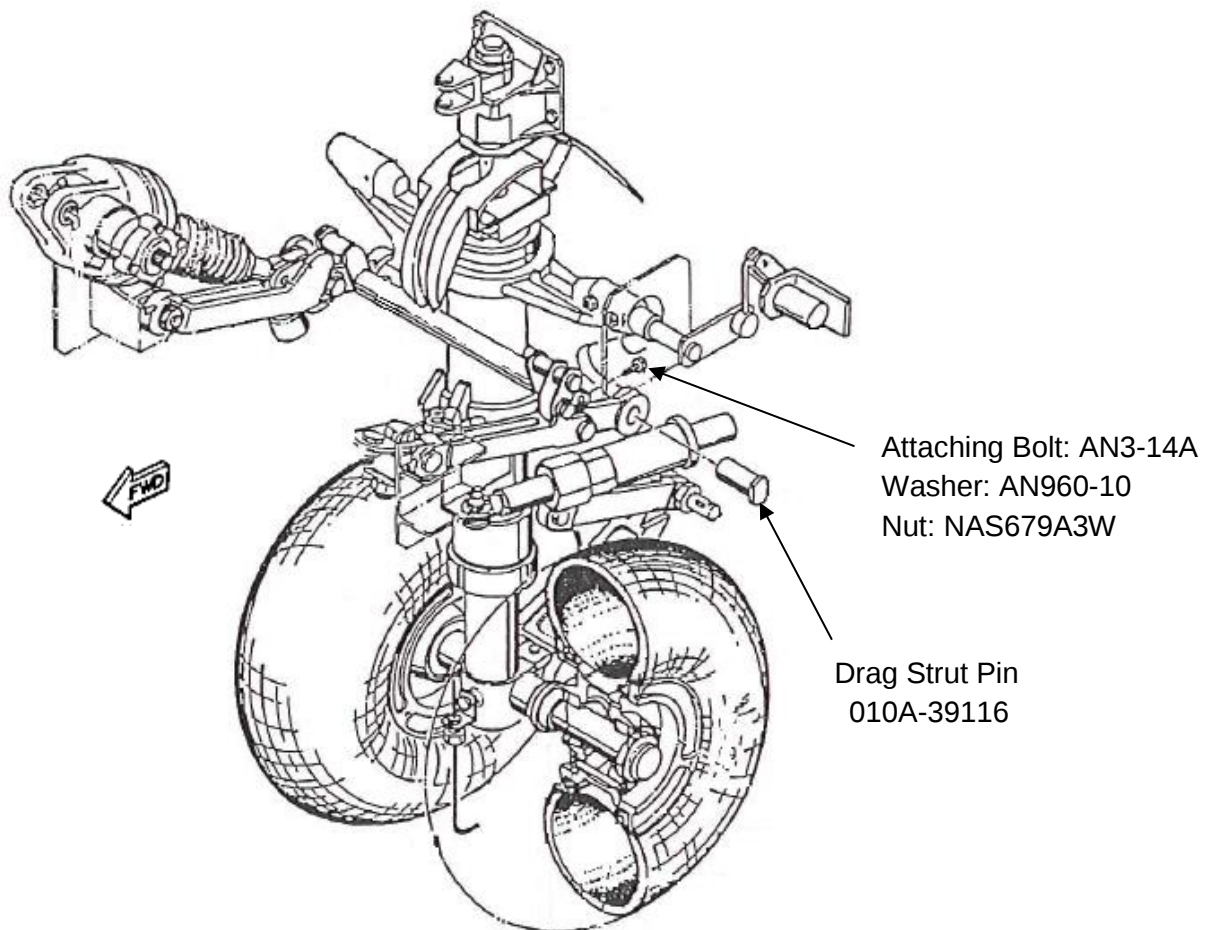
Figure 10: Drag Strut Pins and Attaching Bolts

- (1) Clean LH and RH Drag Strut Pins and visually inspect for wear, cracks, deformation or corrosion. (Figure 10)
  - (a) If any of these conditions are found, replace the Drag Strut Pin with new one.

If Drag Strut Pins are replaced, take into consideration the clearance between LH and RH Drag Strut Links and Drag Strut Pins [0.002" to 0.012"] (0.05 mm to 0.30 mm) before drilling in accordance with the applicable MU-2 Maintenance Manual; Pin shanks must be drilled #11 [4.85 mm (+0.07/-0.02 mm)] in diameter at the position to match the holes in Trunnion for installation of Drag Strut Pin attaching bolts (AN3-14A, Figure 1 ③).

- (a) Apply thread compound (MIL-T-5544) or grease (MIL-G-23827) to Drag Strut Pins and install Drag Strut Pins to Trunnion.
- (b) Apply sealant (PR-1221) to the attaching bolt shank surface, and install the bolts, washers and nuts to Trunnion and Drag Strut Pins.
- (c) Apply sealant (PR-1221) on and around the bolt heads and nuts.

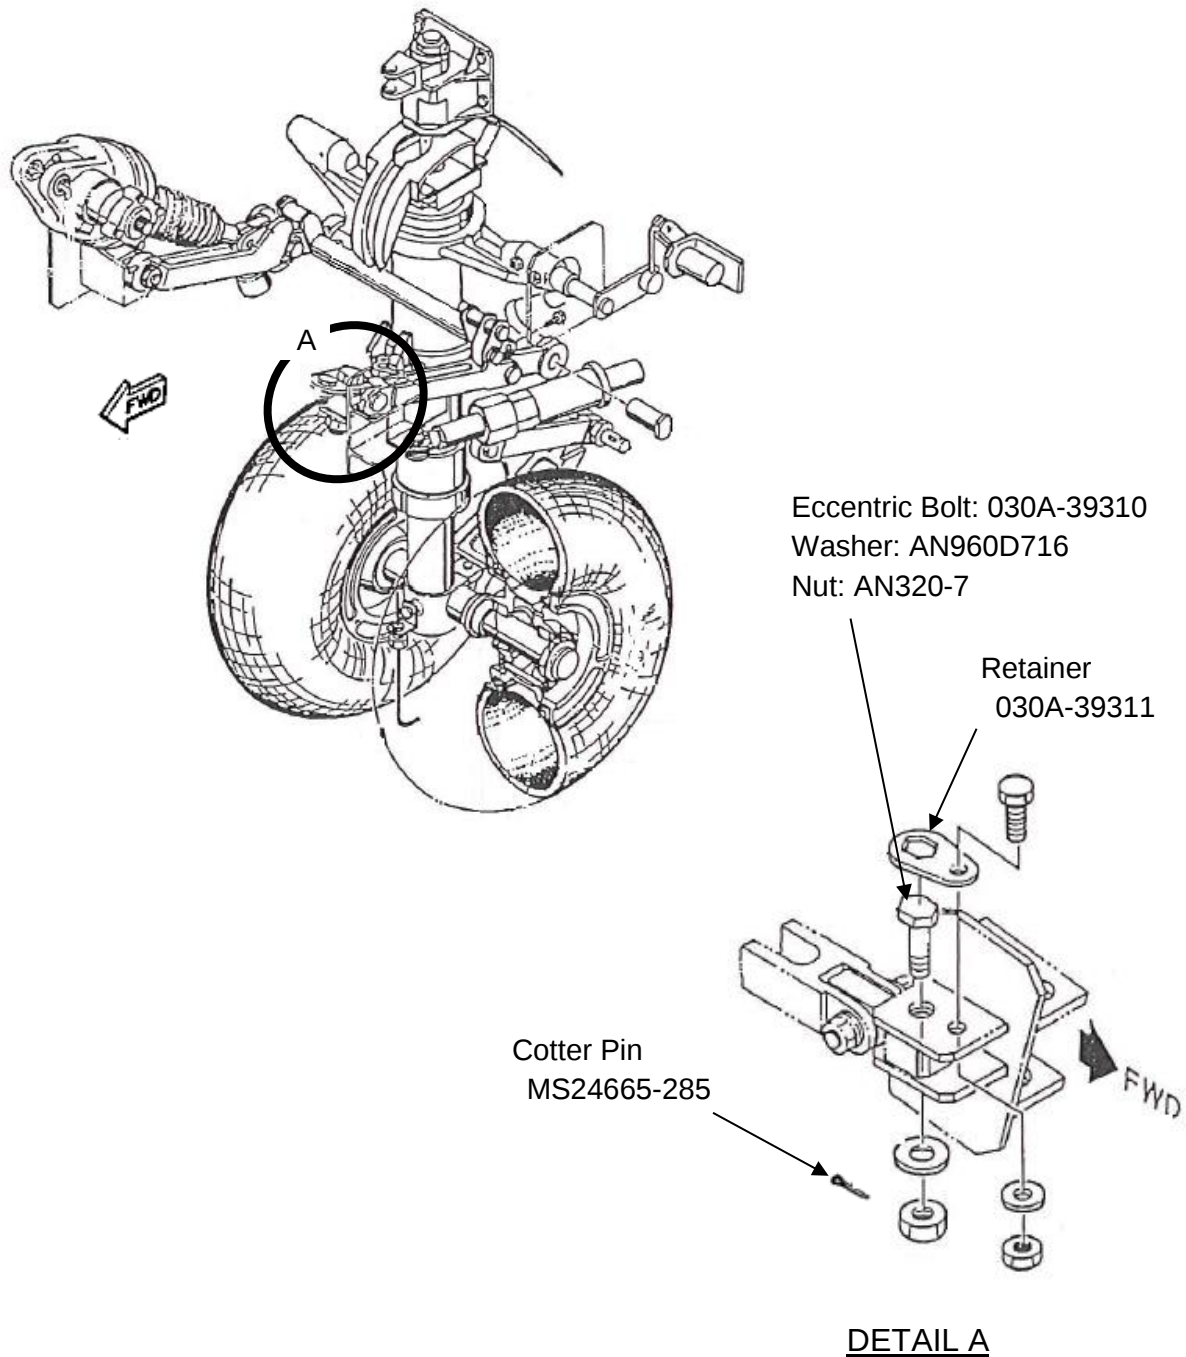
Figure 11: Eccentric Bolt

- (1) Visually inspect Eccentric Bolt for cracks, deformation or corrosion. (Figure 11)
  - (a) If any of these conditions are found, replace the Eccentric Bolt with new one. Prior to installation of a new bolt, apply alignment mark on the same place as the bolt being replaced.

- (a) Apply grease (MIL-G-23827) to the shank of Eccentric Bolt. (Figure 12)
- (b) Install Eccentric Bolt taking into consideration the aligning mating marks on the bolt head and the bolt retainer. (Figure 11 "A")
- (c) Ensure that Down Locks disengage and engage smoothly by partially retracting and extending the nose gear by hand.

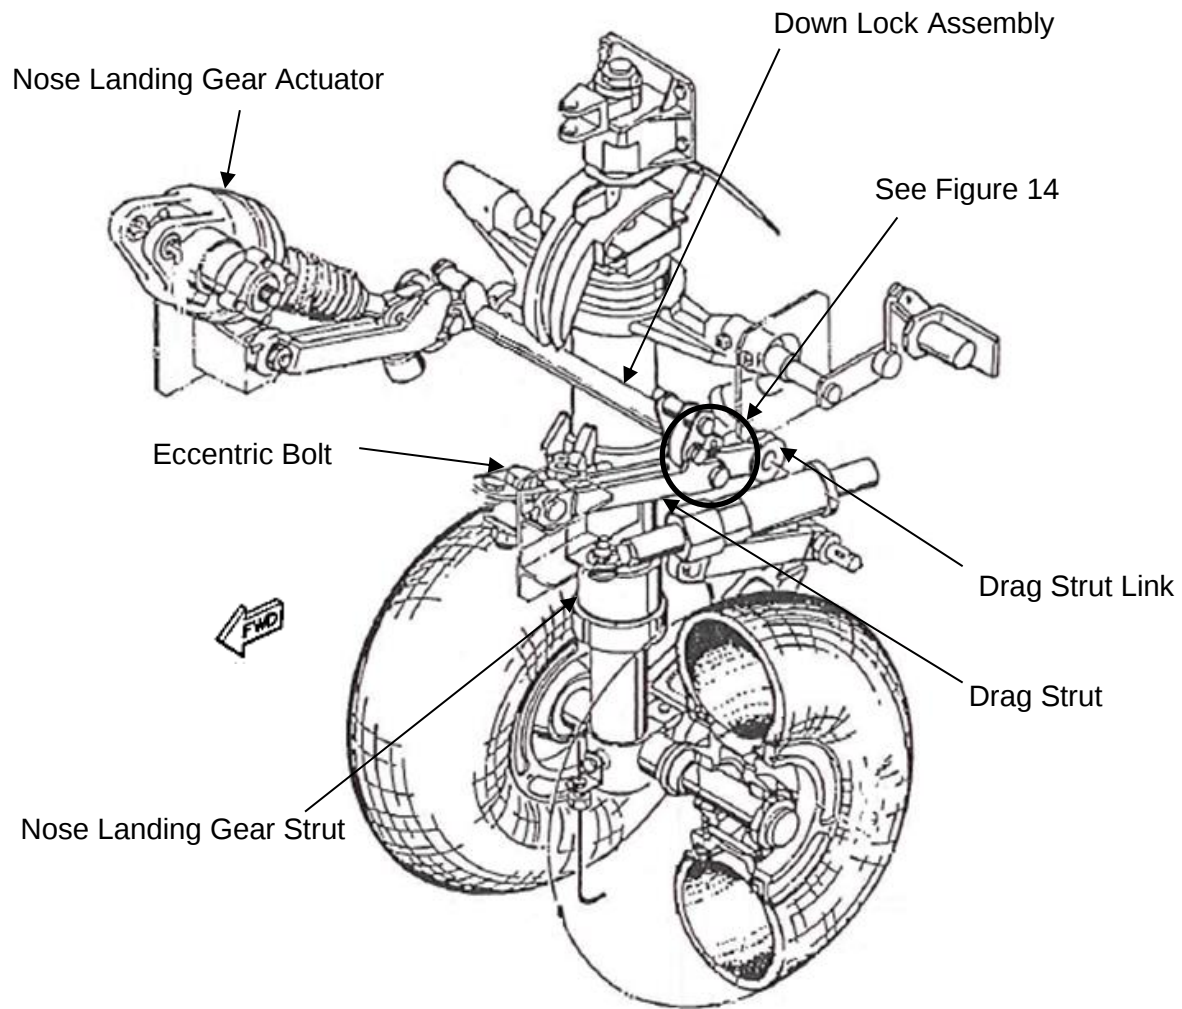
Figure 13: NLG Down Lock Mechanism

- (a) Measure dimension “B” of RH Down Lock unengaged portion. (Figure 13 and 14)
  - (b) Determine the RH Down Lock engagement dimension “A” as follows:
$$A = C - B$$

- (c) The RH engagement dimension “A” must be less than 0.12 inch (3.0 mm). Replace the Down Lock Assembly if the dimension “A” is not within the specified value.

- (a) Calculate the LH and RH Down Lock engagement dimension “A” same as step (4) (a) and (b).
  - (b) The LH engagement dimension “A” must be 0.24 in. (6.0 mm) or more. Readjust the system as necessary to be within the specified value.

- (c) Check the difference between the LH and RH Down Lock engagement dimension “A”. The RH engagement dimension must be greater than the LH by 0.00 to 0.06 inch (0.0 to 1.5 mm). Replace Down Lock Assembly if not within the specified value.

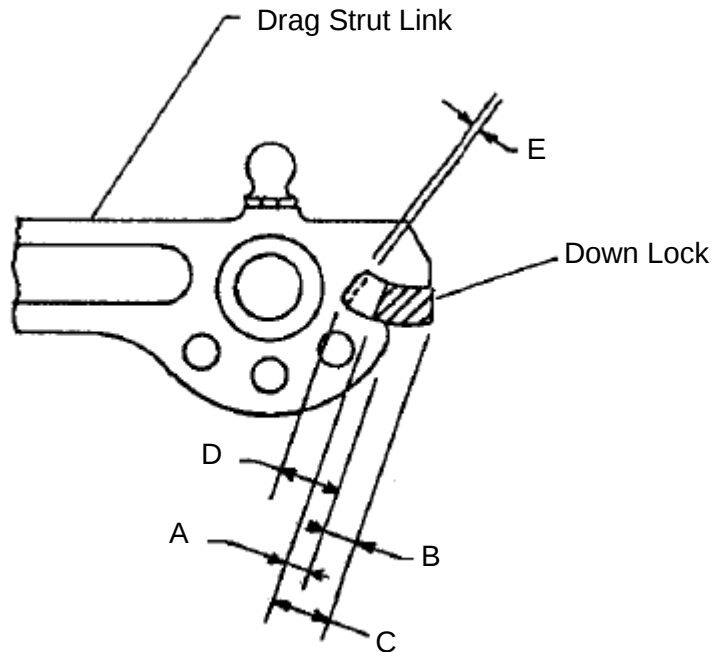
Figure 14: Drag Strut Link and Down Lock

- (b) Calculate the remaining distance “E” of the RH Down Lock as follows:
$$E = D - A$$
  - (c) The distance “E” should be 0.08 inch (2.0 mm) or more. If the distance is less than the specified value, readjust the system.
