### **SR 080B**

#### **Propeller Pitch Control Lever Secondary Retention Feature, Installation of**

# SERVICE RECOMMENDATION

| No.080 Rev.B | DATE: April. 28, 2020 |

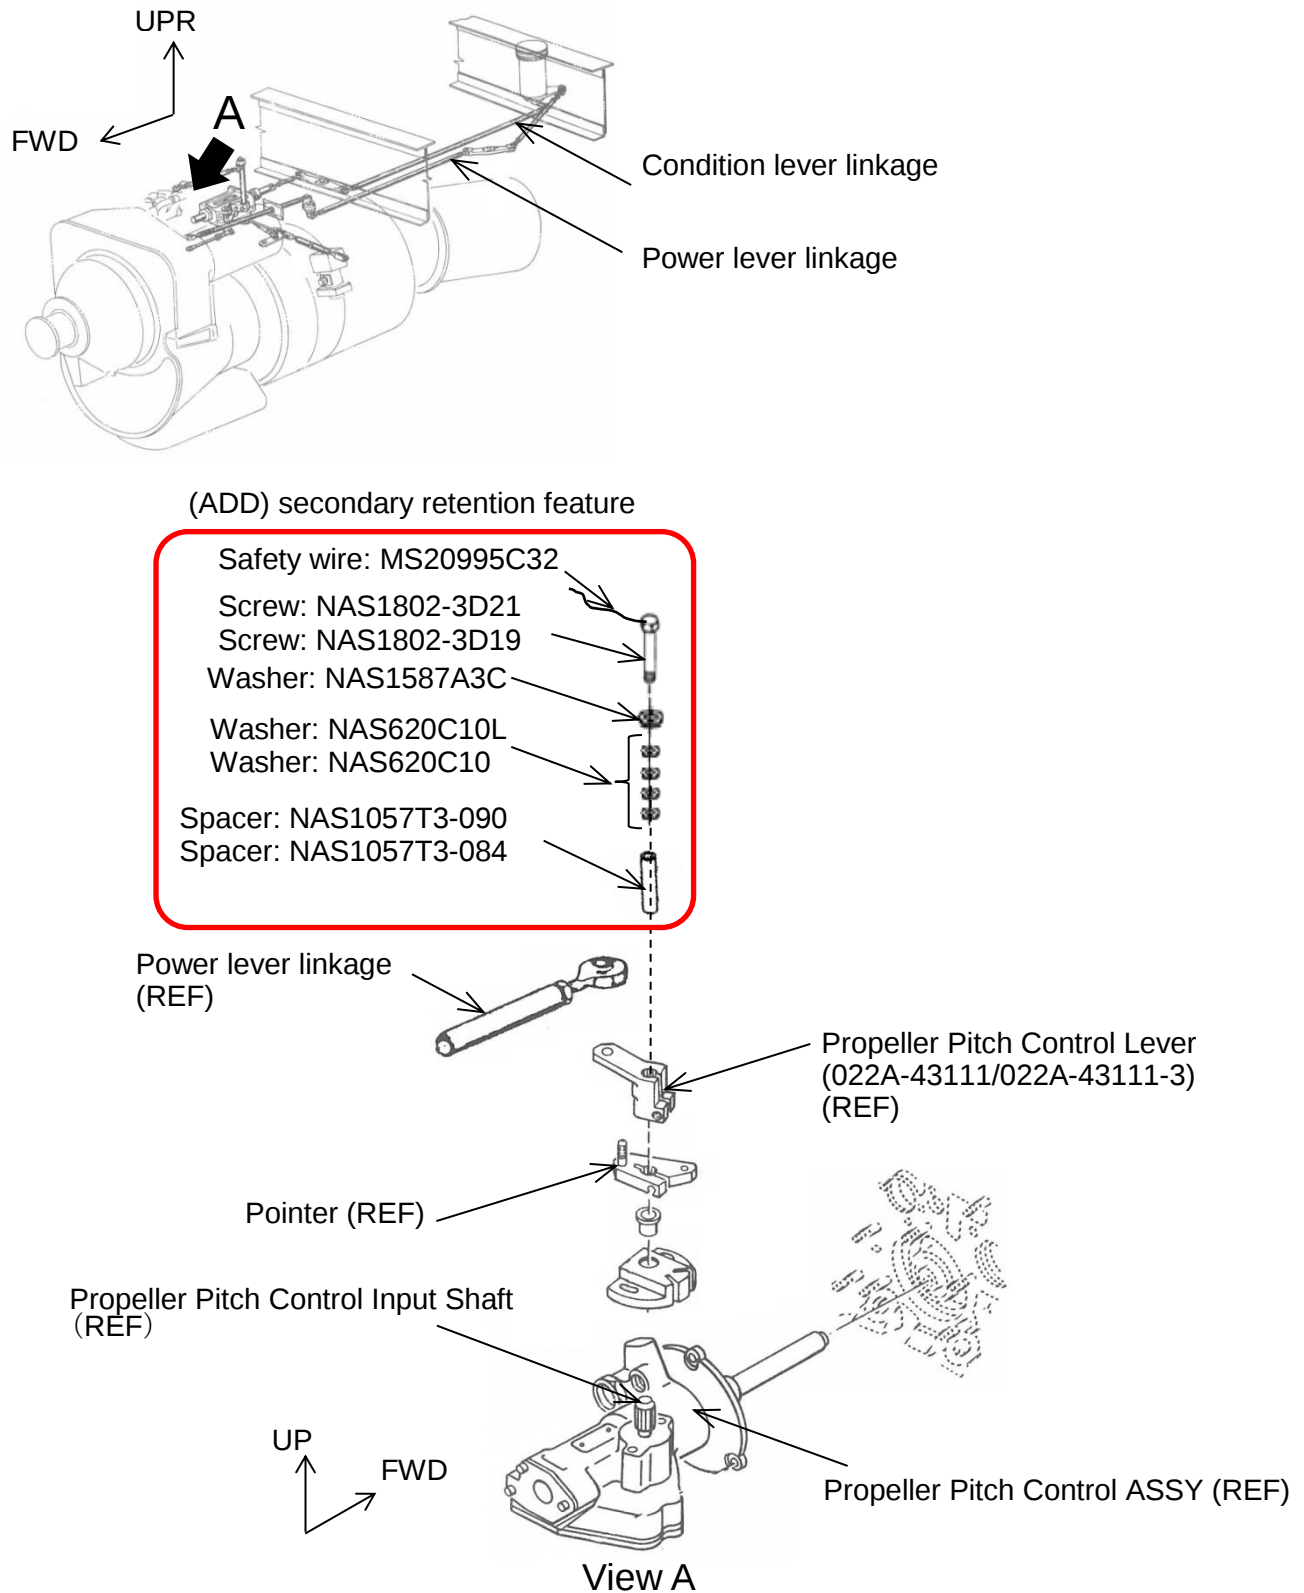
**Figure 1 Installation of Secondary Retention Feature**

| Purpose: | To add a secondary retention method to secure the Propeller Pitch Control (PPC) lever, install the secondary retention feature (screw, washer(s), spacer, and safety wire) in the threaded end of the PPC input shaft. |

- (3) Install screw (NAS1802-3D21/NAS1802-3D19), counter washer (NAS1587A3C), gap adjustment washers (NAS620C10 and NAS620C10L), and spacer (NAS1057T3-090/NAS1057T3-084) to the threaded end of PPC shaft. (Ref to Figure. 1)

- (4) Verify that there are at a minimum two (2) full turns of engagement between screw (NAS1802-3D21/NAS1802-3D19) and Propeller Pitch Control Input Shaft threaded hole. Torque the screw NAS1802-3D21/NAS1802-3D19) to 10 to 15 in-lbs. Screw (NAS1802-3D21/NAS1802-3D19) does not bottom out inside the threaded shaft once required torque is achieved. 1/16" longer or shorter screw may be installed instead of screw (NAS1802-3D21/NAS1802-3D19) to obtain required thread engagement.
