**Jason DuBose and Matt Walton,**  
**Mitsubishi Heavy Industries**  
**Compressor International Corp.,**  
**USA,** share a case study of how a first  
generation syngas steam turbine was  
modified after catastrophic damage.

# A HYBRID approach

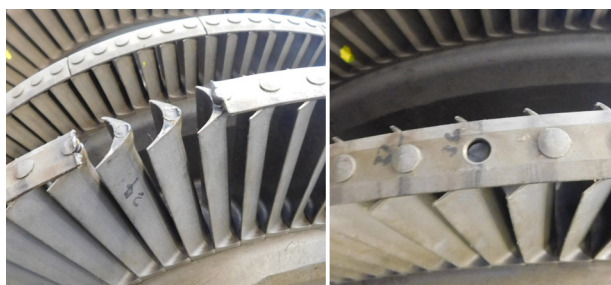
**Figure 2.** Missing shroud band (left) and tenon (right) found after shutdown.

a full shutdown in June 2017. At this time, several tenons on stage 5A were found to have failed, as shown in Figure 2.

UT inspection of tenons is shown in Figure 3. In this case, using a proprietary UT inspection method, MCO-I detected over 12 additional cracks that would have led to additional damage. A root cause failure investigation showed the failure was due to improper peening in a previous repair. The customer's decision to improve the rotor was driven by the desire to have a reliable and safely operating turbine for years to come. MCO-I was consequently tasked with the redesign of stages 5A – 5C.

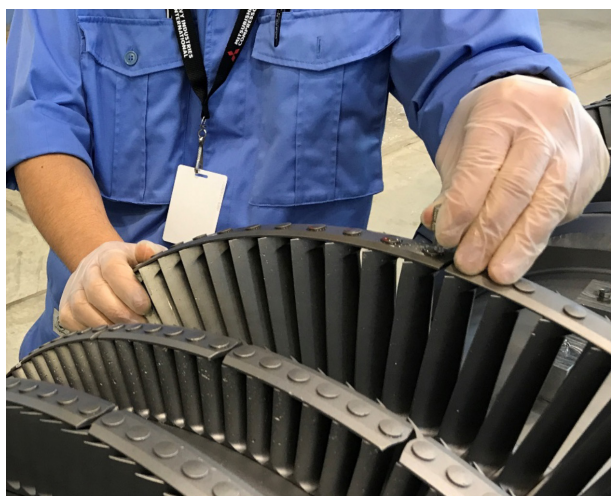
**Figure 3.** Tenon UT inspection of the subject rotor.

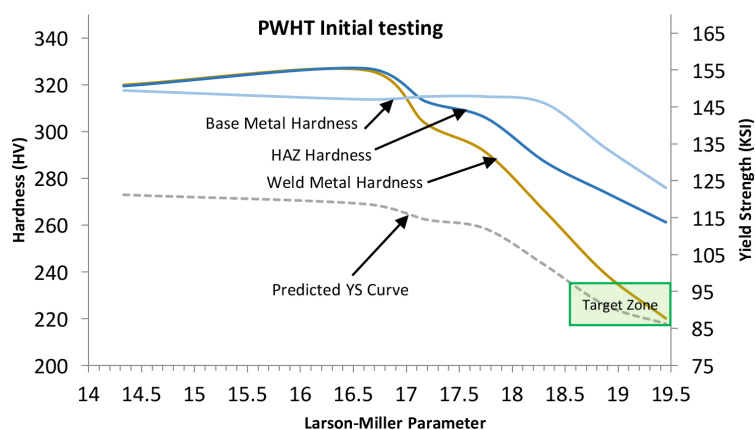
Seven 1 in. thick coupons were created through the fusion line, and were subjected to a three hour PWHT at various temperatures. The resulting pieces were then hardness tested in the base material, heat affected zone (HAZ), and weld material. Figure 7 shows the effect of PWHT in these regions plotted against the Larson-Miller parameter – a dimensionless factor that combines the effects of time and temperature. Based on the hardness results and required strength, a target Larson-Miller parameter for the actual weld was chosen, and test results for the procedure qualification record (PQR) piece showed acceptable yield strength, toughness, and hardness through the weld. Additionally, UT inspection and macroetch samples showed zero unacceptable defects in the test piece.

**Figure 7.** PWHT testing.

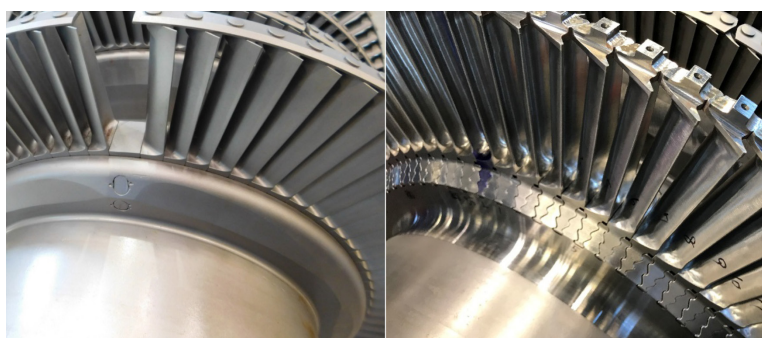
**Figure 8.** Stage 5b before the modification (left) and after modification (right).

Having successfully qualified the procedure, the rotor was prepared for welding by machining off the existing discs and creating a joint profile that removed welding starts and stops from high stressed locations. Care was taken to

After welding, the discs were rough-machined and thoroughly inspected for cracks and other flaws by UT and MT inspection. The rotor was post-weld heat treated to relieve welding stresses and temper the material in the same manner as the test piece and inspected again by MT and UT. Finally, the new discs were machined into their new shape, axial entry roots were cut, and the new discs were inspected again by MT. New blades were installed, as shown in Figure 8, and the rotor was at-speed balanced.
