The following error was found in the EX ROVR Instruction Manual. We apologize for the error and correct it. Please check back for additional details.

The explosion-proof certification has been corrected, but this is due to a change in the certification body, and there is no change in the explosion-proof performance.

#### List of Corrections

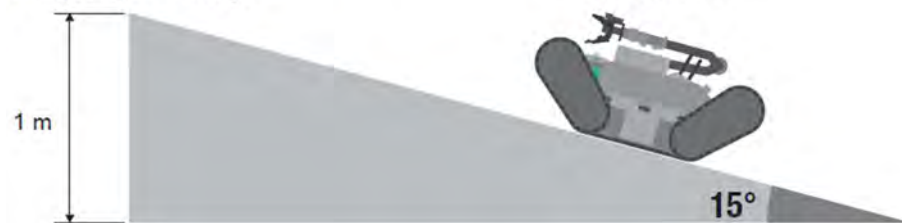
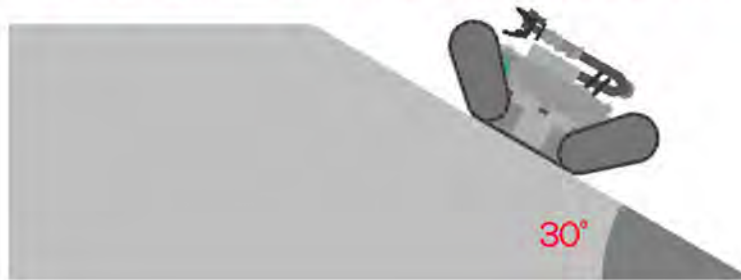
## No.1 Error Correction

**A: Slope that can be navigated during automatic patrol**

Ramps: Up to 1 m high

Slope: Up to 15°

**A : Slope that can be navigated during automatic patrol**

Slope: up to 30 degrees in the frontal direction (There shall be no slip when running)

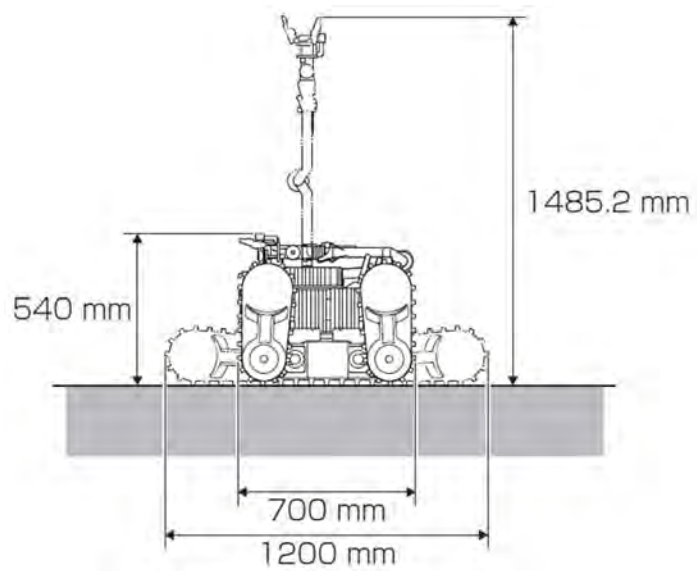
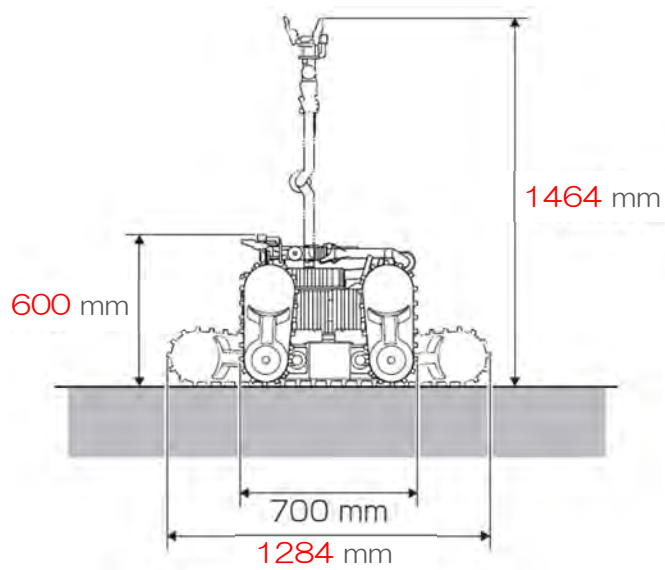
## No.2 Error Correction

Common to all manuals 1.4.1 (p.1-10)

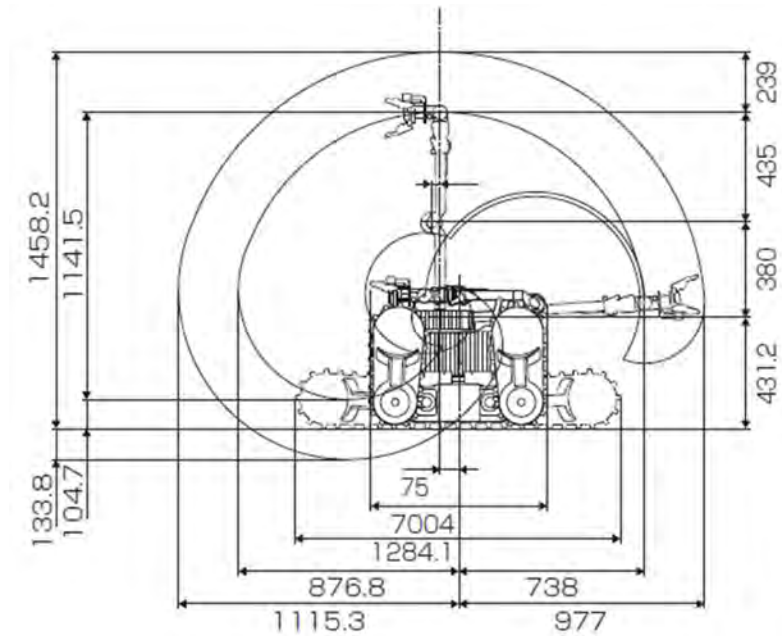
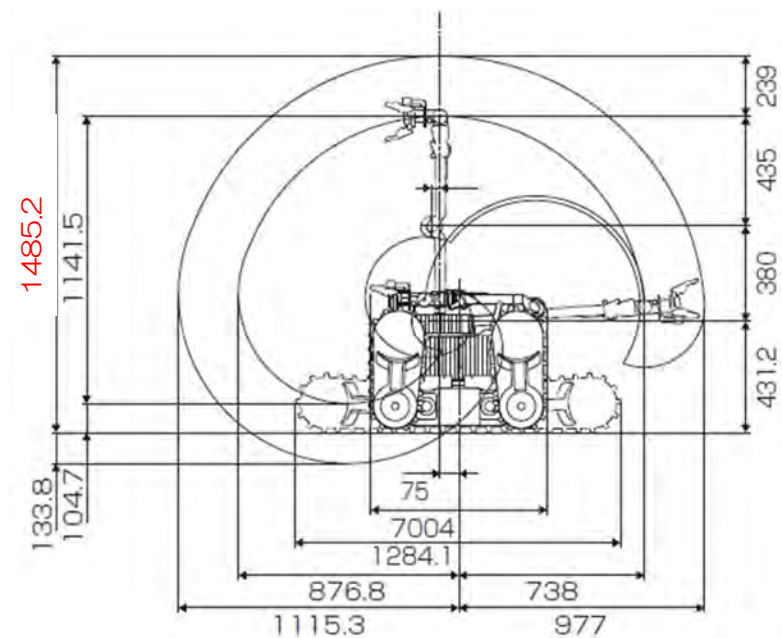
## No.3 Error Correction

Common to all manuals 1.4.1 (p.1-11)

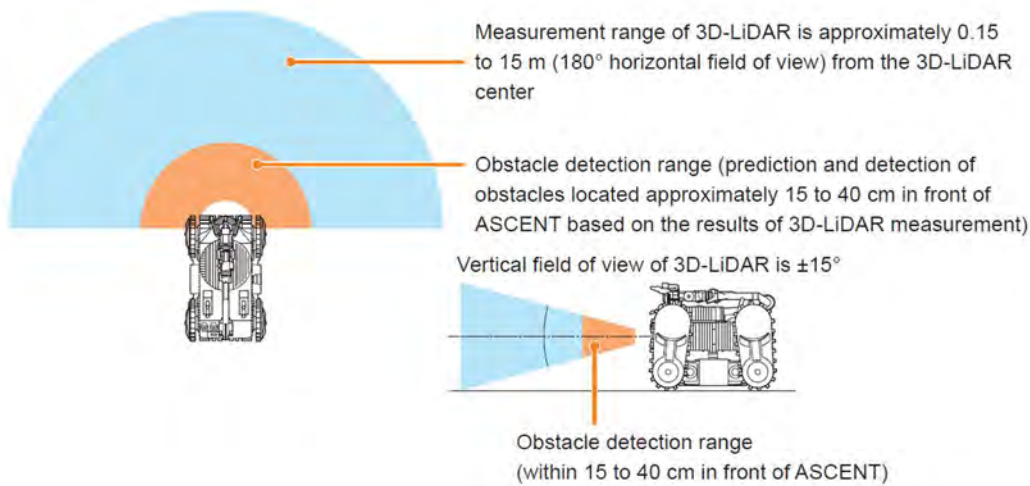
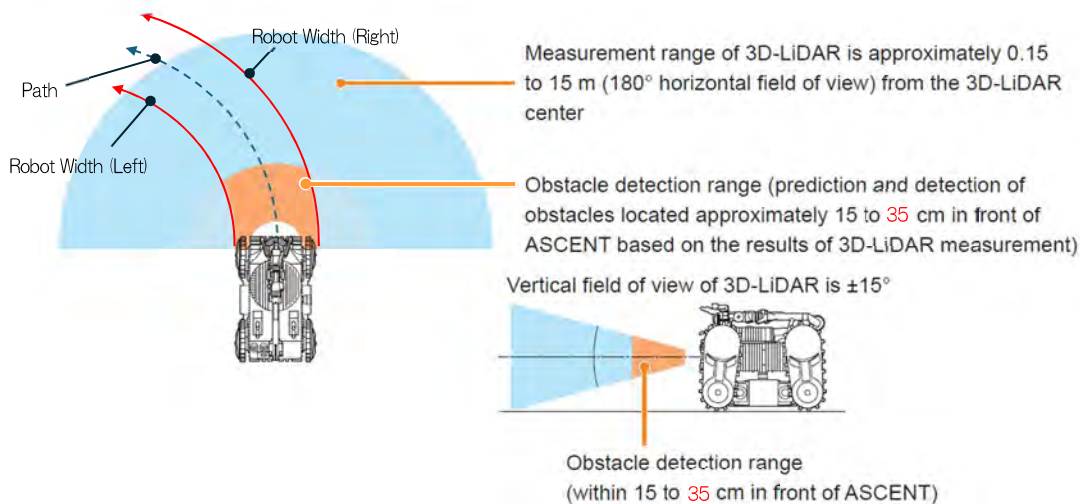
## No.4 Error Correction

The obstacle detection function, based on 3D-LiDAR data, predicts ASCENT's position one second ahead and stops operation if an obstacle is detected at the predicted position. As shown in the figure below, the detection range is approximately 15 to 40 cm in front of ASCENT.

The obstacle detection function, based on 3D-LiDAR data, is designed to stop the operation of ASCENT when it detects an obstacle within approximately 15 to 35 cm in front of it, considering the width of the robot along its path.

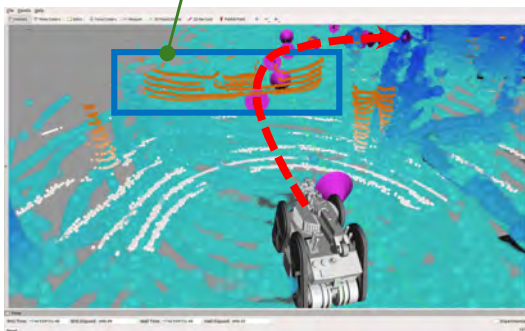
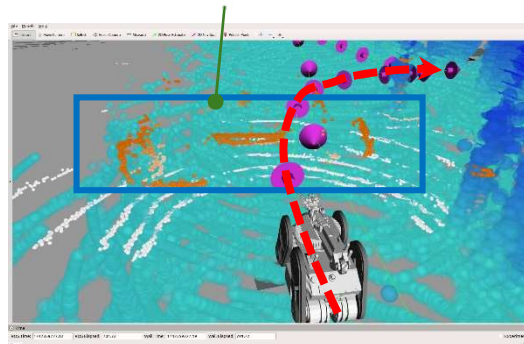
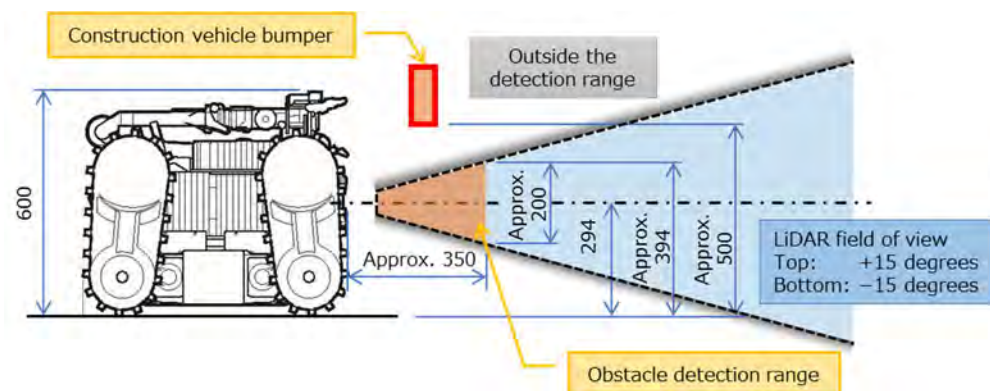
## No.5 Additional Contents

- **Avoid relying exclusively on the obstacle detection function.**

Even if 3D-LiDAR can detect obstacles at a distance, if the robot gets closer and moves out of the detection range, the obstacle detection may fail, and the robot may collide with an obstacle.

As shown in the figure on the left, when a construction vehicle is parked on the route and its bumper is positioned in relation to the robot as depicted in the figure below, the bumper cannot be detected when the robot approaches because it is outside the detection range of the 3D-LiDAR.

Vehicle bumper is detected at a distance

Bumper is not detected at a close position

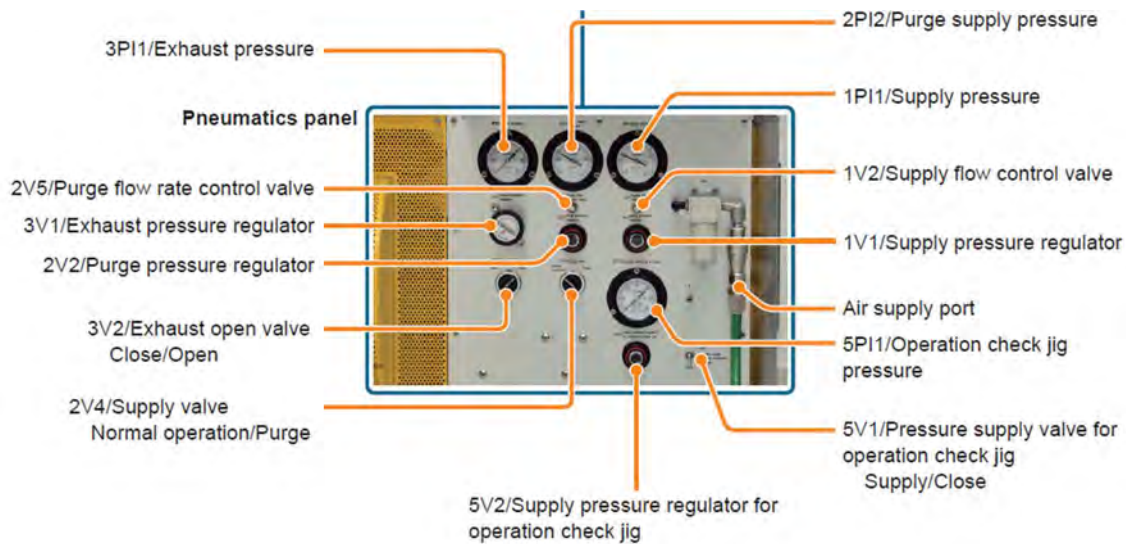
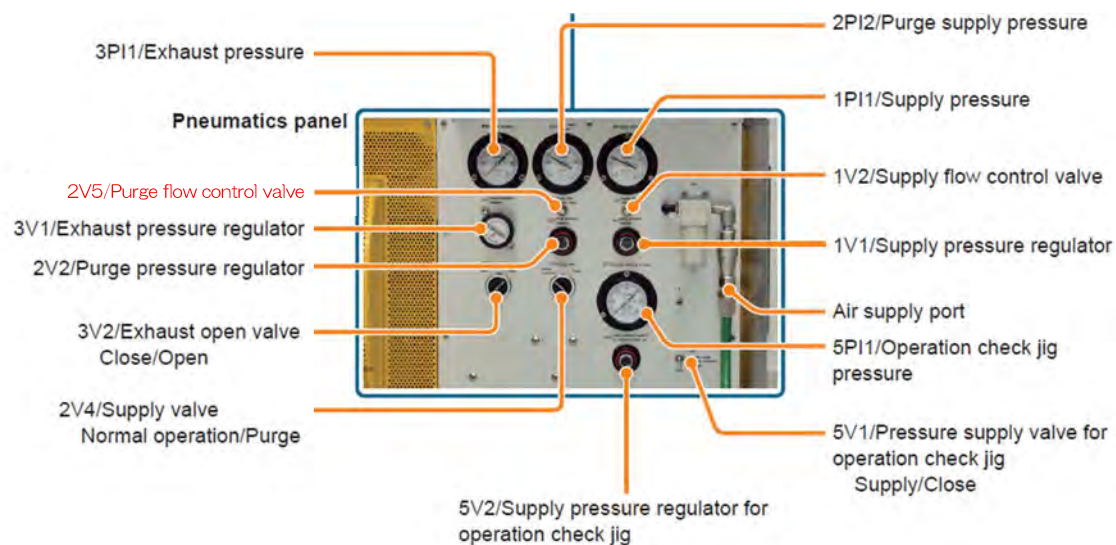
## No.6 Error Correction

Common to all manuals 3.2 (p.3-5)

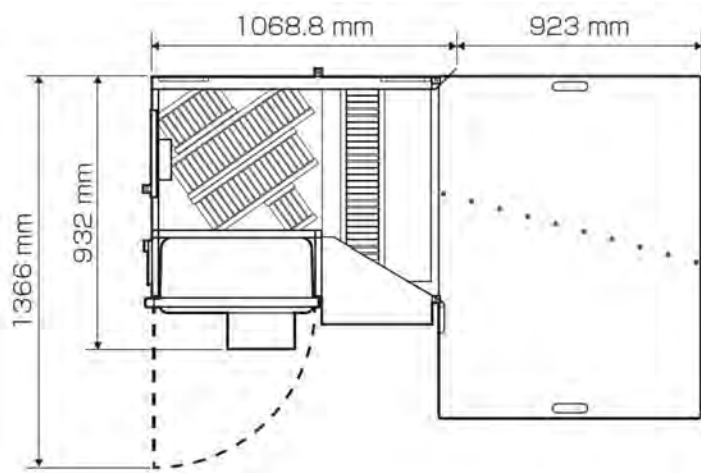
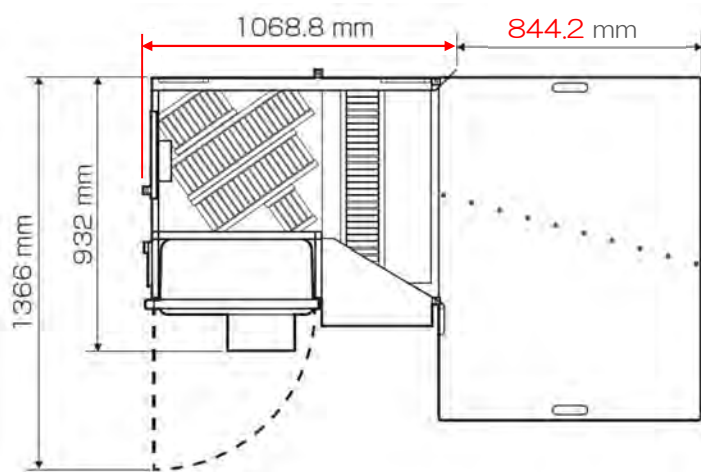
## No.17 Error Correction

10.2(p.10-15)

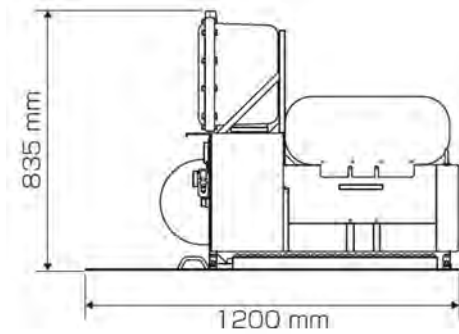
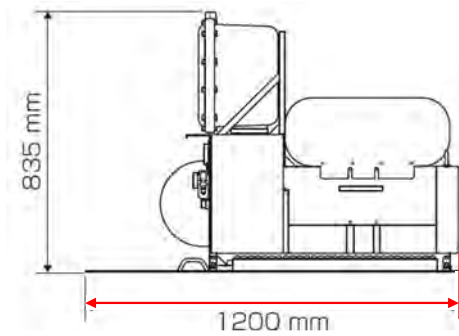
## No.18 Error Correction

10.2(p.10-15)

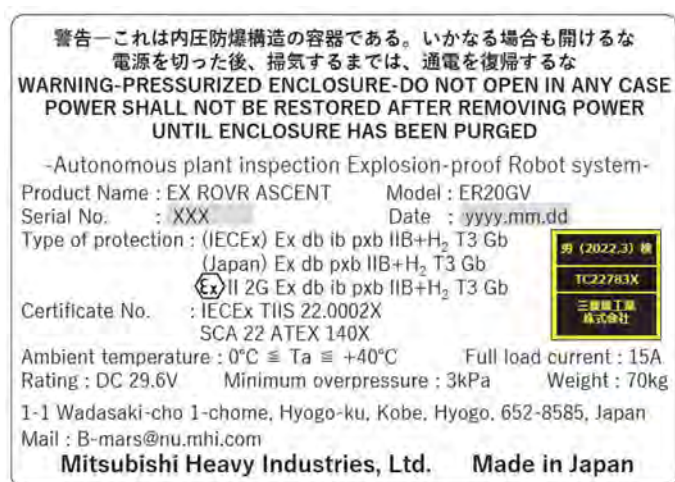
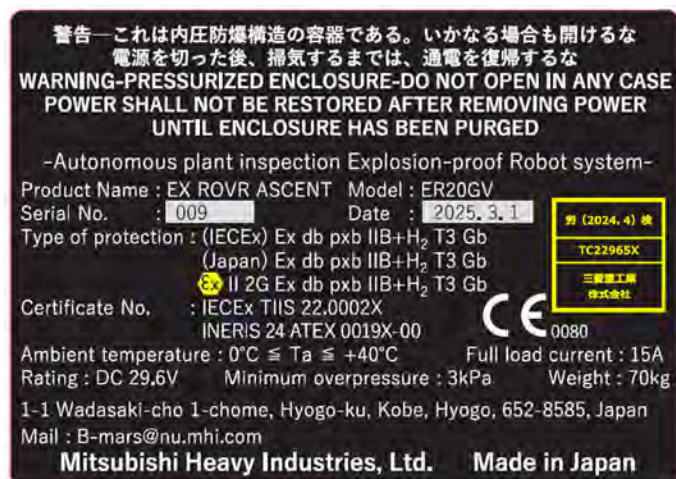
## No.20 Nameplate update

## ■ ASCENT nameplate

Japan/U.S.A./Europe

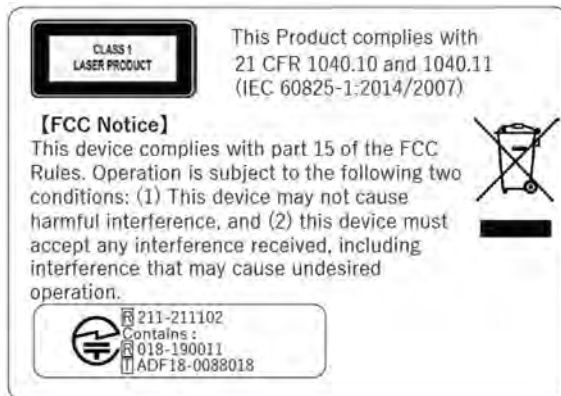
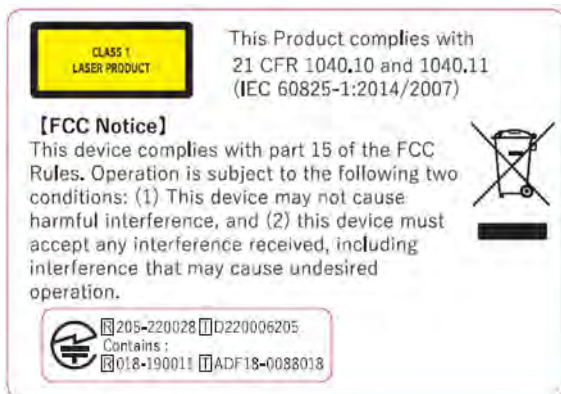
## No.21 Nameplate update

## ■ ASCENT nameplate

Japan

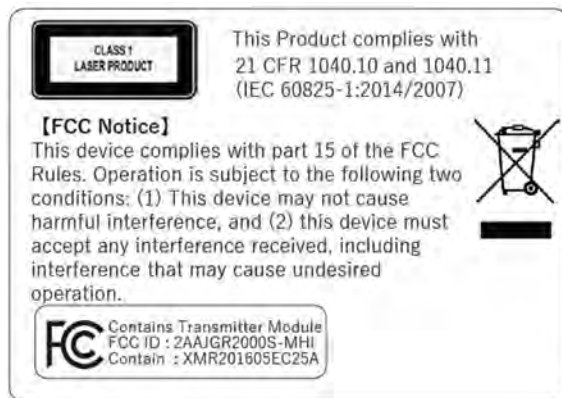
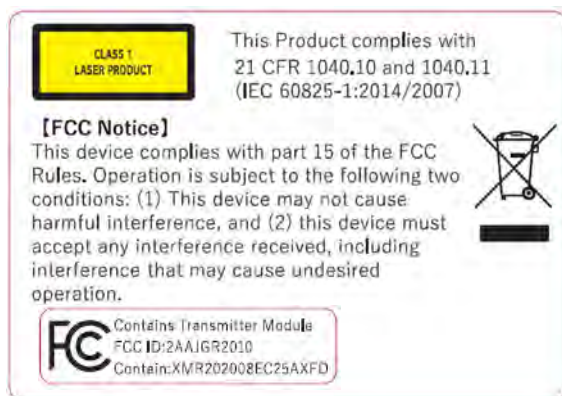
## No.22 Nameplate Update

## ■ ASCENT Nameplate

U.S.A.

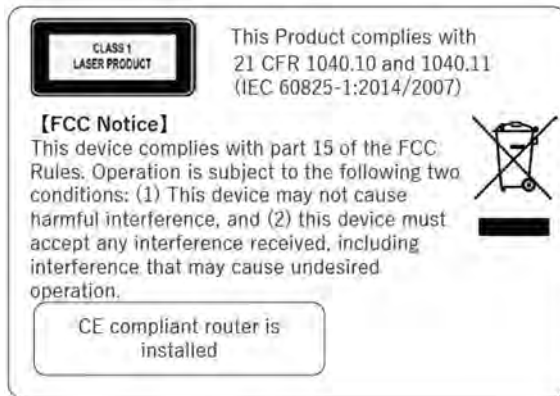
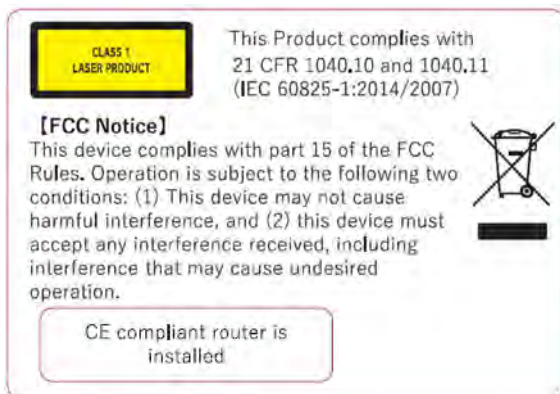
## No.23 Nameplate update

## ■ Nameplate ASCENT

## Europe
