IMPROVING THE PROCESS

Pallavi Baddam, Mitsubishi Heavy Industries Compressor International, USA, discusses how upgrading and revamping syngas turbines in existing ammonia plants can increase capacity and improve the process.

Case study 1: reduction in overall steam consumption by replacing internals

Case study 2: repairing the existing turbine casing and replacing internals

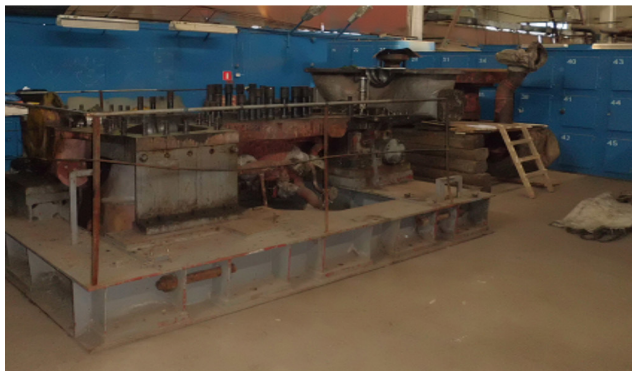
Figure 1. The existing syngas turbine casing in a customer's plant (Russia) before modernisation.

The present condition and turbine history was analysed. It was concluded that steam reduction could be achieved by replacing the turbine internals without replacing the casing. Upgrading the internal components shown in Figure 1, such as the rotor, diaphragms, nozzles and labyrinths, helped improve the overall efficiency of the syngas steam turbine.

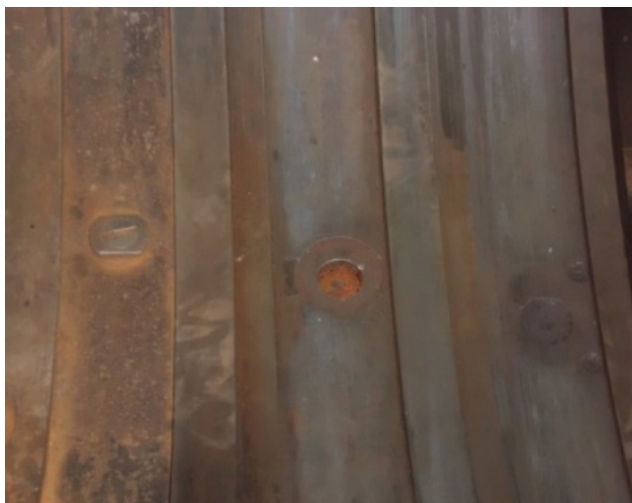
Figure 2. Additional unknown screw inside turbine casing.

casing had been modified by another original equipment manufacturer (OEM). A comprehensive survey/investigation was conducted to document the present state of the equipment, where it was found that the existing spare unit could be restored by using modernisation techniques involving installation of a new turbine rotor and internal parts. The existing turbine casing was then shipped to MCO's factory in Hiroshima, Japan. Figure 2 shows the existing turbine casing pictured in the customer's plant prior to restoration.

The discrepancies from the measured values to the values on the original drawings were captured and analysed. Figures 2 – 5 show distortion and damaged parts, such as additional machining within the casing and unknown screws and piping. An additional inner casing was installed to the existing turbine to match the other OEM's design. The other OEM's design philosophy was completely different to MCO's. An additional inner casing was not required for MCO's design and proved futile. Oversized screw machining was performed for unknown screws and a new plug was welded and installed.

The damages found as a result of a flatness inspection discussed above (Figures 2 – 5) were repaired to increase performance. The turbine casing was repainted after NDT testing and the horizontal surface was machined within the acceptable tolerance for new turbines. A hydrostatic test was performed for the repaired casing applying the same pressure as stated per the original casing technical specification in order to check that there was no leakage.

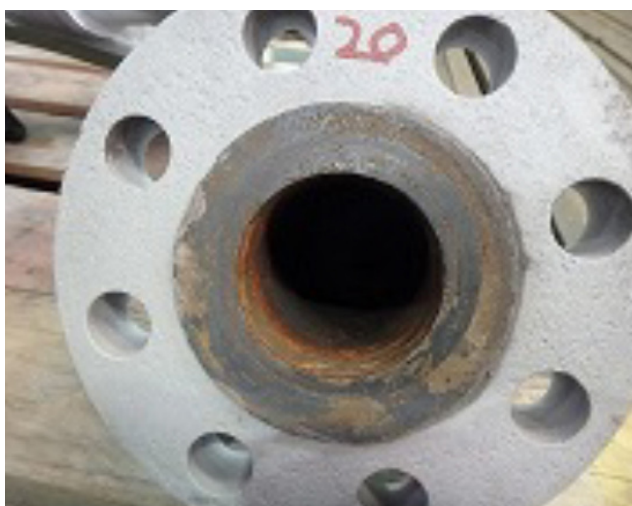
Figure 3. No serration on the flange.

Figure 3 showed no serration on the flanges. Longer periods of operation wore the serration, leading to leakage. Therefore, new flanges were installed.

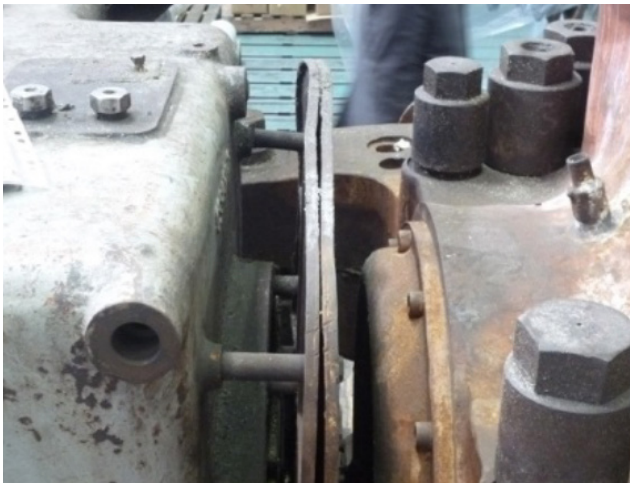
Figure 4. Damaged baffle plate.

Figure 4 shows a deformed baffle plate due to operation, which was installed between the turbine casing and bearing pedestal. The deformed baffle plate was removed and a new baffle plate was installed.

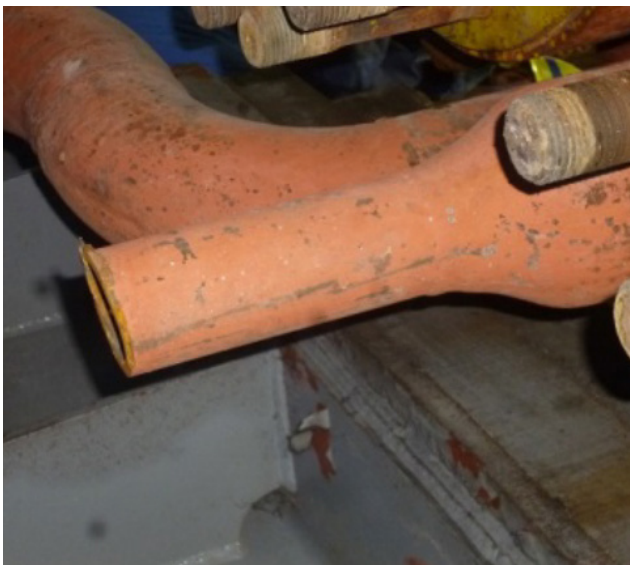
Figure 5. Cut piping.

Figure 5 shows cut piping. This piping leads to the gland sealing within the turbine. This was cut due to unknown reasons. New piping and flanges were installed to ensure the gland sealing system works as desired.
