## **SERVICE NEWS**

## INSPECTION & MAINTENANCE FOR STRUCTURE OF OPERATOR'S CABIN

AS-DC19-002E

Feb 2019

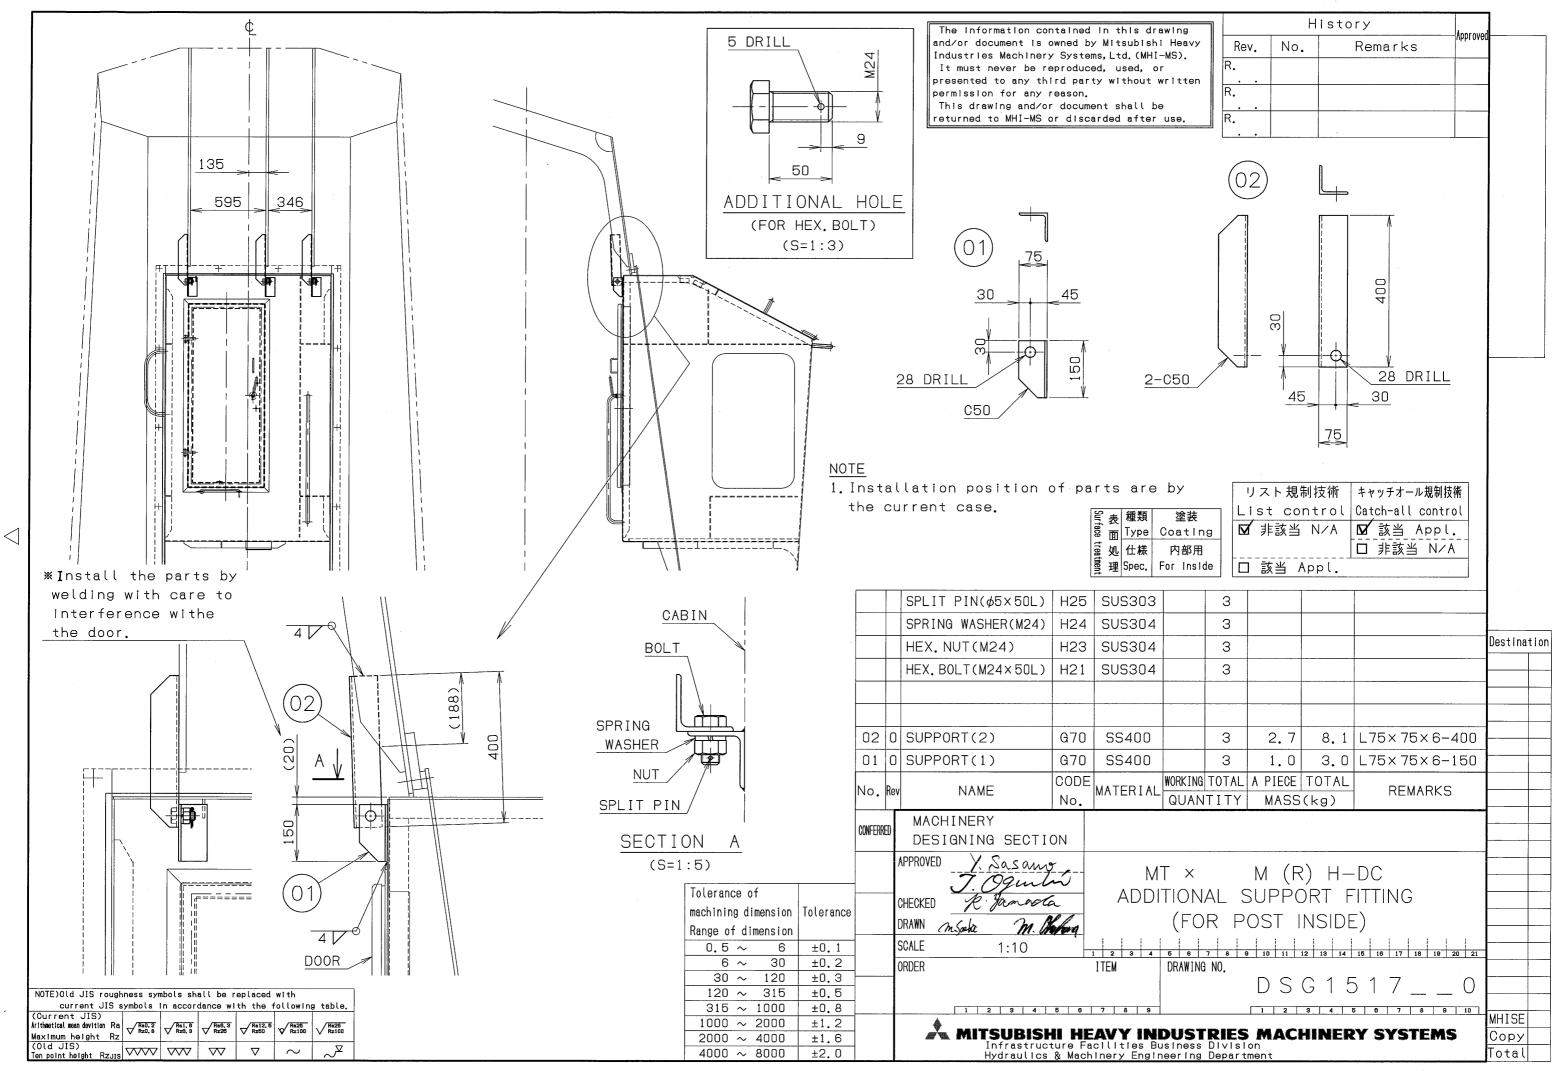
Condition	Necessary measures
Rust / corrosion of steel structure of cabin	Removal of rust and re-painting
Water ingresses through rubber for window	Apply caulking on the edge of rubber packing (outer side of cabin) [Figure 1]
Water ingresses through gap between cabin and crane's body.	Apply caulking on gap of upper of cabin and crane's body [Figure 2]
Hole, damage on steel structure of cabin / handrail	Replacement of steel plate of damaged area (Material: SS400, thickness: 6mm) Replacement of handrail (Material: SGP20A, Outer dia. φ27.2mm, thickness: 2.8mm)
Breakage of fixing bolts of cabin	Replacement of bolts  * In case replacement of bolts is difficult due to accessibility, it can be altered by addition of stiffener from inside of crane's post.  【Refer to appendix】
Breakage of wiper	Replacement of wiper
