# **MITSUBISHI HEAVY INDUSTRIES AMERICA INC.**

# SERVICE LETTER

**SUBJECT:** PPG Heated Windshield Seal

**MODELS AFFECTED:** All MU-2B Airplanes with PPG Heated Windshields

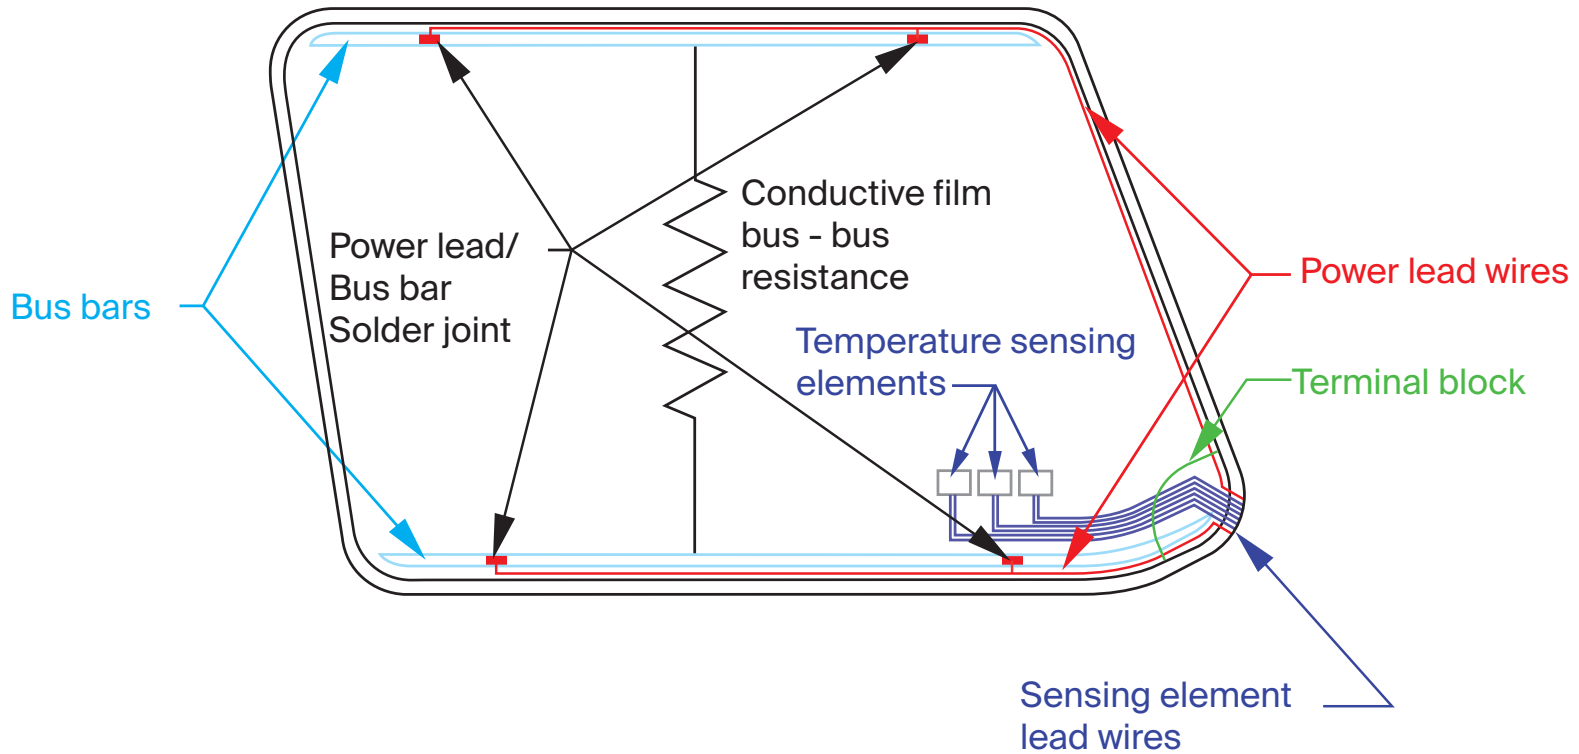
1. Moisture seal degradation caused by wind erosion, rain erosion, cracking or debonding of sealant
2. Moisture ingress into laminate and UV exposure
3. Interlayer degradation (discoloration and cracking)
4. Delamination (separation of interlayer from glass/plastic)
5. Bus bar degradation (discoloration and cracking)
6. Deterioration at the junction of the bus bar and conductive heating film
7. Electrical arcing caused by discontinuity at the junction of the bus bar and conductive heating film
8. Glass ply fracture resulting from surface damage caused by electrical arcing and localized overheating condition
