**SL 113A  
SL 086/25-003A**

**FAA AD 2021-07-13, Global AMOC and Meggitt Service Bulletin -  
Pacific Scientific Company Seat Restraint System Rotary Buckle  
Assemblies**

**SUBJECT:** FAA AD 2021-07-13, Global AMOC and Meggitt Service Bulletin – Pacific Scientific Company  
Seat Restraint System Rotary Buckle Assemblies

**MODELS AFFECTED:** All MU-2B Airplanes equipped with shoulder harness restraint systems installed per  
STC No. SA1751SW

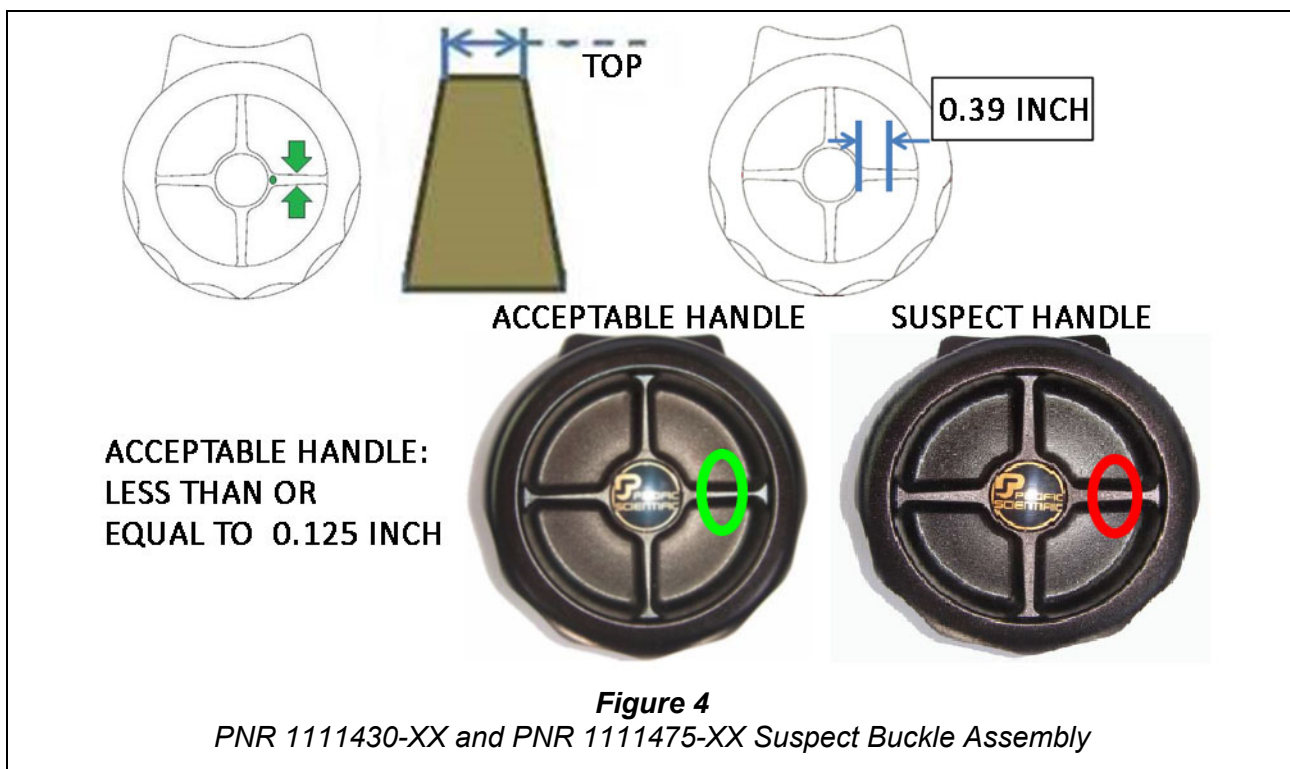
**Figure 3**  
*Correct Buckle Measurement*

(2) Within 12 months, measure the thickness of the buckle handle vane as depicted in Figure 3 of SB 25-1111432. If the handle vane thickness is 0.125 inch or greater, before further flight, remove the buckle from service and replace it with an airworthy buckle.

- (1) Measure the handles in accordance with Figure 3 on page 19 and Figure 4 on page 19 to make sure the handles are less than 0.125 inches at the top edge. Meggitt has created an optional inspection tool (PNR 1111432-GA). Contact Meggitt for purchase of the inspection tool. Refer to Figure 5 on page 20 for correct use of the optional inspection tool.

- (1) Remove and replace the restraint system with a spare.
- (2) Refer to the paragraph 4.D. and 4.E. for disassembly and assembly of restraint system to repair the removed restraint system :
  - (a) Remove the buckle assembly in accordance with Figure 6 on page 22.
  - (b) Replace the suspect buckle assembly with a new and compliant unit.
