**SL 104  
SL 077/56-001  
PPG Heated Windshield Seal**

# SERVICE LETTER

**SUBJECT:** PPG Heated Windshield Seal

**MODELS AFFECTED:** All MU-2B Airplanes with PPG Heated Windshields

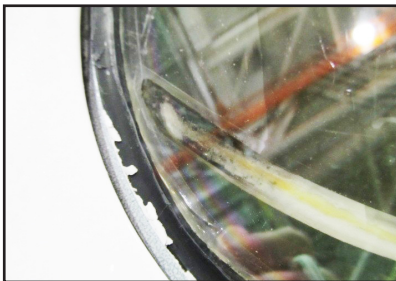
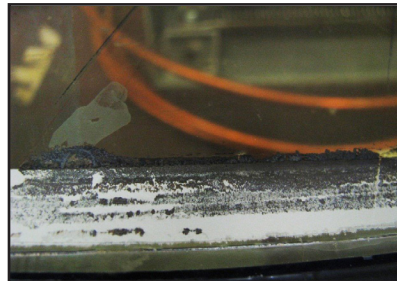
Caused by moisture ingress resulting in bus bar/conductive heating film arcing and localized "hot spots."

- **Moisture ingress** – This can result in oxidation, corrosion, degradation, debonding and cracking of the bus bar material. Discoloration alone is not a reason to remove the window, unless it occurs along the edge of the bus bar at the connection to the heated area (an indication of arcing).

- **Bus bar/conductive film arcing** – Moisture ingress can result in degradation of the electrical system and lead to electrical arcing. This can cause discoloration (amber, brown or black) along the inner edge of the bus bar as a result of the overheating condition. If the heating film bus-to-bus resistance is outside the allowable limits defined in the AMM or applicable CMM/ACMM, the window should be removed.

- On programs with UV stabilized interlayer, the bus bars will degrade the same as all other windshields. Special attention should be given to inspecting the bus bars since the interlayer will not break down and show moisture ingress. Discoloration along the edge of the bus bar at the connection to the heated area is an indication of a potential failure and the part should be scheduled for removal.

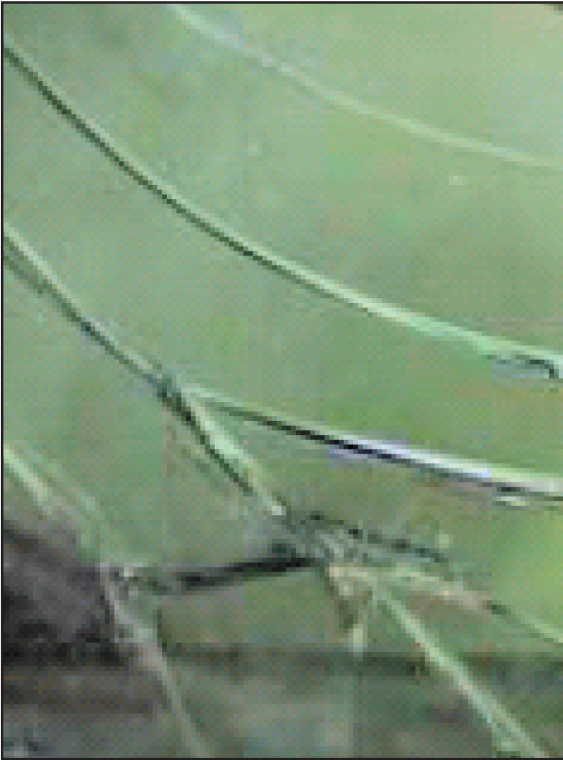
Typical fracture pattern  
fragment size of  
chemically strengthened glass
