**MU-2**

# SERVICE RECOMMENDATION

No.046/32-004                      DATE: February 28, 2017

Subject:                              Nose Landing Gear System Inspection

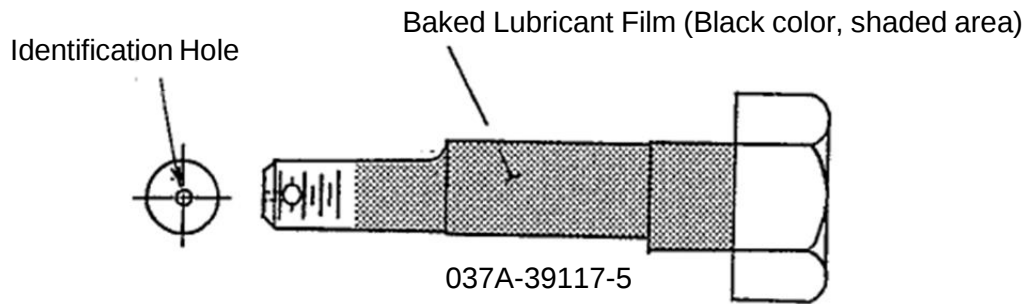
Figure 13: Eccentric Bolt Identification

- (1) Check aircraft Log Books for compliance of SB 072/32-011 Rev. "A".
  - (a) If not previously complied with the SB, install a new Eccentric Bolt in accordance with SB 072/32-011 Rev. "A".
- (2) Confirm the part number of Eccentric Bolt. The part number should be 037A-39117-5. Correct bolt has identification hole on the bottom of the bolt shank. (Figure 13)
  - (a) If the part number is 037A-39107 or 037A-39117-3, replace the Eccentric bolt with a new 037A-39117-5 bolt.
  - (b) If the part number is 037A-39117-5 and the bolt has more than 4,000 hours in service, replace the Eccentric bolt with a new 037A-39117-5 bolt.
