**Jason DuBose and Matt Walton,**  
**Mitsubishi Heavy Industries**  
**Compressor International Corp.,**  
**USA,** share a case study of how a first  
generation syngas steam turbine was  
modified after catastrophic damage.

# A HYBRID approach

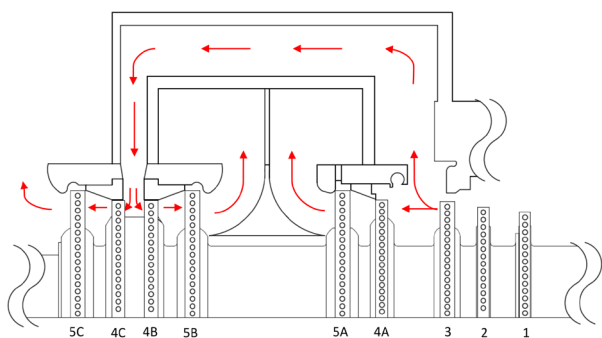
**Figure 1.** Configuration of the subject turbine.

In this case, the subject rotor was a split-flow steam turbine operating at 11 230 RPM, which is above second critical. To accommodate the centrifugal forces associated with this type of operating speed, the rotor was configured with a single disc for stages 1 – 3, and triple discs for stages 4 and 5, which minimises the maximum outside diameter (OD) of the latter stages. This reduces thrust loads and was done due to manufacturing and technological limitations relating to the blade height when the turbine was manufactured. An illustration of the turbine is shown in Figure 1. In February 2017, the unit began experiencing vibration issues, which continued until
